**REPORT ON PHASE I ENVIRONMENTAL
SITE ASSESSMENT**

DESIGNATION: Stetson Village

LOCATION: Northeast Corner of Happy Valley Road and
39th Drive in Glendale, Arizona

PROJECT NO: 211817EA

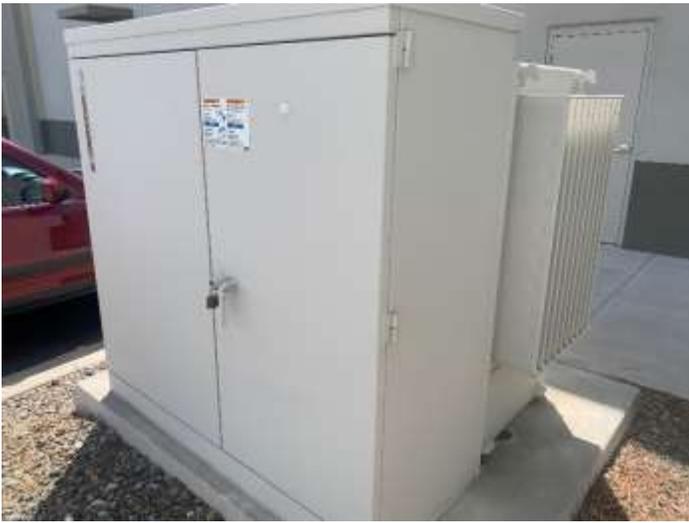
In the past, oil found in electrical transformers contained Polychlorinated Biphenyls (PCBs), which have been found to be a human carcinogen. Since 1984, manufacturers of transformers have been certifying them “non-PCB”, containing less than 50 parts per million (ppm). During the site visit, 13 transformers were observed on the Property at the time of the site visit. The transformers appeared to be in good condition with no observed staining, or obvious odors. Mr. Anthony Williams with the Arizona Public Service (APS) was contacted regarding PCB status of the transformers. Mr. Williams reported that most of the transformers were certified as non-PCB containing; the PCB status of transformer located on Happy Valley Road and near 37th Avenue was unknown (Williams; APS).

Photo No. 13: View of typical pad-mounted transformer centrally located on the Property.

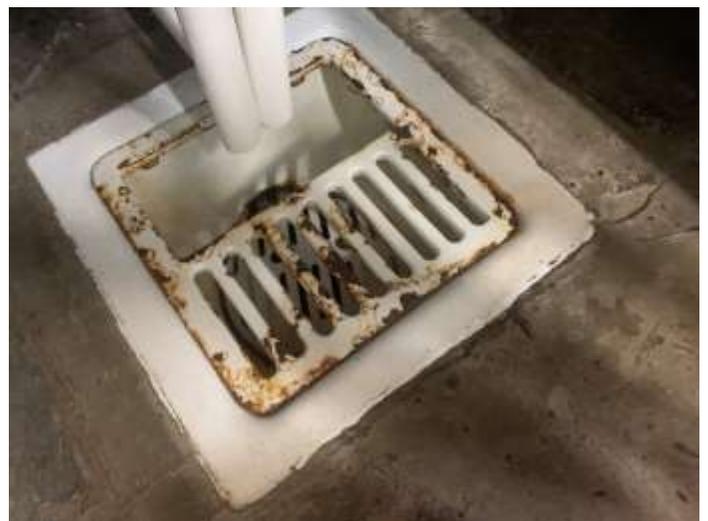
Photo No. 18: View of floor drain located in the Blimpie kitchen located in the western portion of the Property.

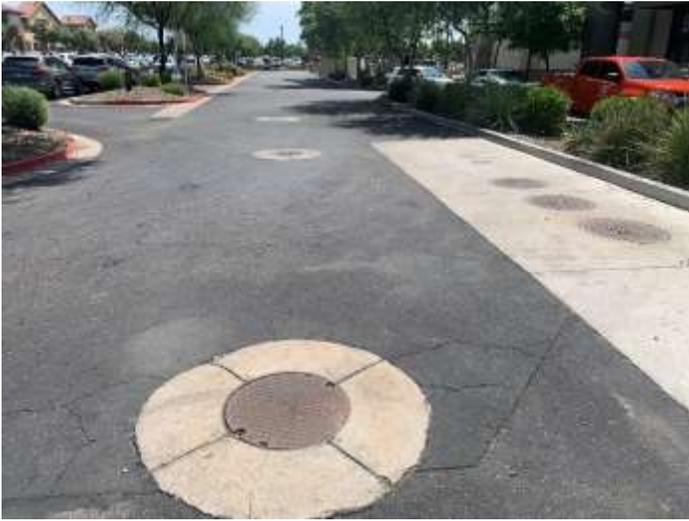
Photo No. 25: View of drywell and grease interceptor centrally located on the Property.

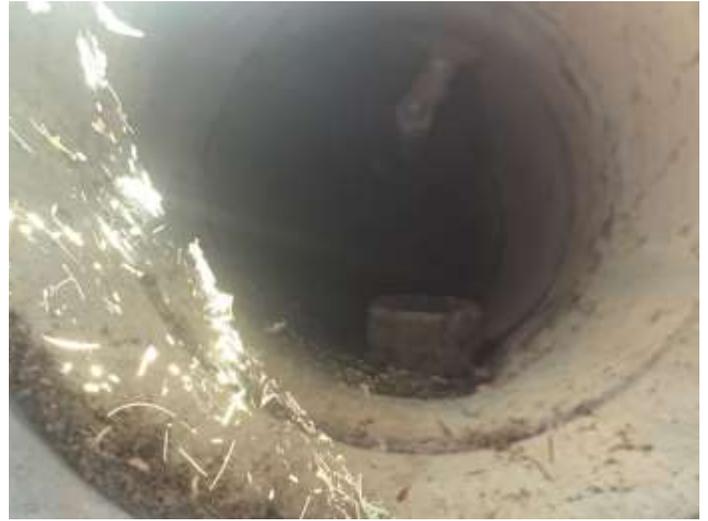
The ADEQ maintains a database of dry wells, the registration of which has been required since 1986. Allands reviewed this database for dry wells registered within a 0.125-mile search distance of the subject Property. Based on this review, 18 dry wells registered to Stetson Village were identified within the search distance (Allands). At the time of the site visit, 18 dry well systems were observed on the Property. The Property's stormwater management system appeared to divert excess stormwater towards the dry wells via surficial retention areas and numerous sub-grade retention chambers located throughout the Property. The dry wells appeared to be in good condition, although observation inside the chambers was limited due to the depth of the settling chambers.

Photo No. 26: View of settling chamber located in a centrally located in the southern paved parking area of the shopping center.

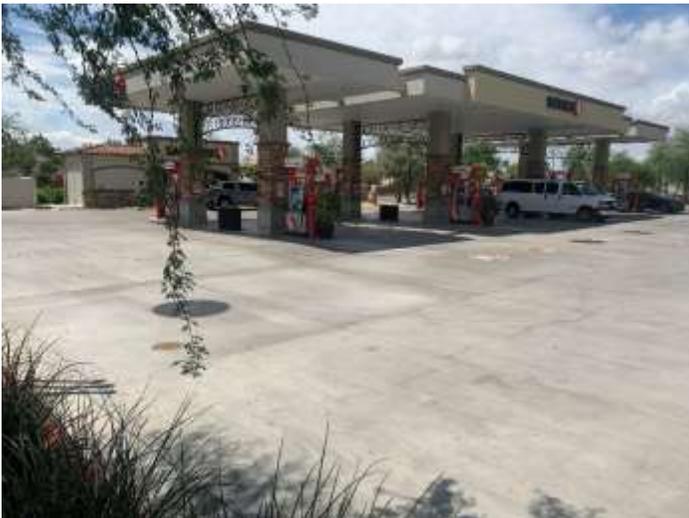
Safeway Fuel Station	A Safeway fuel station was located in the southeast portion of the Property. The fuel station consisted of a single fuel canopy that covered eight (8) fuel dispensers servicing two (2) 20,000-gallon USTs. The USTs are located northeast of the fuel canopy and were reported to be double-walled and equipped with integral secondary containment and leak detection. The surface of the fuel station consisted of concrete and appeared to drain into a walled landscaped retention feature on the east side of the fuel canopy. A catch basin on the west side of the fuel canopy and a break in the western wall appeared to be the only flow paths into this retention feature. A system monitoring well was located between the tank bed and the retention feature. An approximate 350 square foot Safeway convenience store building was located on the south side of the fuel canopy. This store contained various foods, drinks, and other merchandise, a checkout counter, and a back room. The back room of the convenience store contained fire risers, restrooms, and several sinks. No obvious staining or odors were detected at the time of the site visit.	N

Photo No. 27: View of Safeway fuel islands and UST beds located near the southern Property boundary.

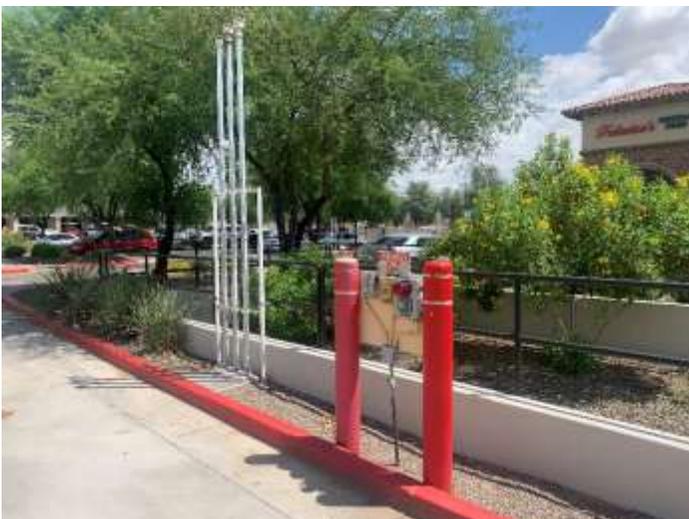
Photo No. 29: View of leak detection system located in the Safeway fuel center.

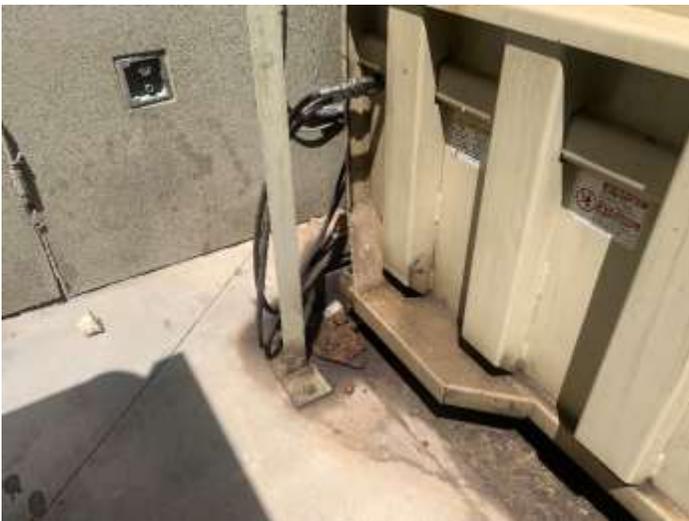
Photo No. 33: View of surficial staining located near the hydraulic components of the trash compactor.

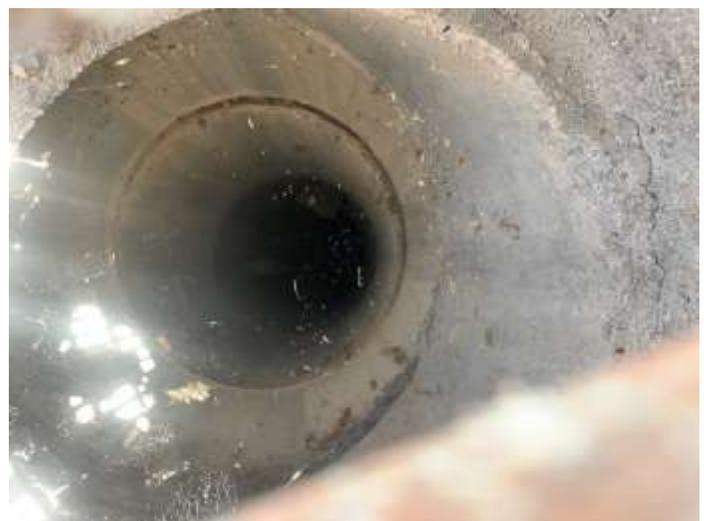
Photo No. 36: View of settling chamber of the northernmost drywell located in the northern retention area.
