Phase I Environmental Site Assessment

Talinn West

North of North 56th Street and East Deer Valley Drive
Phoenix, Maricopa County, Arizona 85054

September 21, 2022

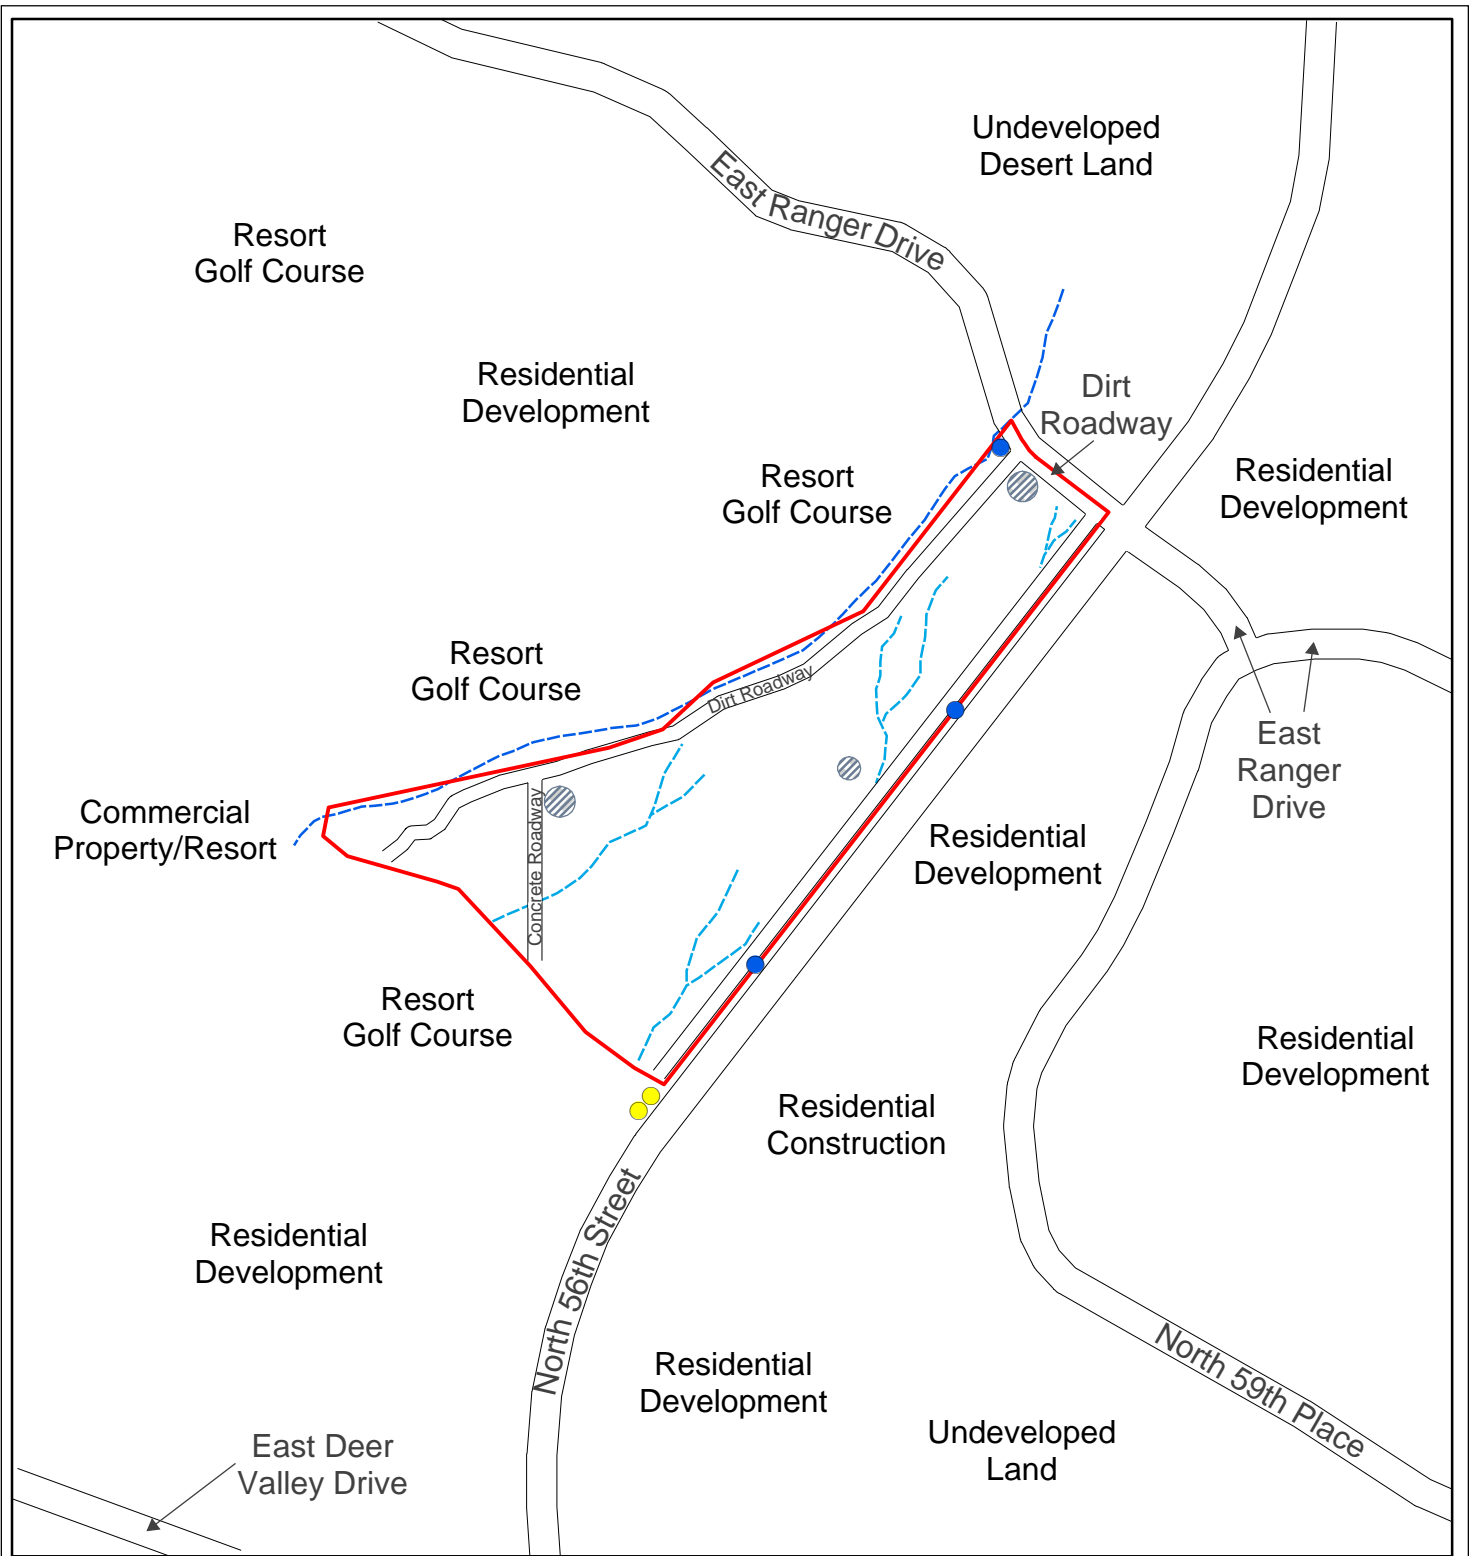
- Debris was observed on the northeastern, east central, and western portions of the property and consisted of a sediment pile, minor concrete, and wooden shed debris. All debris appeared to be surficial in nature.

BC's site reconnaissance revealed evidence of solid waste on the northeastern, east central, and western portions of the target property in the form of debris/trash. Items observed included a sediment pile, minor concrete, and wooden shed debris.

The debris should be collected and disposed from the target property in accordance with state and local regulations. If indications of any potential regulated materials or releases are observed during removal, BC should be contacted to determine if additional assessment is warranted.
