**REPORT ON PHASE I ENVIRONMENTAL  
SITE ASSESSMENT**

**DESIGNATION:** Lake Pleasant - State Land Triangle

**LOCATION:** Northwest Corner of Lake Pleasant Parkway and  
Happy Valley Road in Peoria, Arizona

**PROJECT NO:** 200342EA

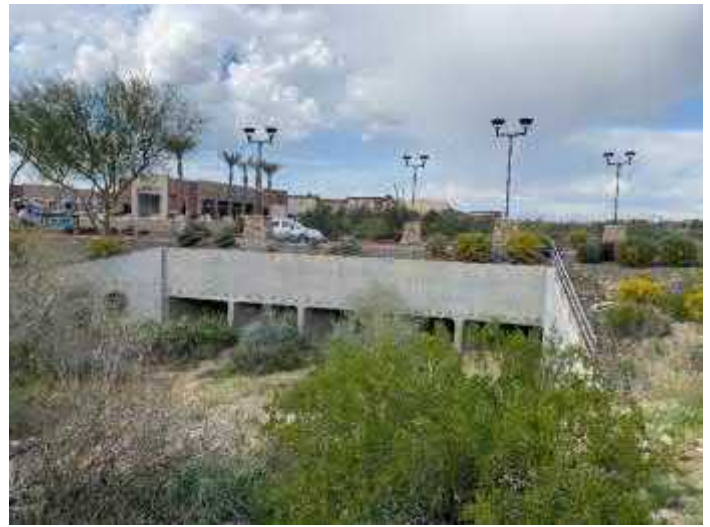
**Photo No. 8: View of large box culvert and paved access road extending east to west near the center of the Property.**

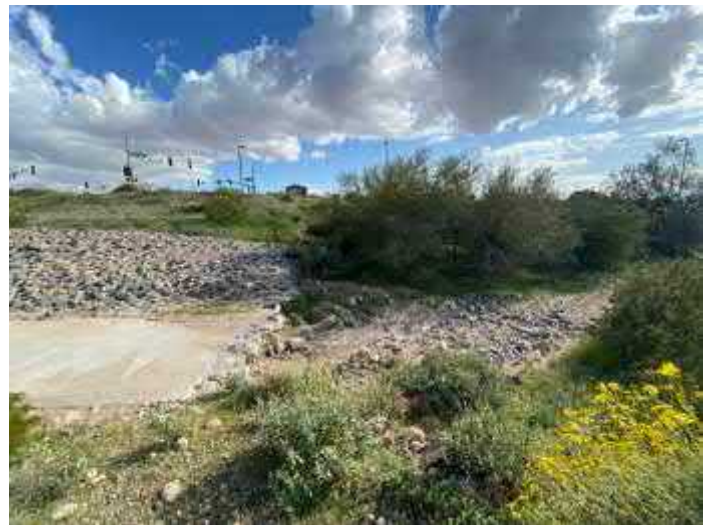
**Photo No. 10: View of drainage feature leading into a wash; view to the south.**

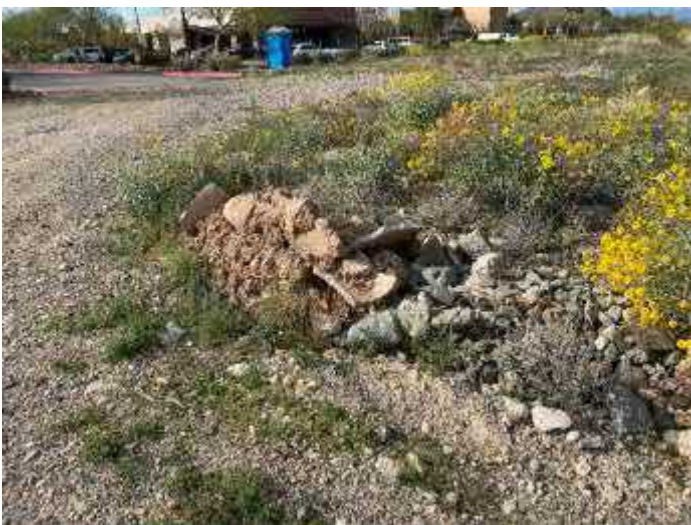
**Photo No. 11: View of rubble located near the southern portion of the Property; view to the northwest.**

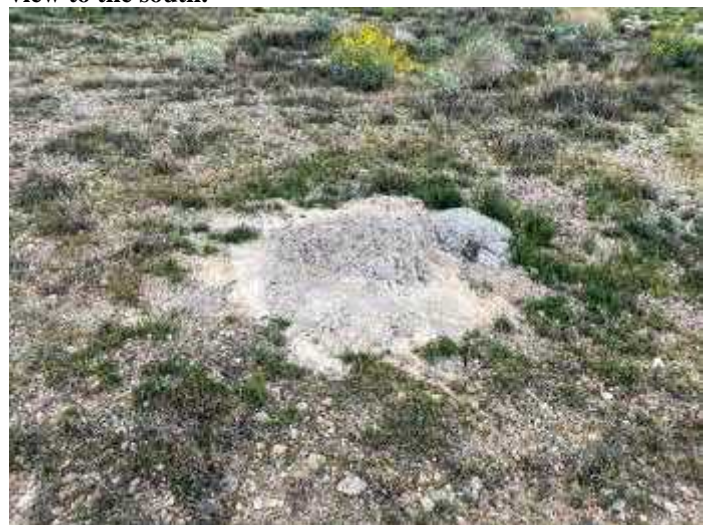
**Photo No. 12: View of dried concrete washout located near the center of the southern portion of the Property.**

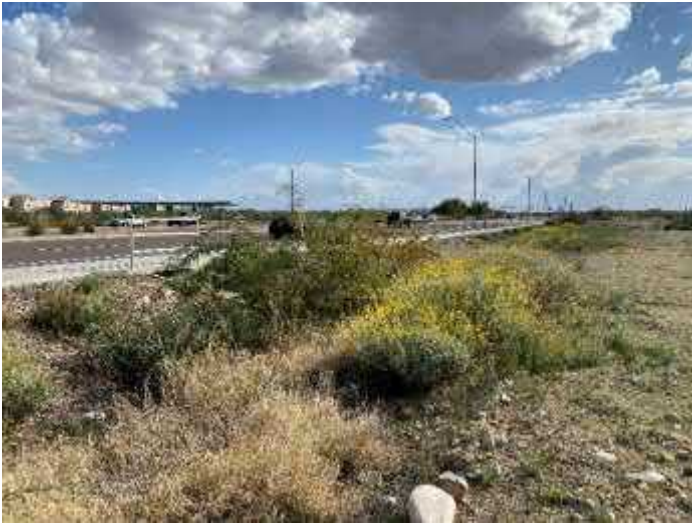
**Photo No. 13: View of drainage channel extending to the south along the eastern Property boundary; view to the southeast.**
