Phase I Environmental Site Assessment

**Land With Electrical Substation
Northeast Side of Maricopa-Casa Grande Highway East of Porter Road
Maricopa, Arizona 85138**

Project 27572

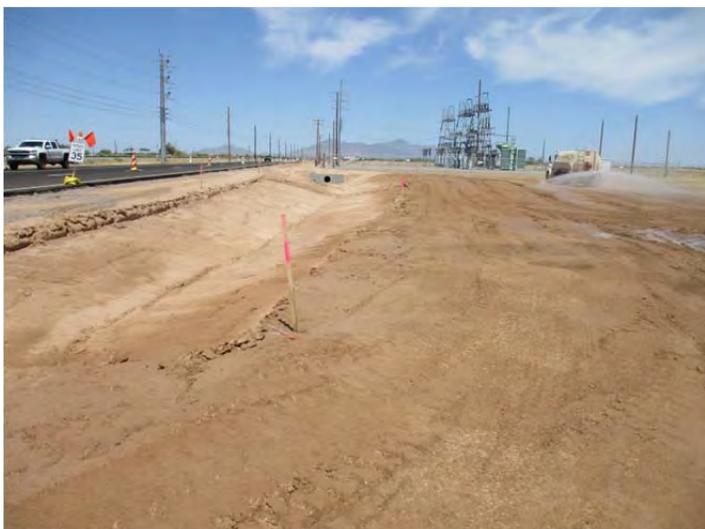
Photograph 1 – A view of the property, looking northwest from its southeast corner.

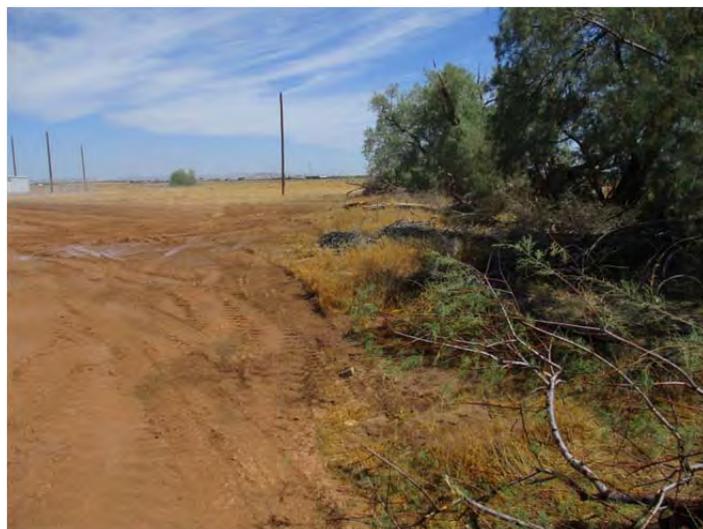
Photograph 2 – A view of the property, looking north from its southeast corner.

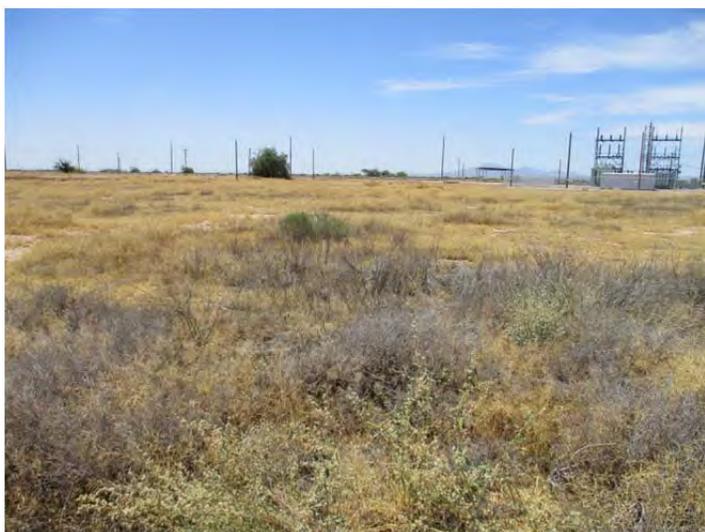
Photograph 3 – A view of the property, looking south from its northeast corner.

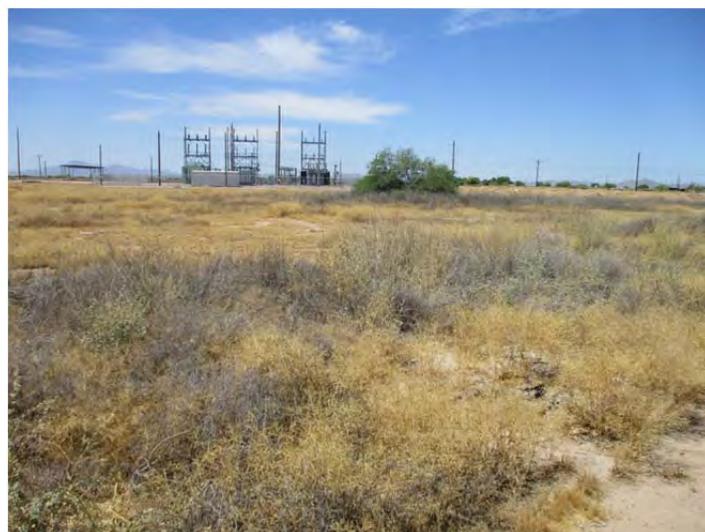
Photograph 4 – A view of the property, looking southwest from its northeast corner.

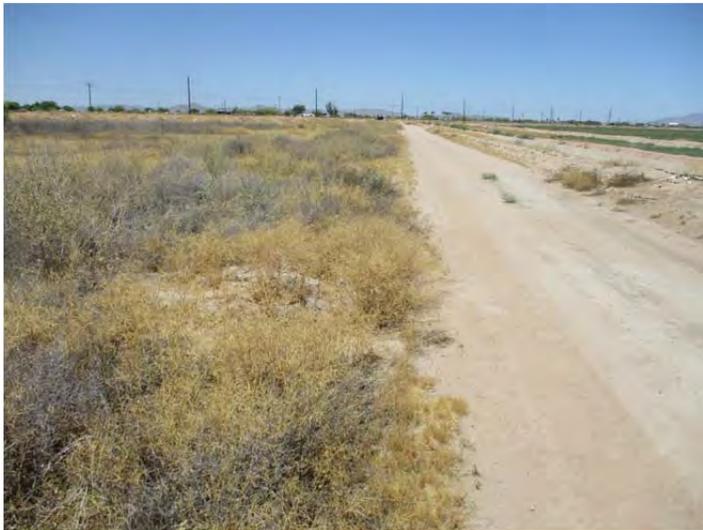
Photograph 5 – A view of the property, looking west from its northeast corner.

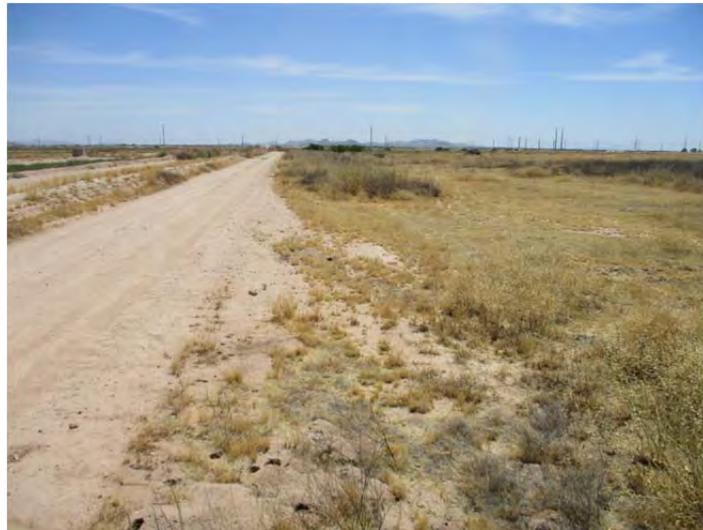
Photograph 6 – A view of the property, looking east from its northwest corner.

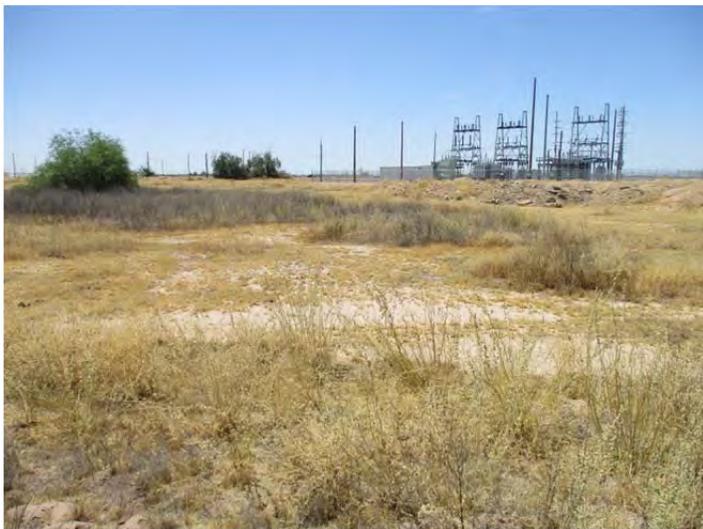
Photograph 7 – A view of the property, looking southeast from its northwest corner.

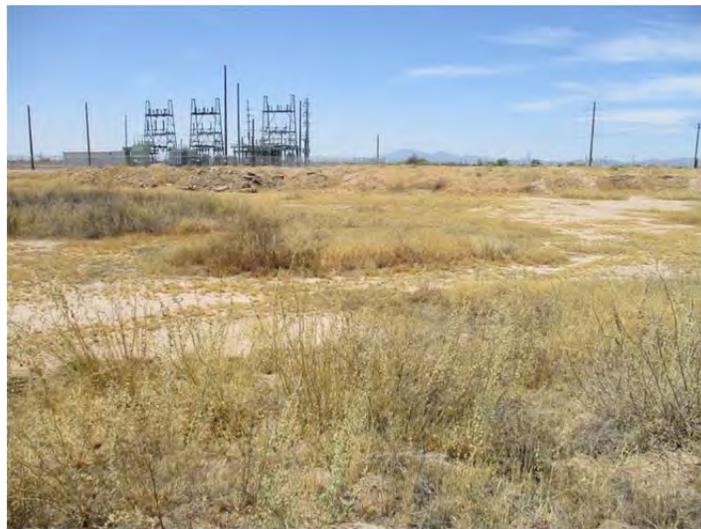
Photograph 8 – A view of the property, looking south from its northwest corner.

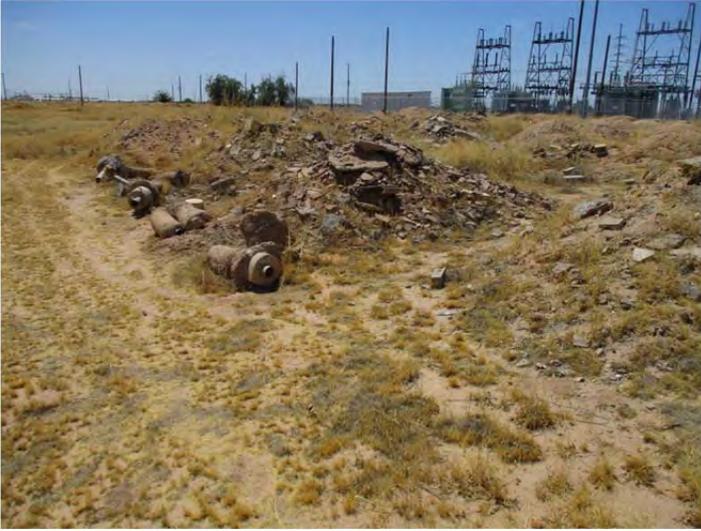
Numerous end-dumped soil piles and a few piles of soil with demolition debris cover much of the west half of the property north of the substation. The demolition debris was seen to consist mostly of chunks of broken masonry wall with some rebar, broken concrete roof tiles, pieces of concrete, chunks of asphalt pavement, pieces of wall stucco with wire lath, clay brick, and fencepost footings. An occasional segment of lumber or small diameter plastic pipe was also seen.

Numerous end-dumped soil piles and a few piles of soil with demolition debris cover much of the west half of the property north of the substation. The soil type appears consistent from pile to pile, the piles are mostly grouped together, and the soil exhibits no discoloration or odors indicative of contamination with hazardous substances or petroleum products. These soils are likely discarded overburden soils excavated from the borrow pit west of the property. Based on this information, we have no recommendations for further investigation of these soils.

The demolition debris was seen to consist mostly of chunks of broken masonry wall with some rebar, broken concrete roof tiles, pieces of concrete, chunks of asphalt pavement, pieces of wall stucco with wire lath, clay brick, and fencepost footings. An occasional segment of lumber or small diameter plastic pipe was also seen. No materials unsuitable for regular landfill disposal were seen.

Photograph 9 – A typical view of the soil and demolition debris piles on the property.

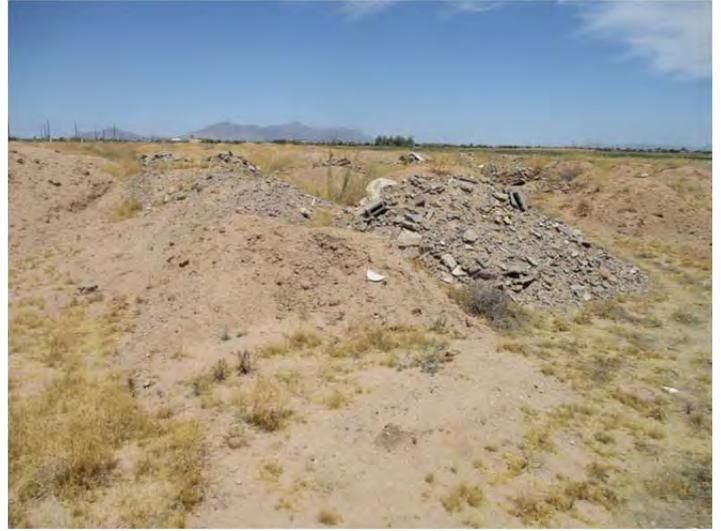
Photograph 10 – Another typical view of the soil and demolition debris piles on the property.

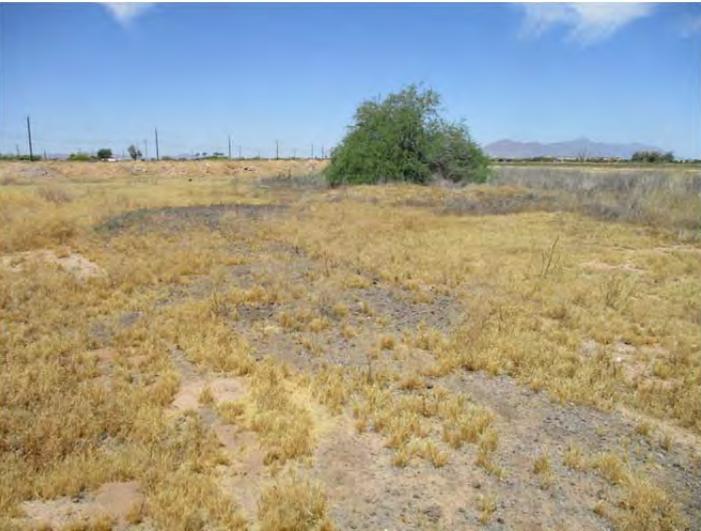
There is a lone desert tree on the north side of the property. Two piles of soil with cobbles and thinly spread remnants of mulch were seen east and southeast of the tree. The soil piles on the property exhibit no discoloration or odors indicative of contamination with hazardous substances or petroleum products.

Photograph 11 – A view of the mulch remnants and soil piles near the northeast corner of the property, looking west.

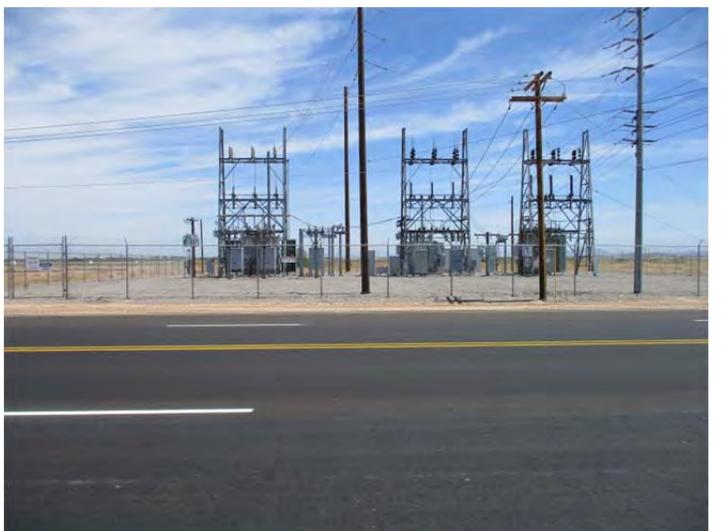
Photograph 12 – A view of the Electrical District No. 3 Sonny Dunn substation on the property, looking northeast across Maricopa-Casa Grande Highway.

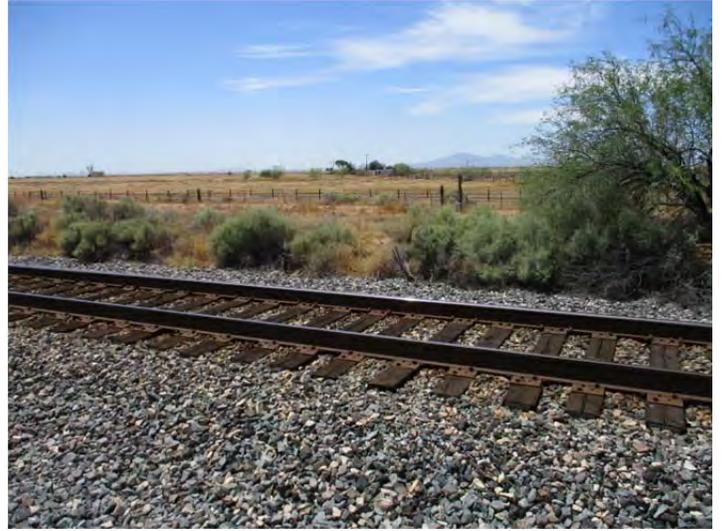
Photograph 22 – A view of the south adjoining inactive dairy farm, looking generally south from a point south of the southeast corner of the property.

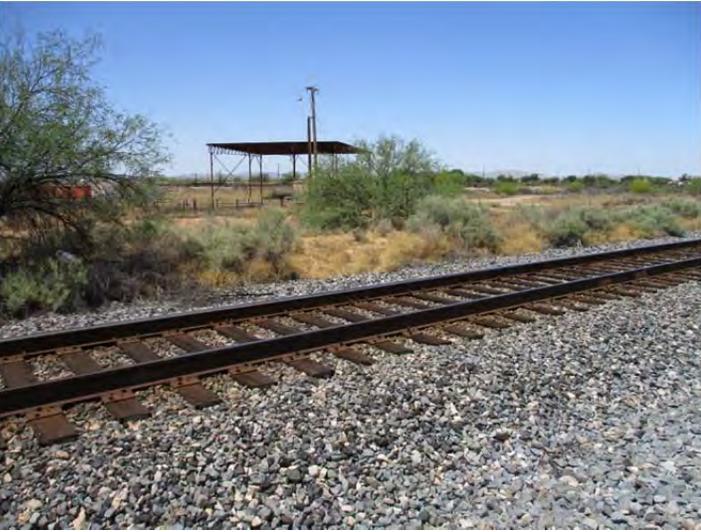
Photograph 23 – Another view of the former dairy farm south of the property, looking southwest from the same point as the previous photograph.
