## **PHASE I ENVIRONMENTAL SITE ASSESSMENT**

### **APPROXIMATE 99.35-ACRE LAND PARCEL**

Northwest of Van Buren Street & Cotton Lane  
Goodyear, Arizona 85338

Project Number: 23-1013

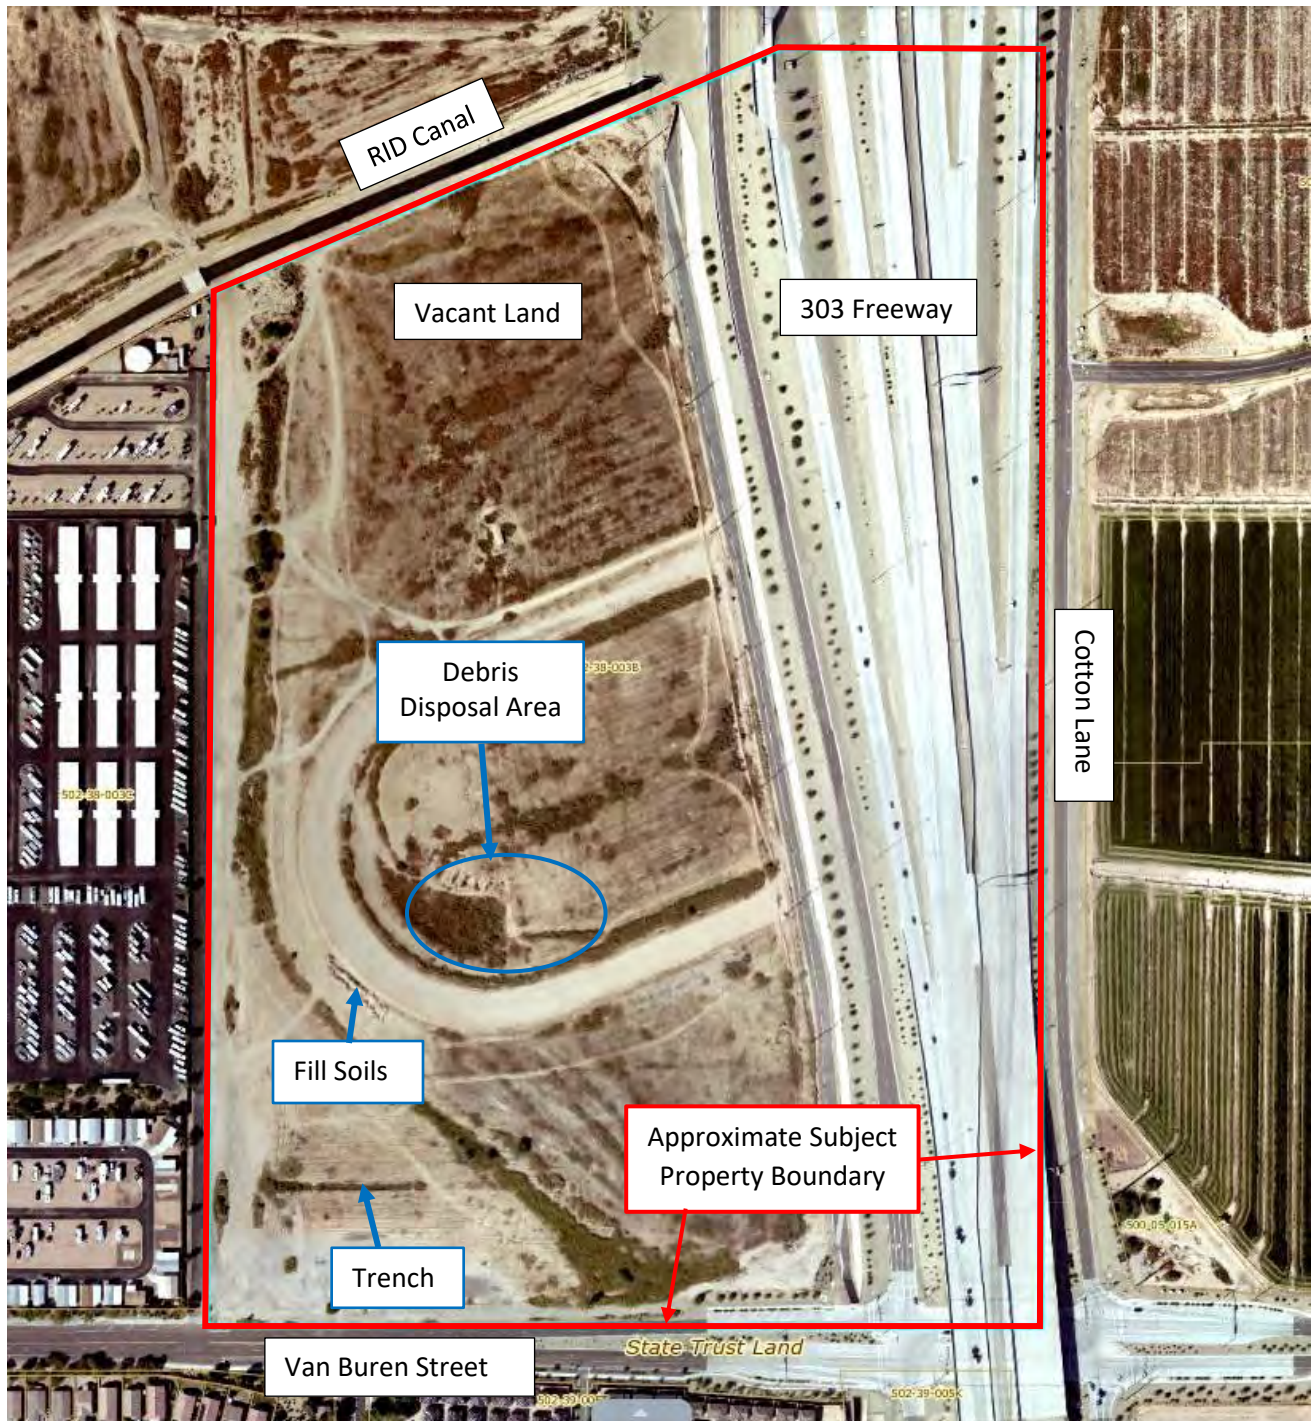
Selected records from the Maricopa County Assessor are included in **Appendix E**. Maps and figures are included at the end of this report. **Figure 1** identifies the Property location, and **Figure 2** identifies the approximate Property boundaries and conditions on a recent aerial photograph.

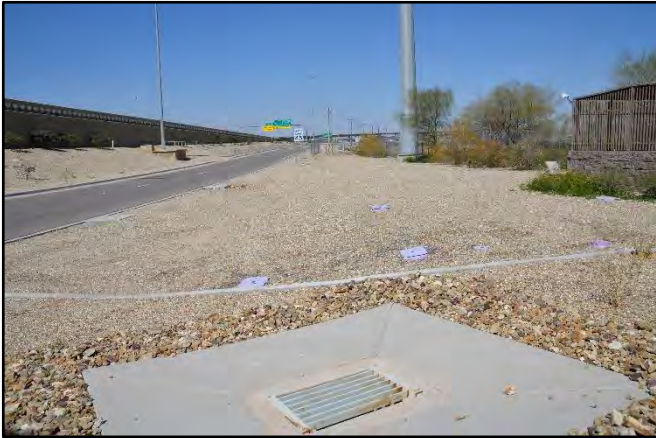
Photo 1- Looking north along Cotton Lane and the eastern Subject Property boundary from near the southeast corner of the Subject Property.

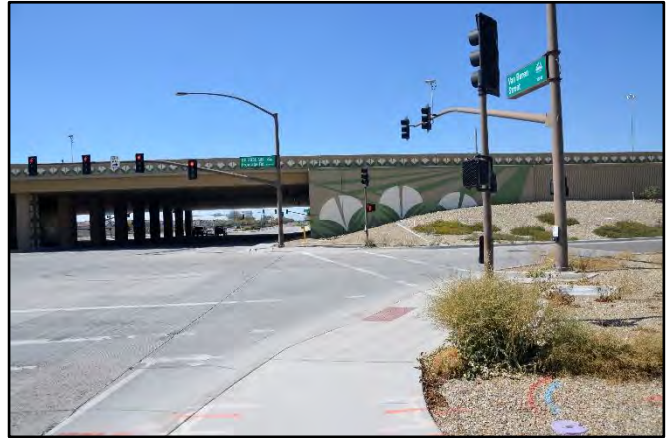
Photo 2- Looking west along Van Buren Street and the southern Subject Property boundary from near the southeast corner of the Subject Property.

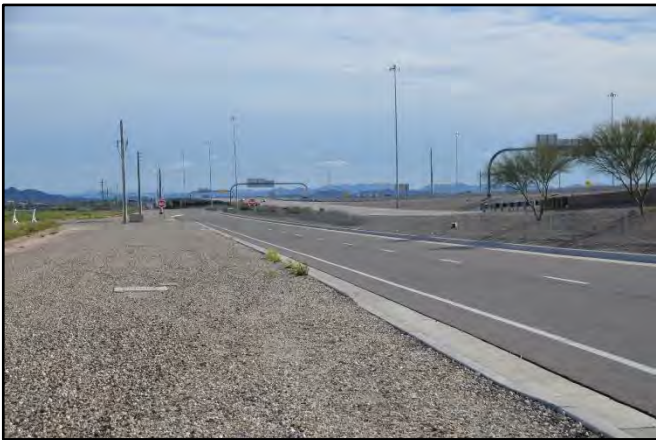
Photo 3- Looking south along Cotton Lane and the eastern Subject Property boundary from near the northeast corner of the Subject Property.

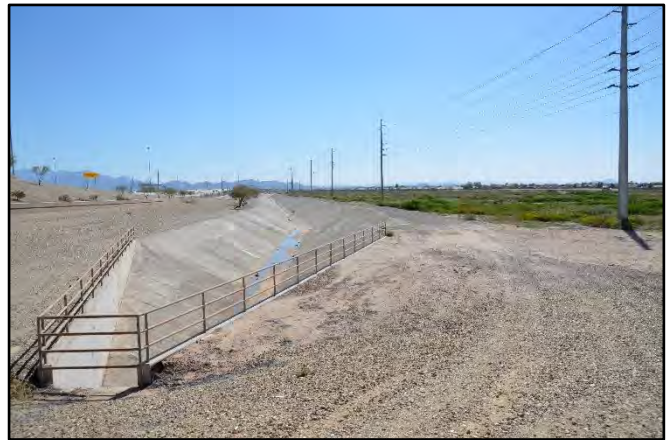
Photo 4- Looking south across the east-central portion of the Subject Property along the boundary between the 303 Freeway and vacant (western) portion of the Subject Property.

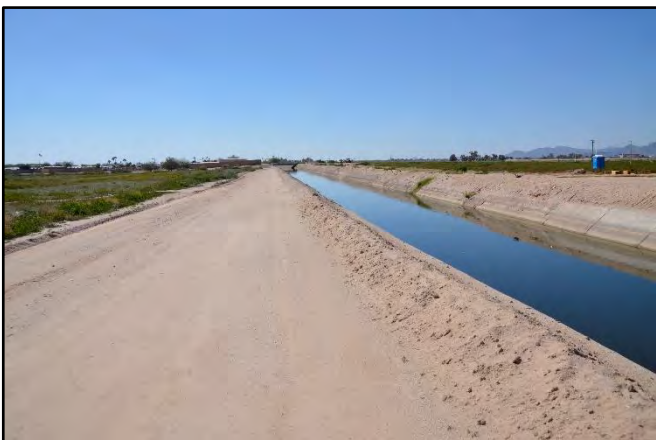
Photo 5- Looking west along the northern boundary of the Subject Property and the RID Canal.

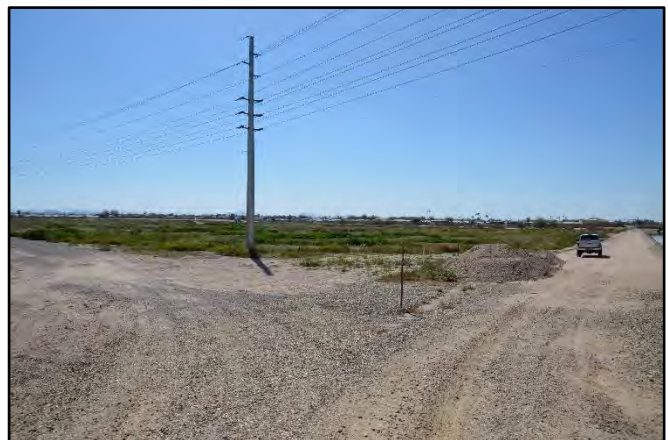
Photo 6- Looking southwest across the undeveloped portion of the Subject Property from near the northeast corner of the undeveloped land.

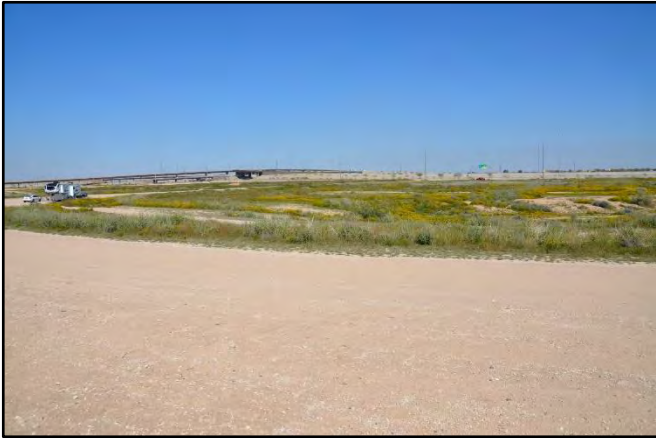
Photo 7- A portion of a dirt racing track associated with the former trotting park facilities is centrally located on the Subject Property.

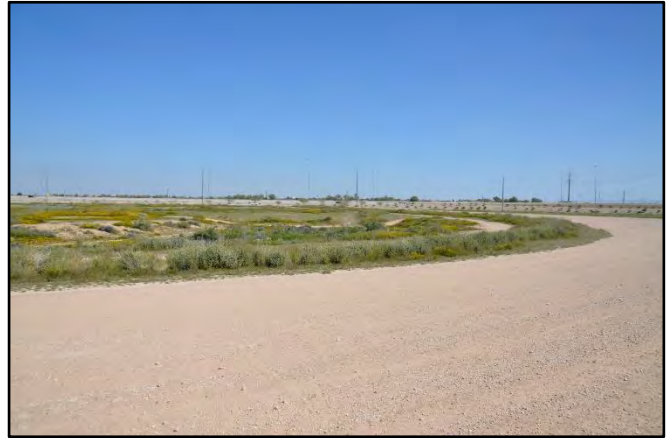
Photo 8- Another view of the dirt track. The eastern portion of the dirt track was demolished as part of the construction of the 303 Freeway on the eastern portion of the Subject Property.

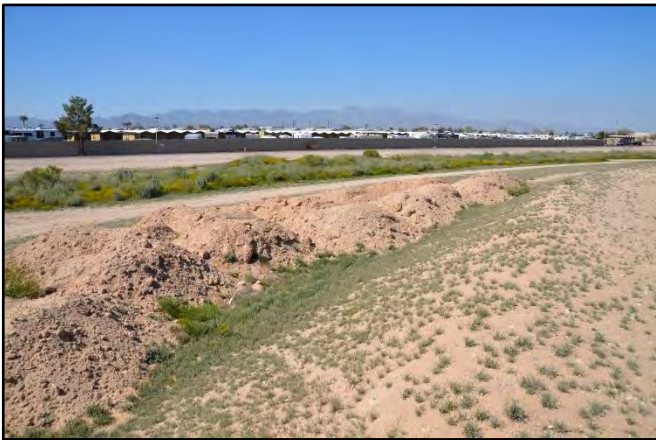
An approximate 200 foot long area of dumped fill soils was observed outside the southwest portion of the dirt track. Aerial photographs show that these fill soils were placed in this area between 2020 and 2021. During the site visit, the fill soils appeared clean with no visible debris, soil staining or odors.

Photo 9- Recently placed soil fill piles were located around the exterior of the southwest portion of the dirt track.

No environmental concerns were observed to be associated with the trash and debris, the recently placed fill soils, or the 300 foot long trench. However, not all of the debris could be observed, and the dumping areas have been used for dumping for many years, and there may be buried areas containing hazardous materials or petroleum products. These areas of dumping, fills soils and trench are considered to be a de minimis condition for the Subject Property. Additional investigations would be required to further evaluate these areas for possible environmental concerns.

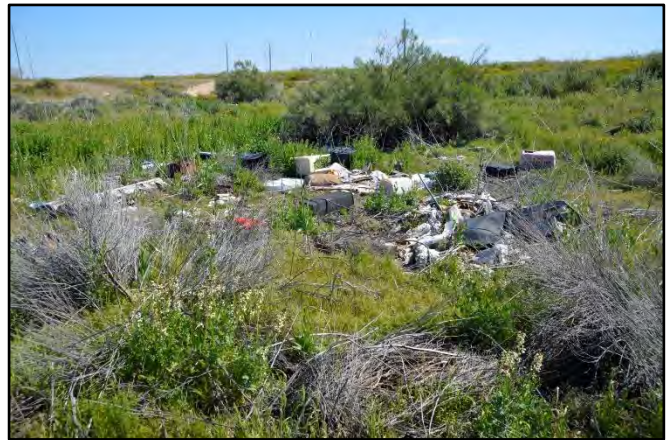
An approximate 1-acre area in the southwest portion of the Subject Property, on the inside of the southwest portion of the dirt track, appears to have been used for dumping. A dirt road runs through the dumping area. Several debris piles and areas of partially buried debris were observed in this area. Not all of the debris could be observed. No environmental concerns were observed to be associated with the visible trash and debris.

Photo 10- An approximate 1-acre area in the southwest portion of the interior of the track has been used for dumping for many years.

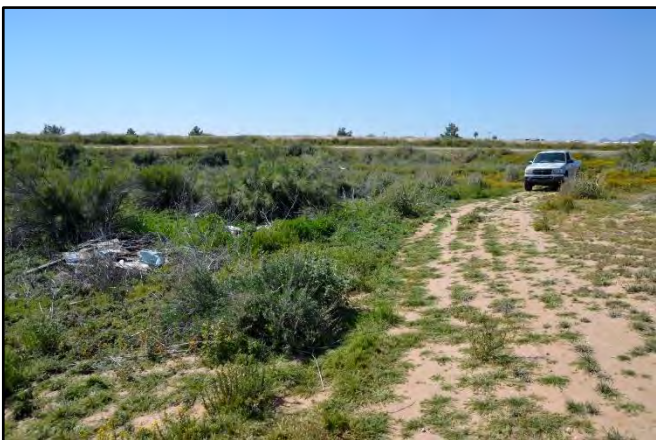
Photo 11- A dirt road runs through the dumping area.

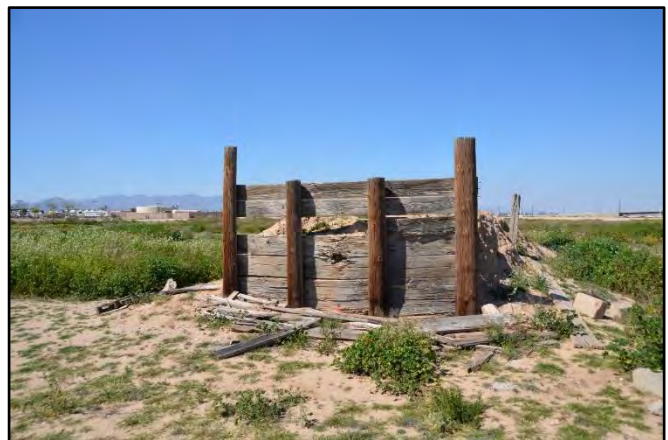
Photo 12- Remnants of an apparent loading dock are located just north of the dirt track.

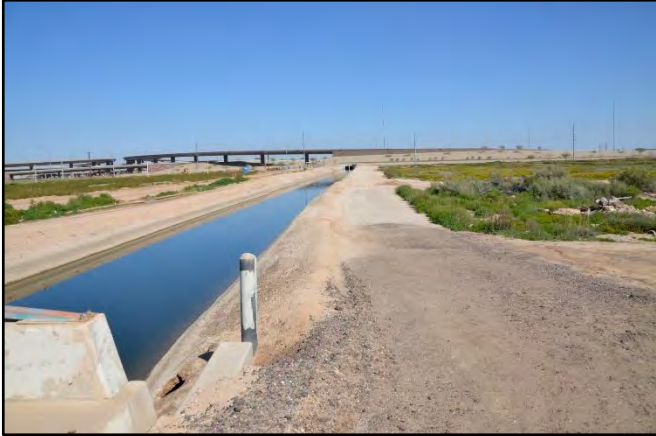
Photo 13- Looking east-northeast along the RID Canal and the northern Subject Property boundary from near the northwest corner of the Subject Property.

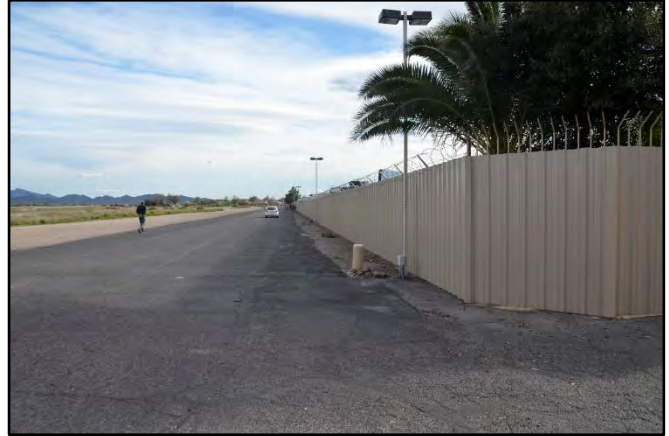
Photo 14- Looking south along the western boundary of the Subject Property from near the northwest corner of the Subject Property. An R/V Park is west of the Subject Property.

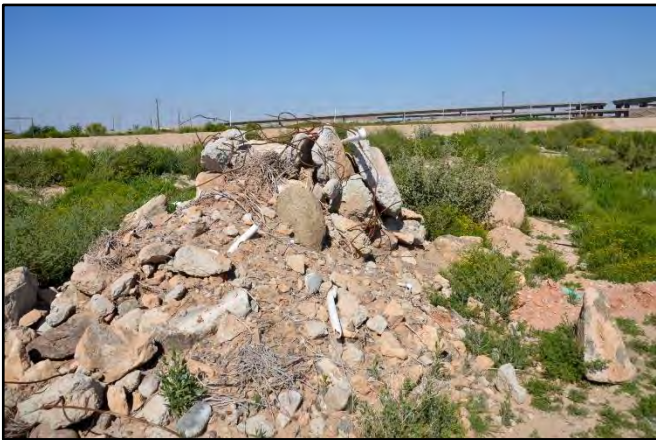
Photo 15- A small area containing apparent inert construction debris was observed near the northwest corner of the Subject Property.

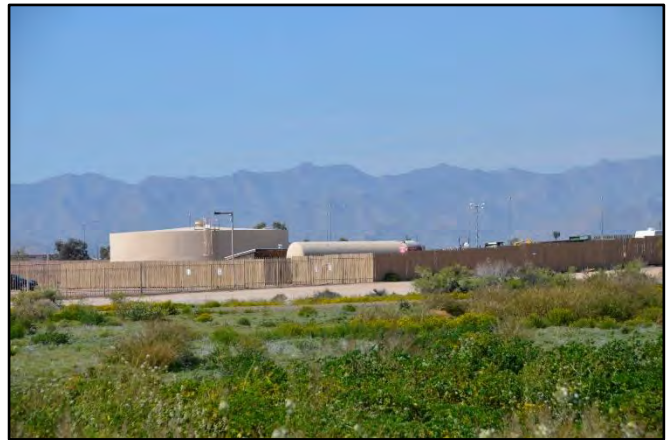
No water wells were observed or reported to be located on the Subject Property. A water well, large water storage tank, and water pressure tank associated with the west adjacent R/V park is located adjacent to the northwest corner of the Subject Property. This well was installed in 1964 as part of the development of the trotting park. A water well belonging to the RID is located near the northeast corner of Van Buren Street and Cotton Lane, adjacent to the southeast portion of the Subject Property. No environmental concerns were observed to be associated with the wells adjacent to the Subject Property.

Photo 16- A water well, water holding tank and pressure tank associated with the adjacent R/V park is located adjacent to the northwest corner of the Subject Property.

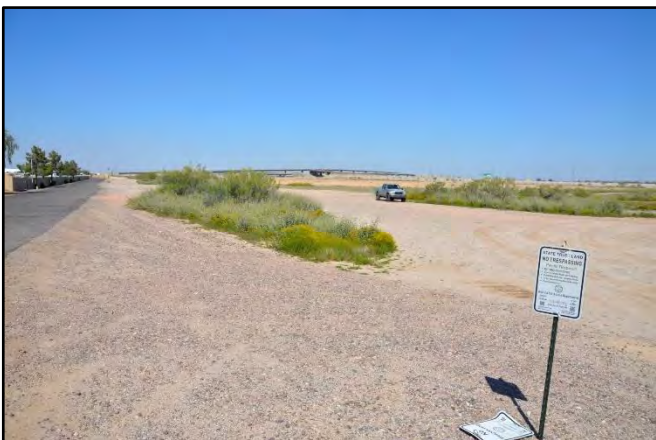
Photo 17- Looking north along the western boundary of the Subject Property from near the southwest corner of the Subject Property.

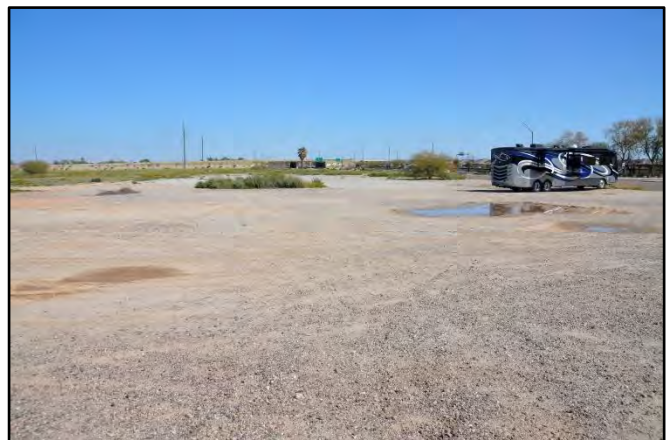
Photo 18- Looking east along the southern boundary of the Subject Property from near the southwest corner of the Subject Property.
