PHASE I ENVIRONMENTAL SITE ASSESSMENT

SITE: CORTEZ ROAD, APACHE JUNCTION, AZ 85119

REPORT DATE: July 2, 2022

PROJECT NO. 51922

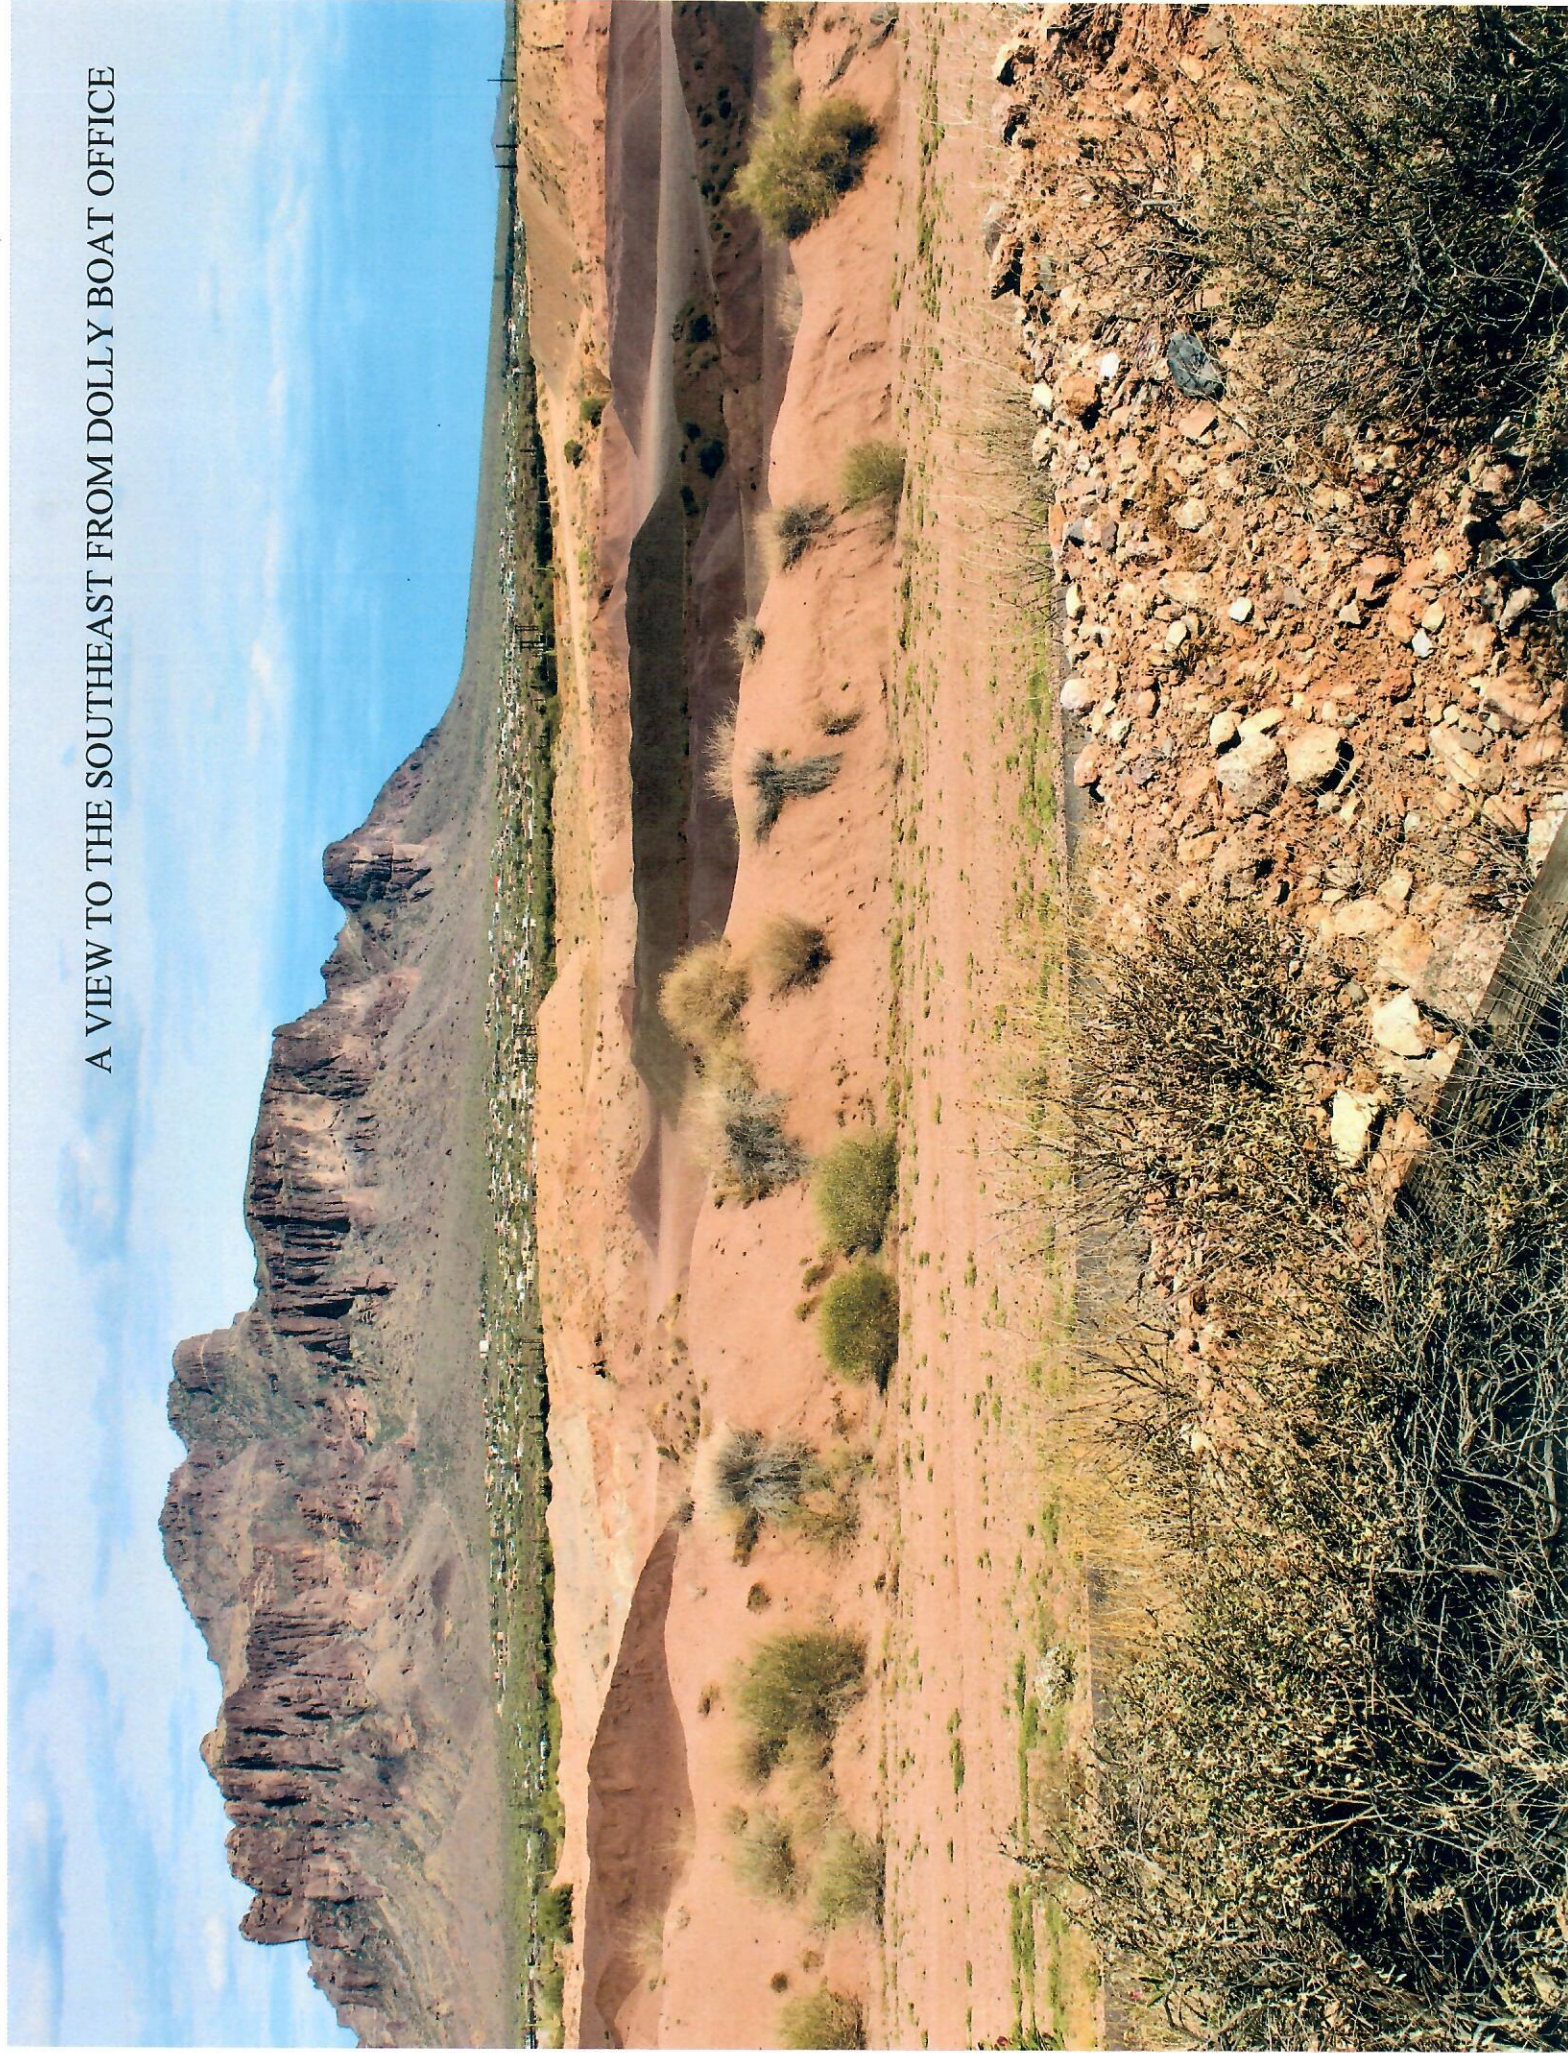
A VIEW TO THE SOUTHEAST FROM DOLLY BOAT OFFICE

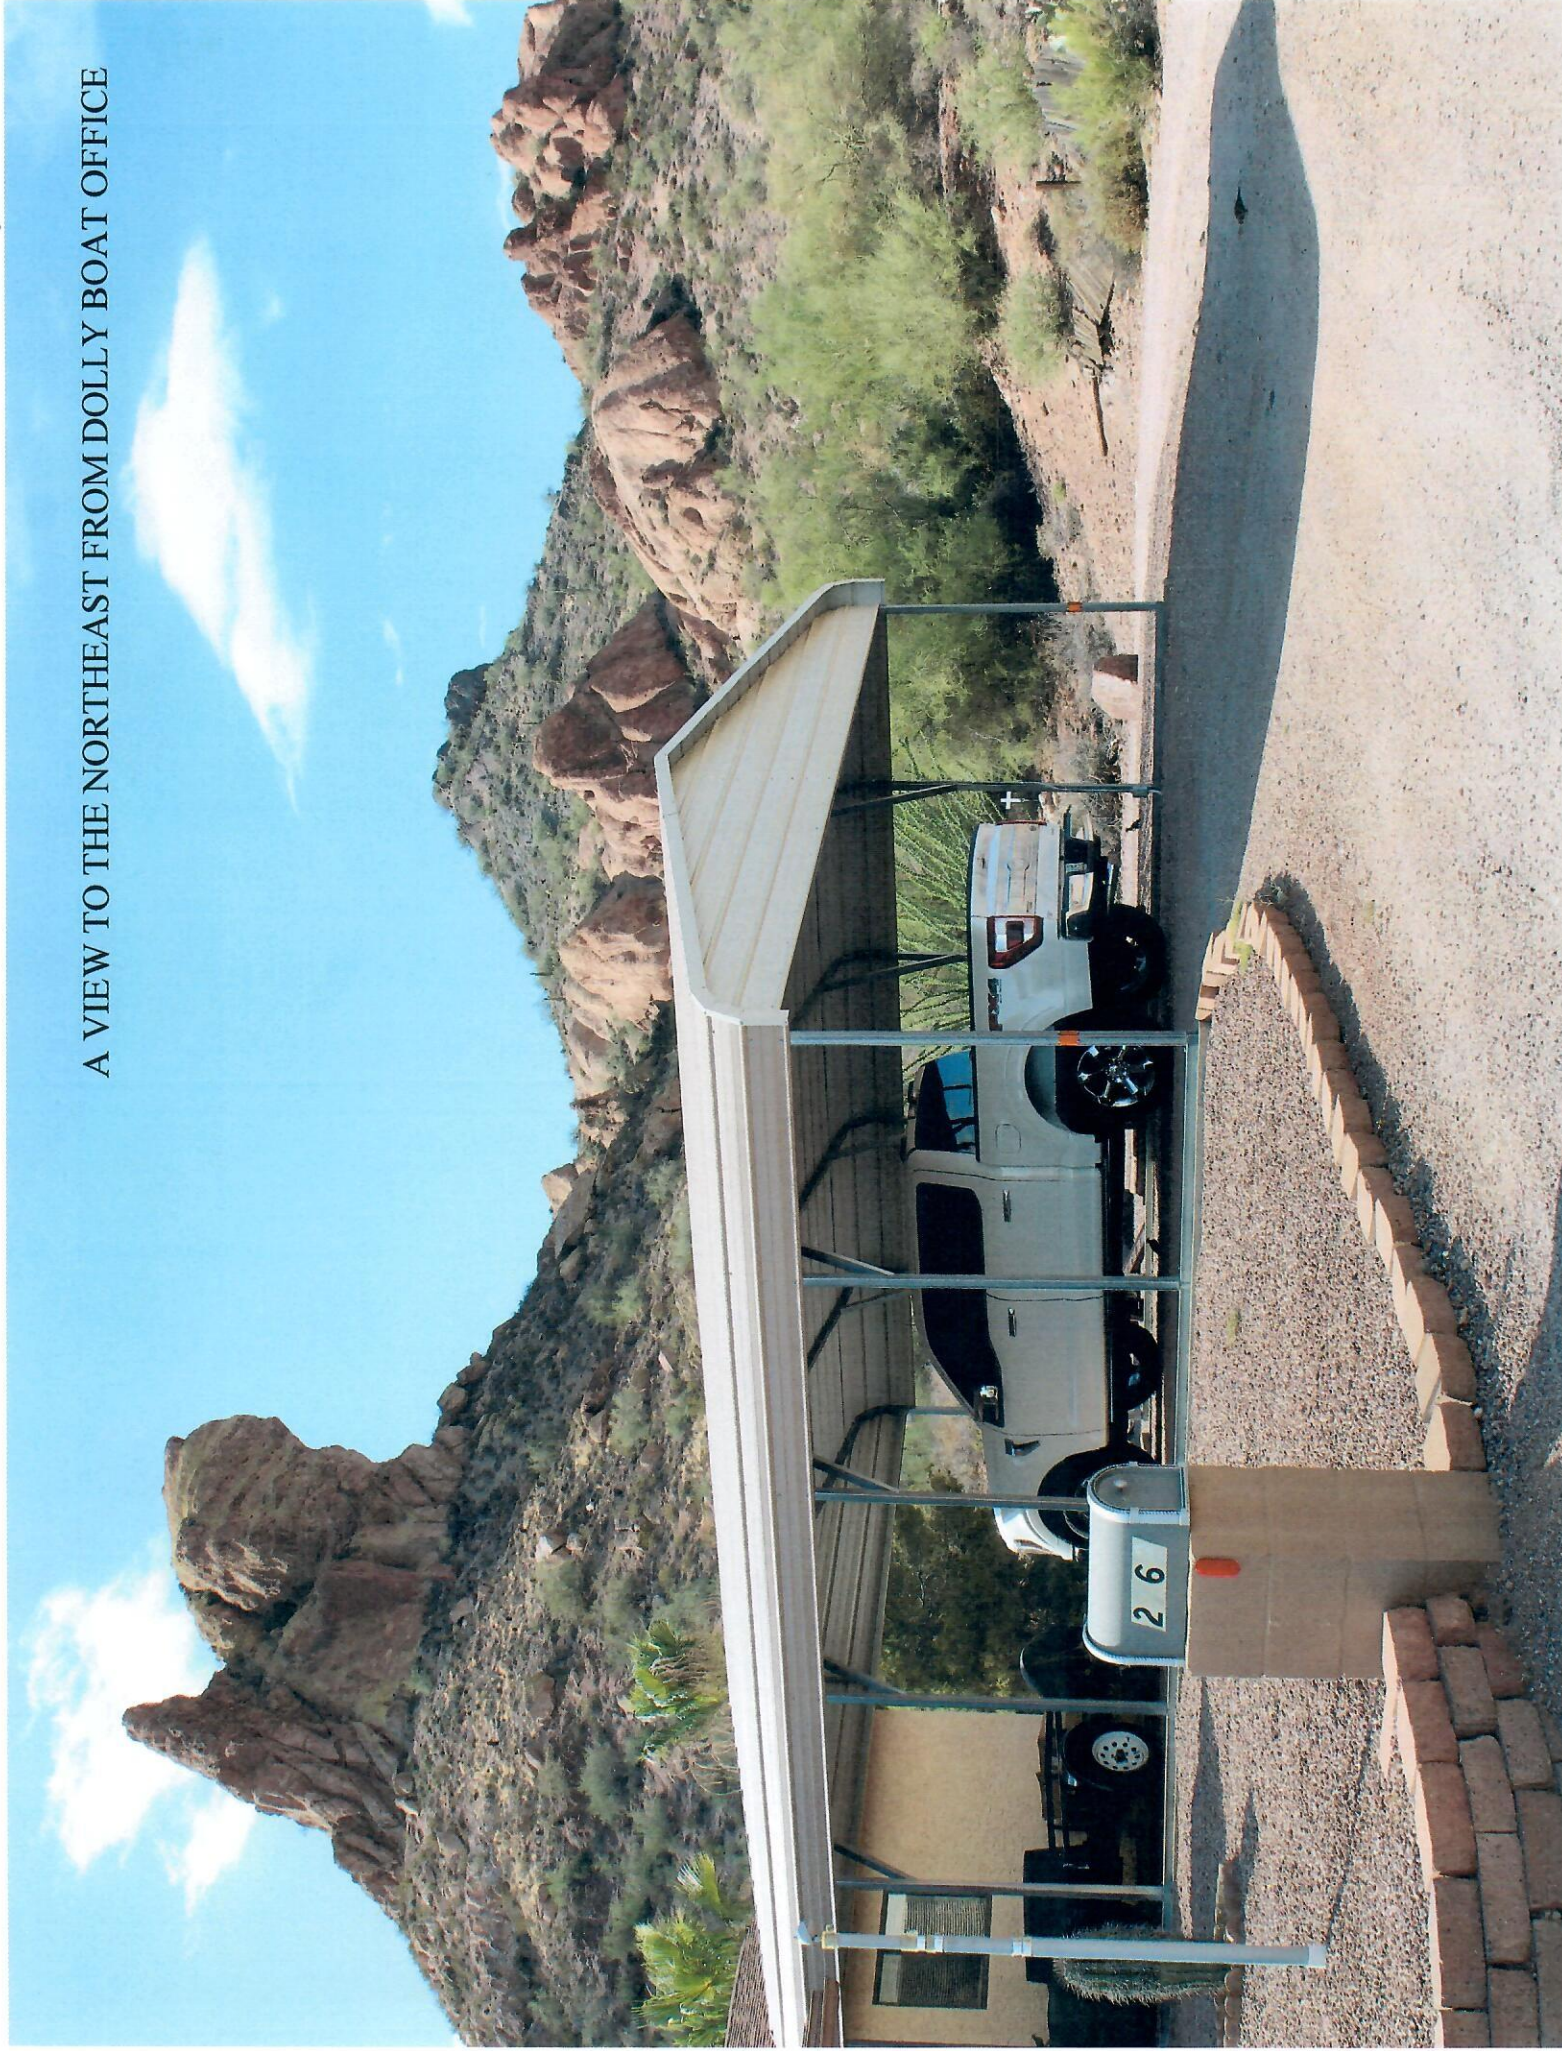
1
A VIEW TO THE NORTHEAST FROM DOLLY BOAT OFFICE

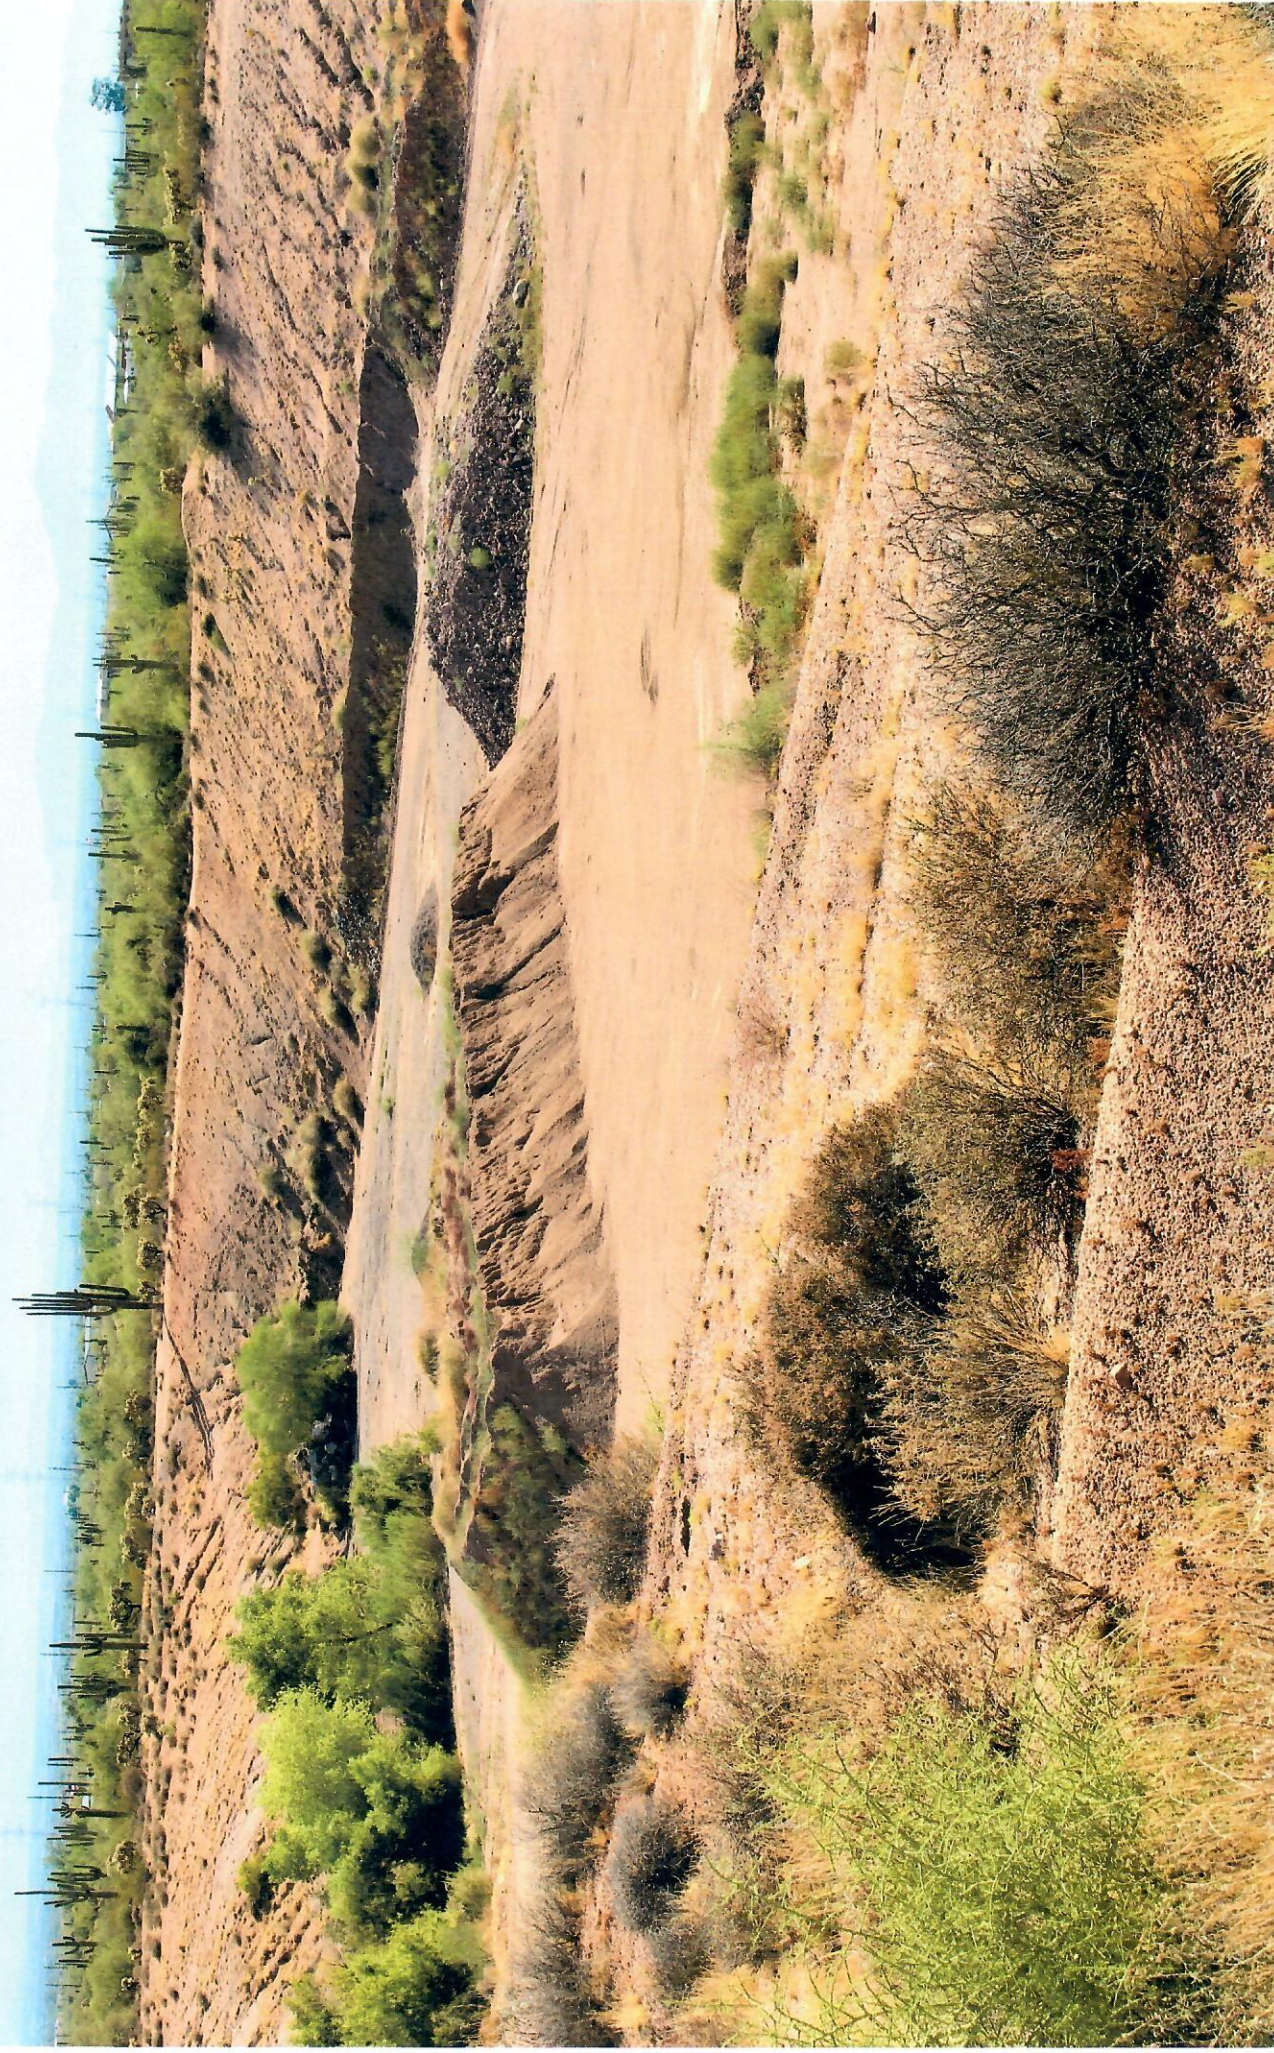
A VIEW A SMALL QUARRY WEST OF THE TREASURE CHEST MINING COIMPANY

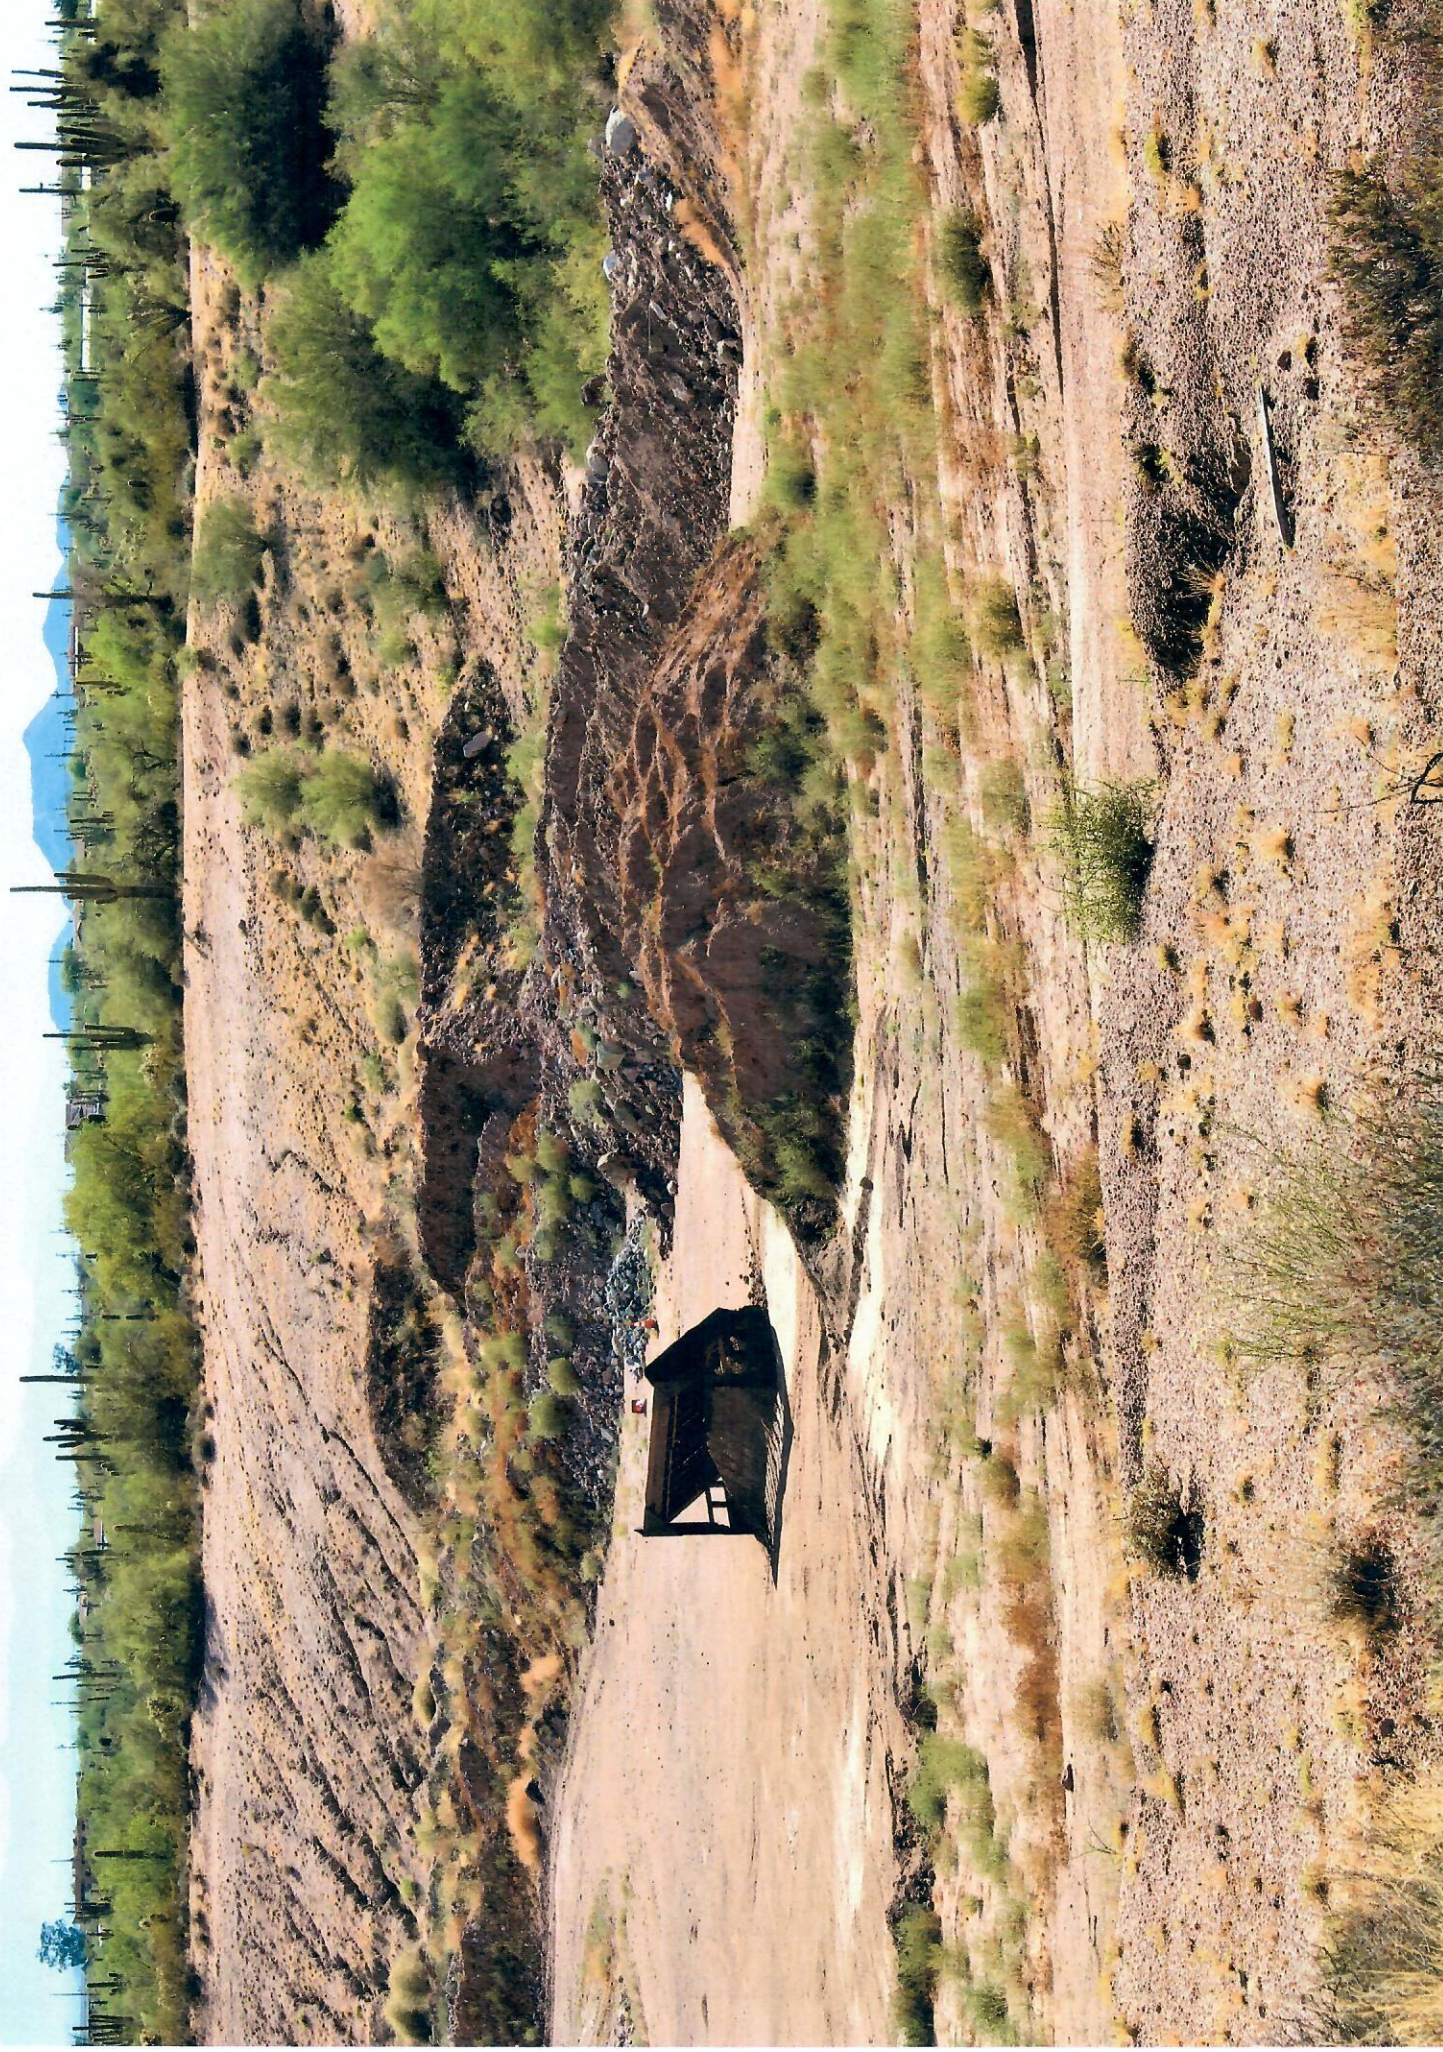
5
A VIEW A SMALL QUARRY WEST OF THE TREASURE CHEST MINING COIMPANY

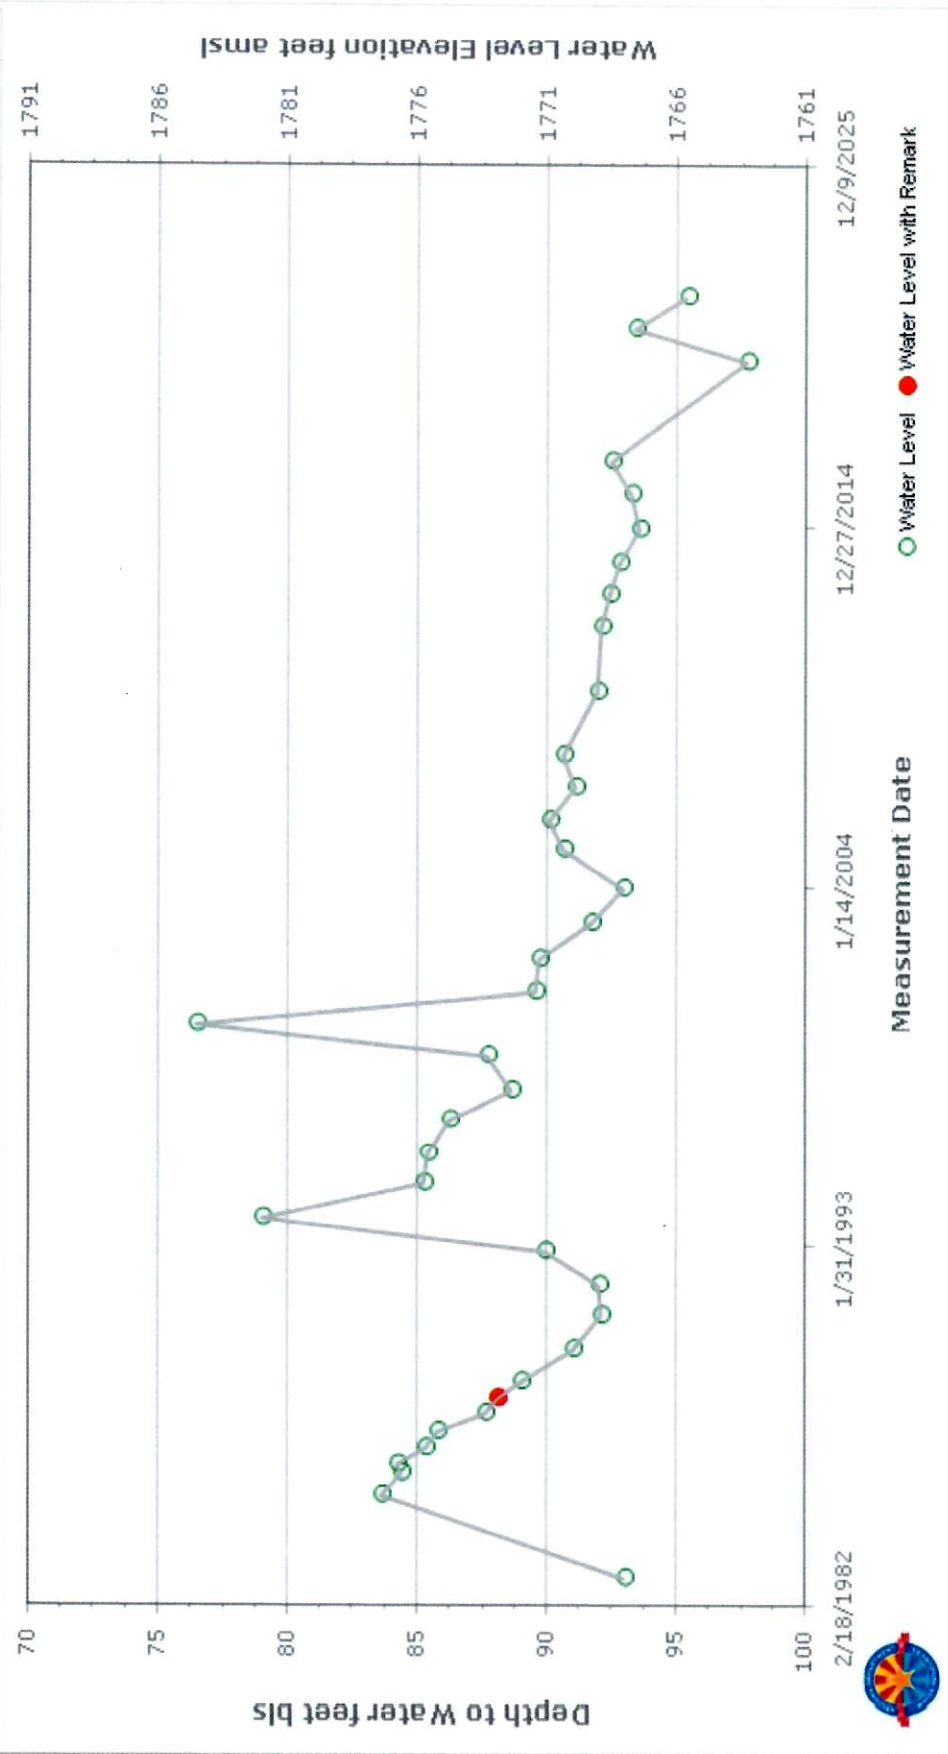
Arizona GroundWater Monitoring Site Hydrograph

Local ID	Site ID	Registry ID	Latitude NAD27	Longitude NAD27	Alt. (ft amsl)	Water Use	Well Depth (ft)	Case Dia. (in)	Drill Date	Latest WL Date	DTW (ft)	WL Elev. (ft)
A-01-08 10DCC1	332614111311101	614002	33° 26' 14.4"	111° 31' 5.9"	1861	UNUSED	300	8	6/1/1970	11/29/2021	95.4	1765.6

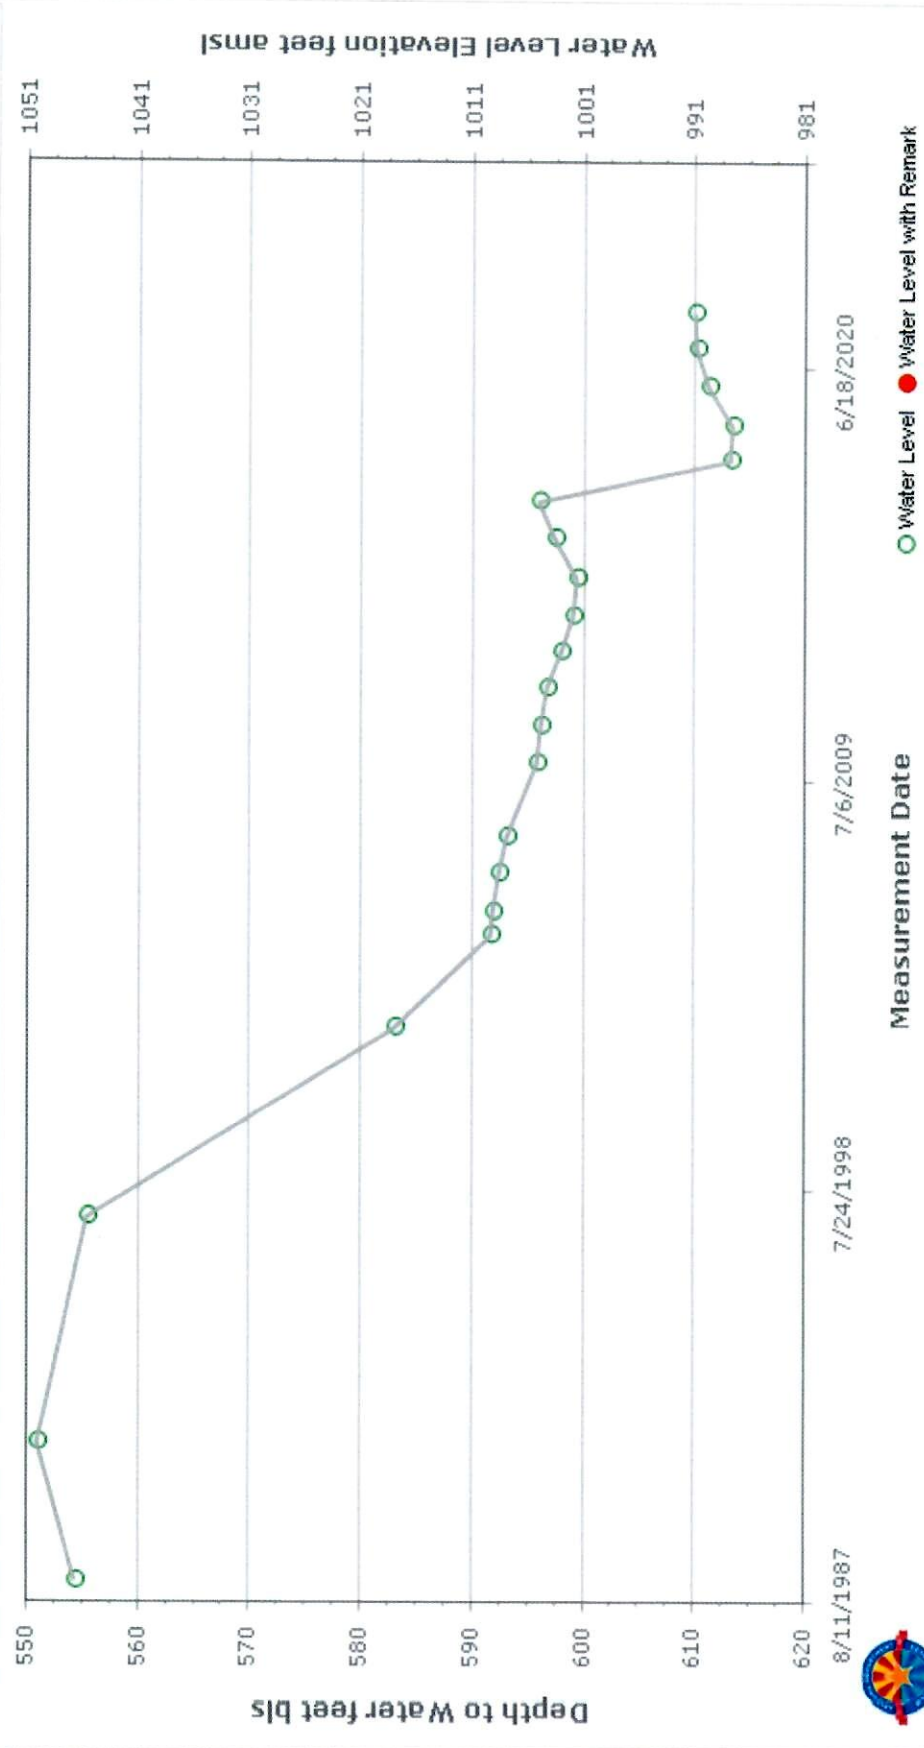
Arizona GroundWater Monitoring Site Hydrograph

Local ID	Site ID	Registry ID	Latitude NAD27	Longitude NAD27	Alt. (ft amsl)	Water Use	Well Depth (ft)	Case Dia (in)	Drill Date	Latest WL Date	DTW (ft)	WL Elev. (ft)
A-01-07 23ACA	332507111361001	613969	33° 25' 6.8"	111° 36' 10.6"	1601	UNUSED	700	8.62	7/15/1970	11/29/2021	609.9	991.1

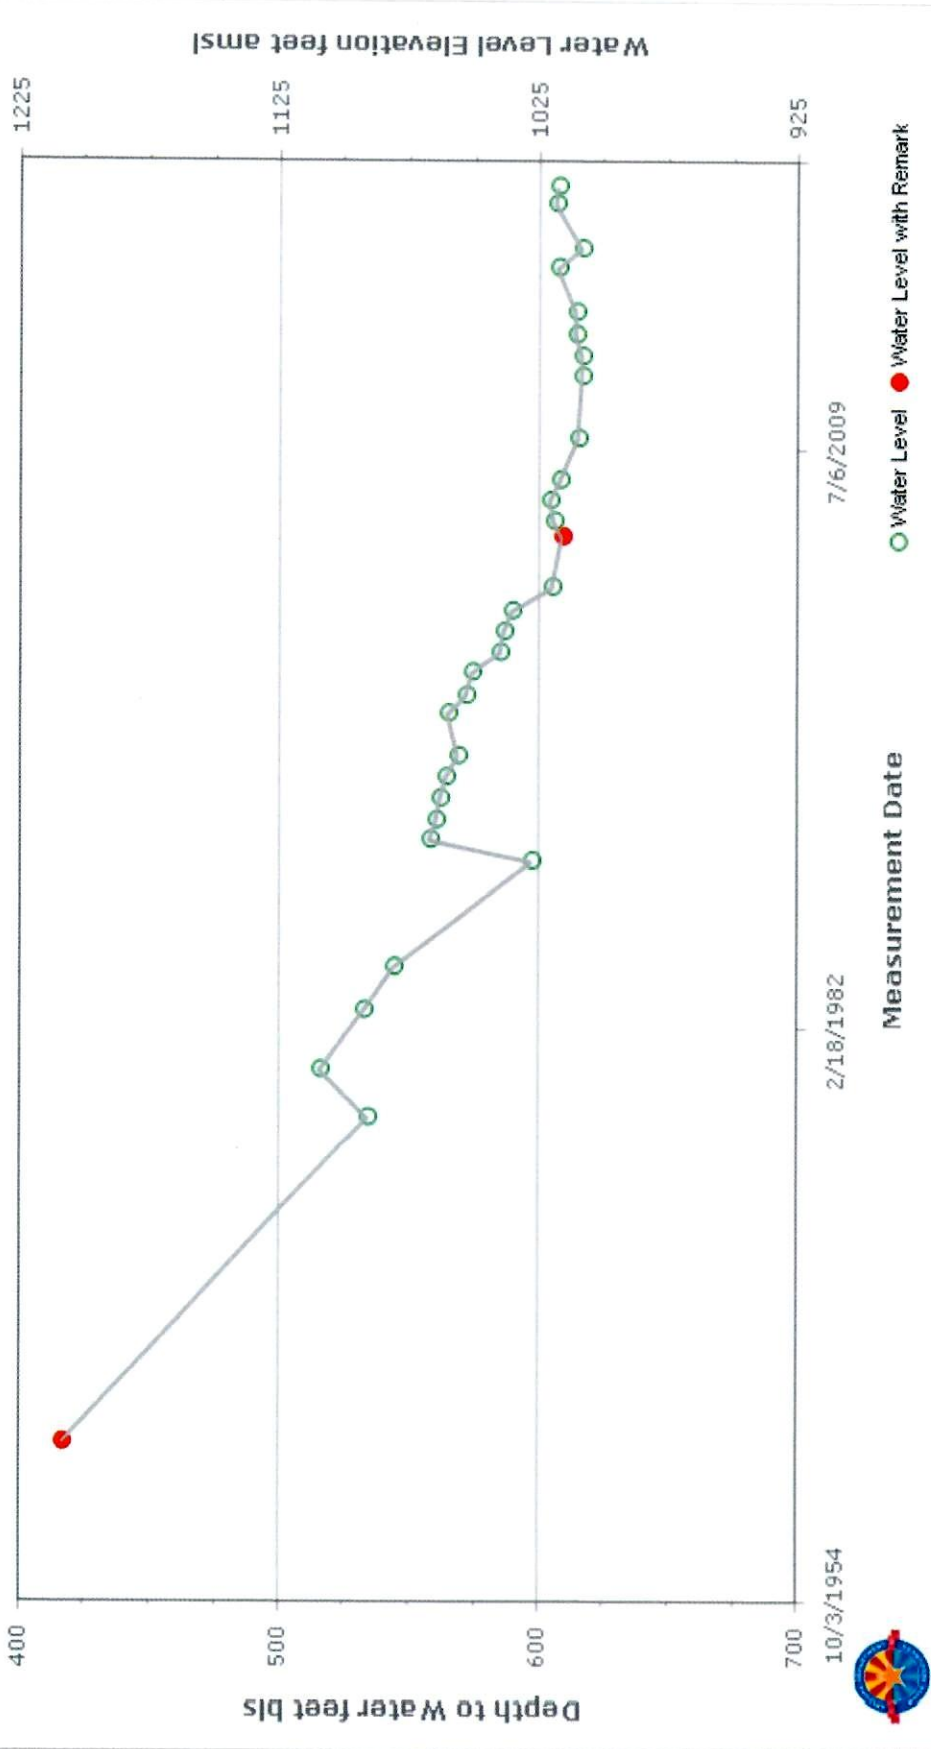
Arizona GroundWater Monitoring Site Hydrograph

Local ID	Site ID	Registry ID	Latitude	Longitude	Alt. (ft amsl)	Water Use	Well Depth (ft)	Case Dia. (in)	Drill Date	Latest WL Date	DTW (ft)	WL Elev. (ft)
A-01-08 32BBA	332332111333401	800843	33° 23' 32.8"	111° 33' 35.4"	1625	IRRIGATION	700	16	10/1/1962	11/30/2021	607.3	1017.7

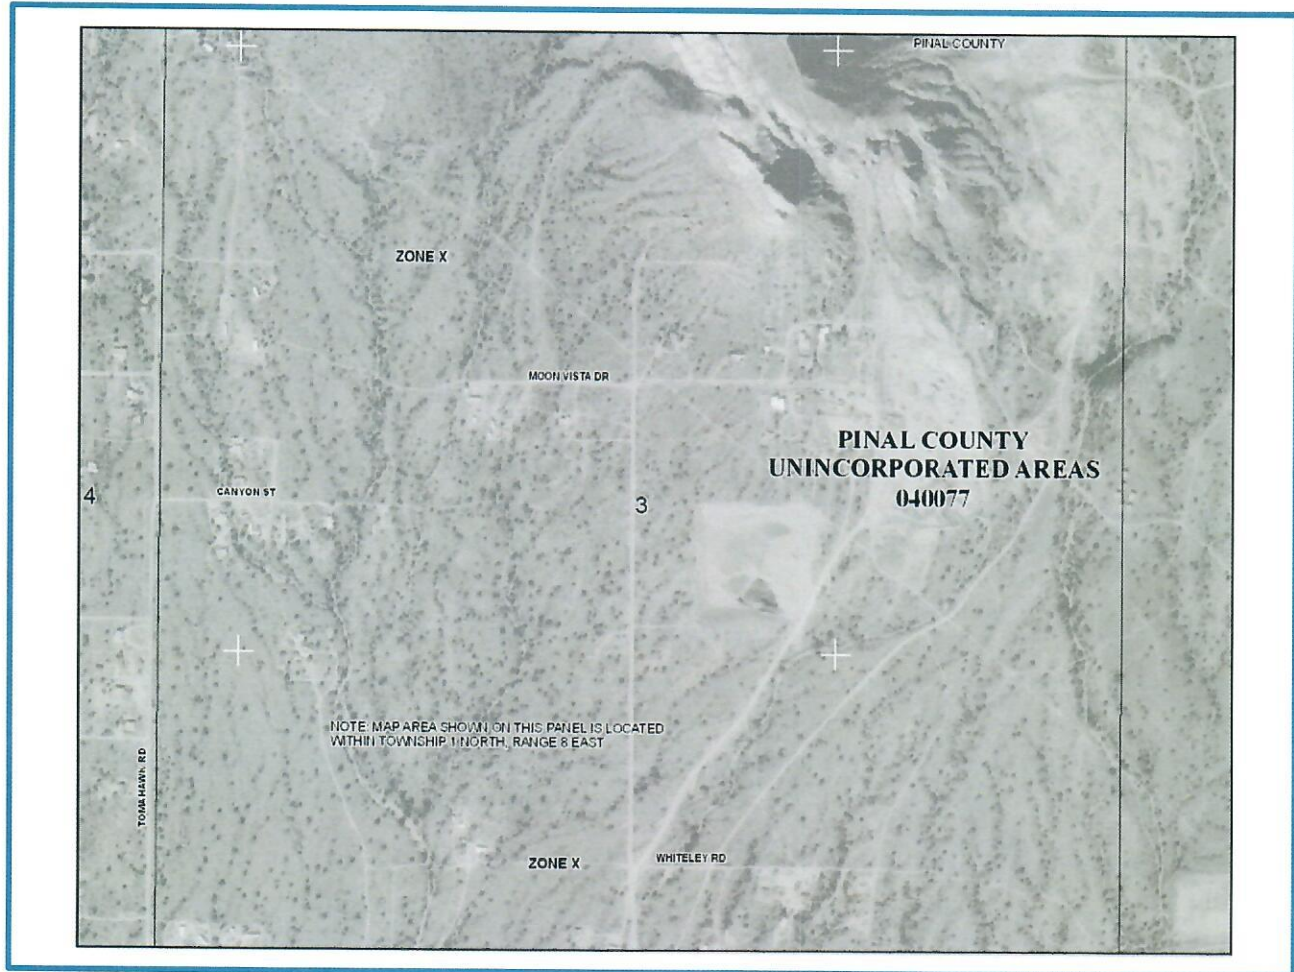
You are located in Flood Zone X

Zone X: Minimal risk areas outside the 1-percent and .2-percent-annual-chance floodplains. No BFEs or base flood depths are shown within these zones. (Zone X (unshaded) is used on new and revised maps in place of Zone C.)
