**REPORT ON PHASE I ENVIRONMENTAL
SITE ASSESSMENT**

DESIGNATION: 35-Acre Development

LOCATION: Southwest Corner 7th Street and Deer Valley Drive
Phoenix, Arizona

PROJECT NO: 211709EA

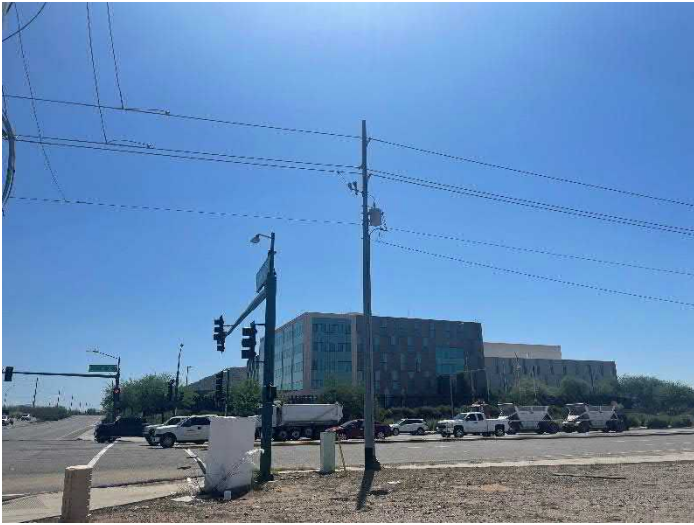
Photo No. 13: View of pole-mounted transformer located near the northeast corner of the Property; view to the east.

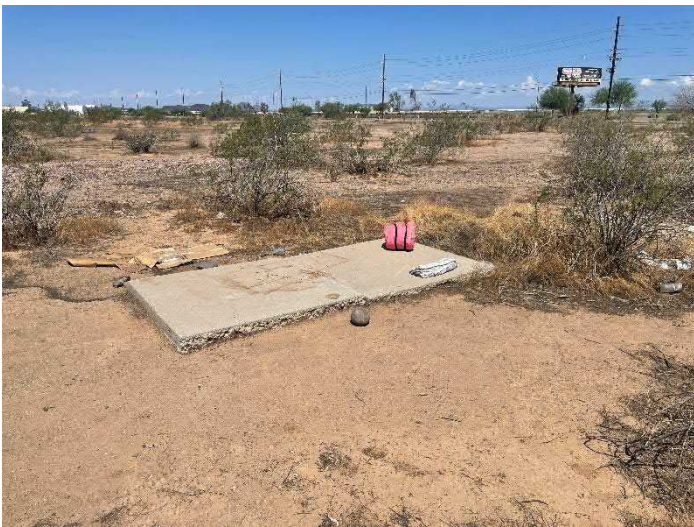
Photo No. 15: View of small concrete pad located near the eastern portion of the Property; view to the northwest.

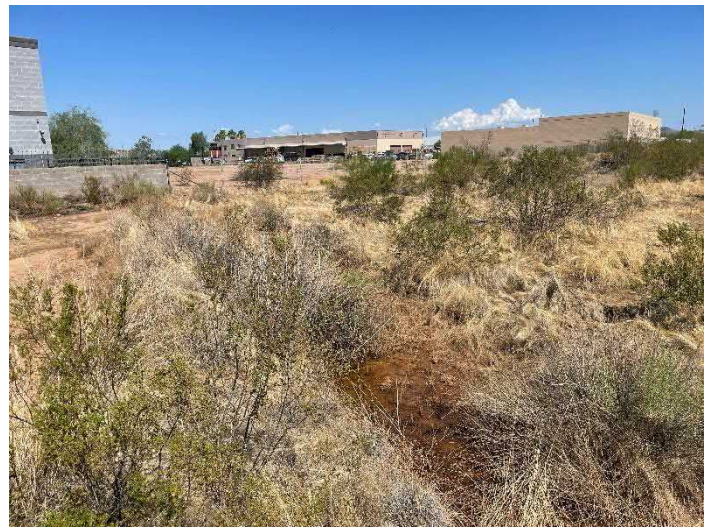
On-site surface water: Standing water from recent rainfall was observed within a small wash located near the western portion of the Property. The wash appeared to drain to the southwest onto the south adjoining property. No other surface water was observed on the Property at the time of the site visit. Concrete curbing appeared to prevent surface water from migrating across the northern boundary and portions of the eastern Property boundary. A CMU wall appeared to prevent surface water from migrating across portions of the western Property boundary. It

Photo No. 16: View of water within a wash located near the western boundary of the Property; view to the northwest.

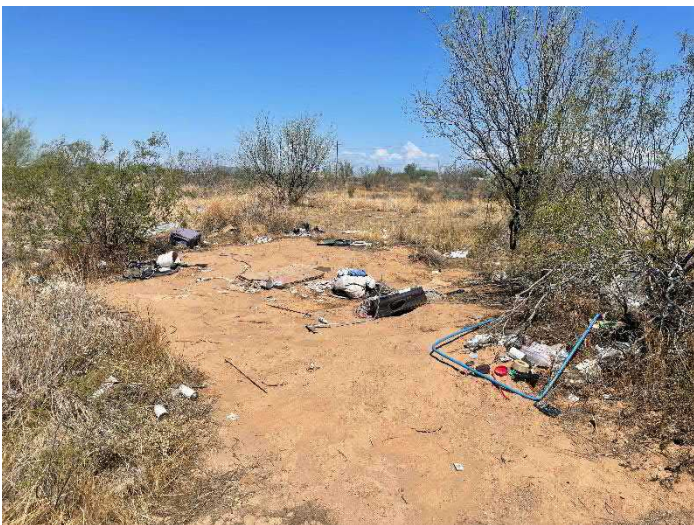
Photo No. 17: View of vagrant camp located near the easternmost southeast portion of the Property; view to the northwest.

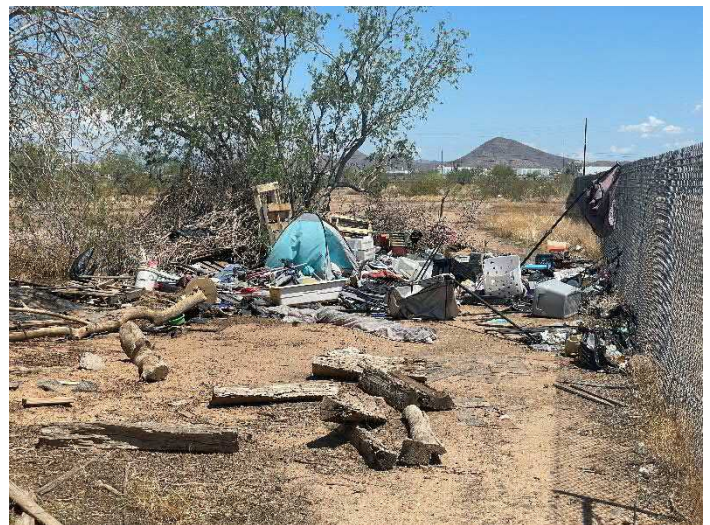
Photo No. 18: View of vagrant camp located near the southernmost southeast portion of the Property; view to the north.
