PHASE I ENVIRONMENTAL SITE ASSESSMENT

Vistancia West (280-Acre Portion)
Southwest of the Intersection of
Vistancia Boulevard & West Lone Mountain Road
Peoria, Maricopa County, Arizona

ProTeX Project No.: 12356

Subject: **PHASE I ENVIRONMENTAL SITE ASSESSMENT**
Vistancia West (280-Acre Portion)
Southwest of the Intersection of
Vistancia Boulevard & West Lone Mountain Road
Peoria, Maricopa County, Arizona

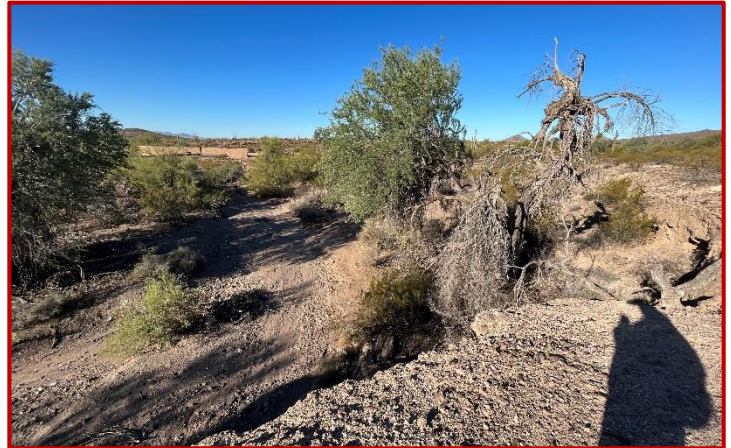
Photo #8: Representative view of the washes/arroyos within the boundaries of the Subject Property.

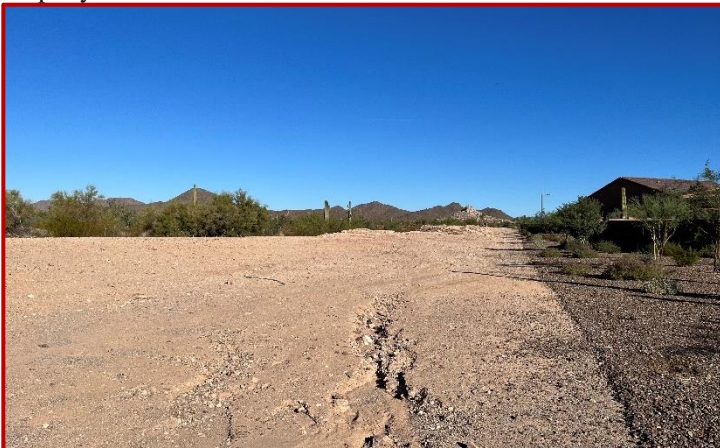
Photo #9: Representative view of the overburden consisting of fill dirt and imported soils from the adjoining development, located along the south-central boundary of the Subject Property.

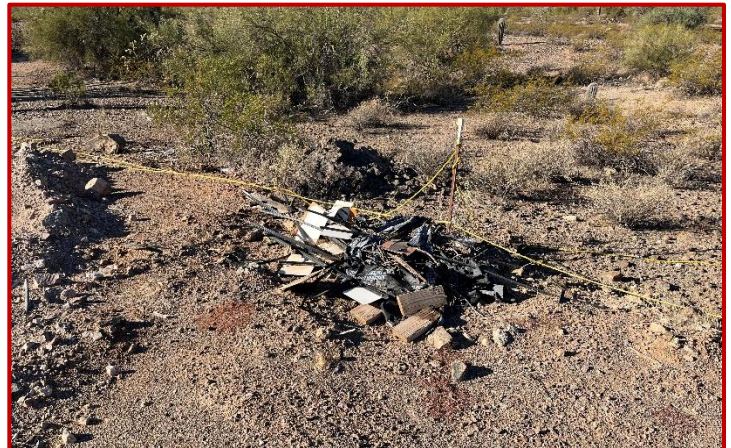
Small amounts of trash and debris were observed to be scattered throughout the interior of the Subject Property. These materials appeared to have originated from the development of the adjoining residential communities and the residences that make up the communities. At this time, the materials appear to be non-hazardous in nature, and therefore, are considered a De Minimis condition at this time.

It should be noted that small amount of trash and debris were observed along the Site boundaries adjacent to the residential communities. The observed materials are primarily discarded building materials, excess concrete pour, and transplanting materials. In addition to these, a small amount of debris from the adjoining households are present as well. At this time, these materials are considered non-hazardous in nature, and therefore, are considered a De Minimis condition at this time.

Photo #10: Representative view of the *De minimis* debris observed within the boundaries of the Subject Property.

NO FURTHER ACTION IS RECOMMENDED FOR THE SITE AT THIS TIME.
