# PHASE I ENVIRONMENTAL SITE ASSESSMENT

**WESTWORLD PARCEL #4**

South of School Road and  
North of McDowell Mountain Golf Club Golf Course  
Scottsdale, Arizona  
WT Reference No. 2186JQ126

Re: Phase I Environmental Site Assessment  
Westworld Parcel #4  
South of School Road and  
North of McDowell Mountain Golf Club Golf Course  
Scottsdale, Arizona

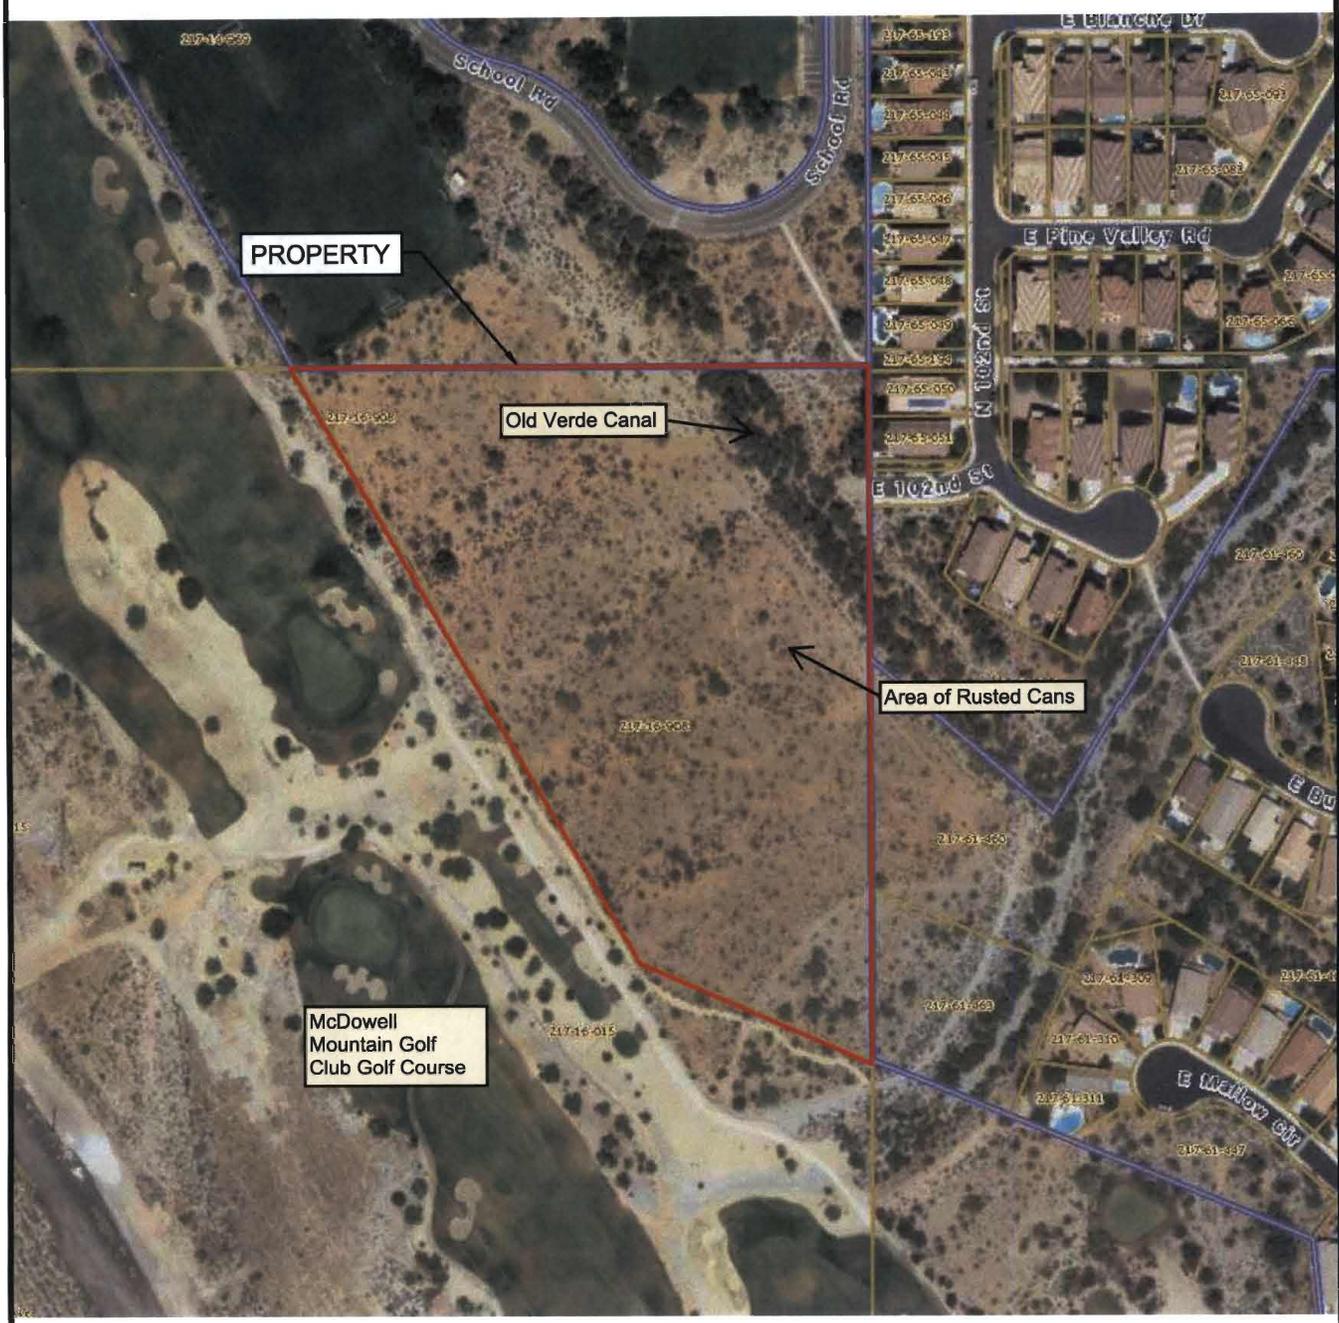
The reconnaissance of the Property was performed by Mr. Holmquist on May 9, 2016. Mr. Holmquist was unaccompanied during the reconnaissance. The reconnaissance was performed by a combination of walking the Property and driving on streets in the Property vicinity. No limiting conditions were encountered during the reconnaissance of the Property. Pictures taken during the reconnaissance of the Property are included in Appendix B. Figure 2 in Appendix A depicts general features observed on the Property.

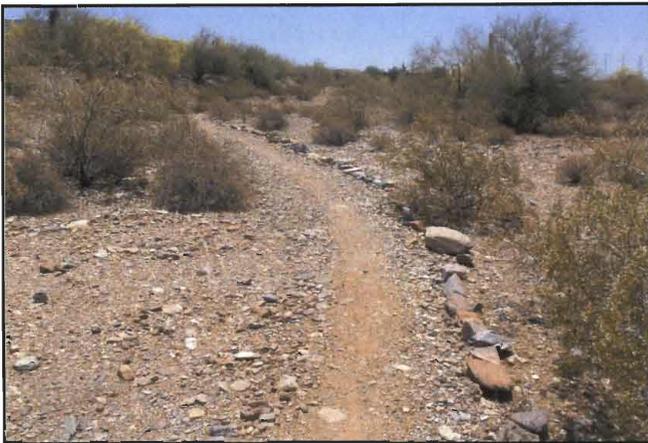
Picture 3 – The path on the east side of the Property along the Old Verde Canal.

A 300-foot long section of the Old Verde Canal was observed crossing the northeastern corner of the Property. The canal path was excavated through the Paradise Valley and Scottsdale area circa 1895, but was reportedly never completed or used. Except for a chair, we did not observe discarded solid waste or other materials in the section of the canal that crossed the Property.

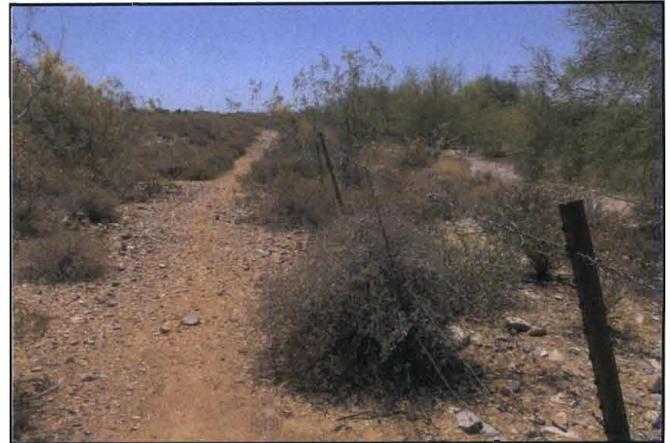
Picture 4 – The path and barbed wire fence along the west side of the Property.

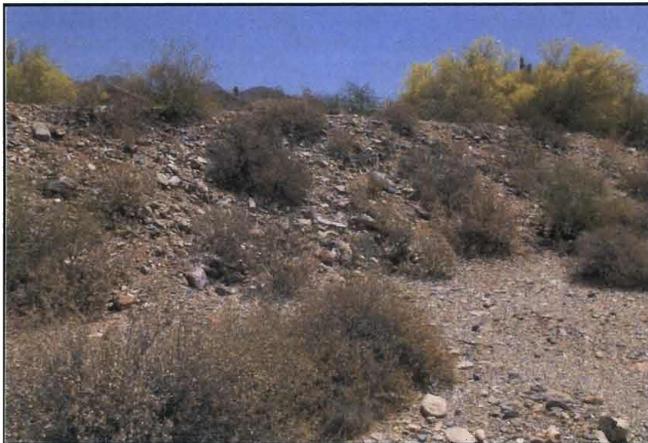
Picture 5 – The berm of soil and rock that forms the exterior western side of the Old Verde Canal on the northeast corner of the Property.

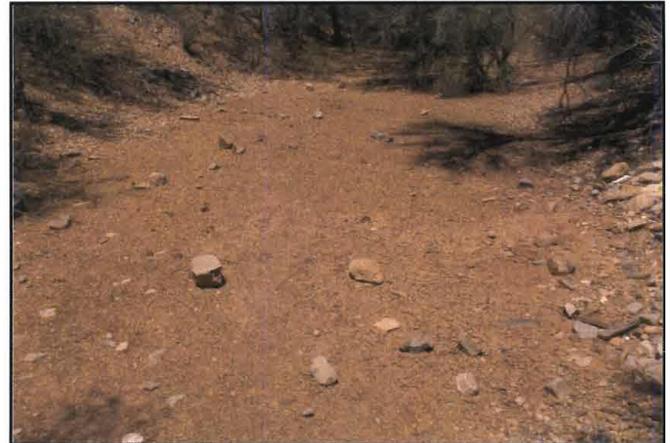
Picture 6 – A section of the bottom interior of the Old Verde Canal.

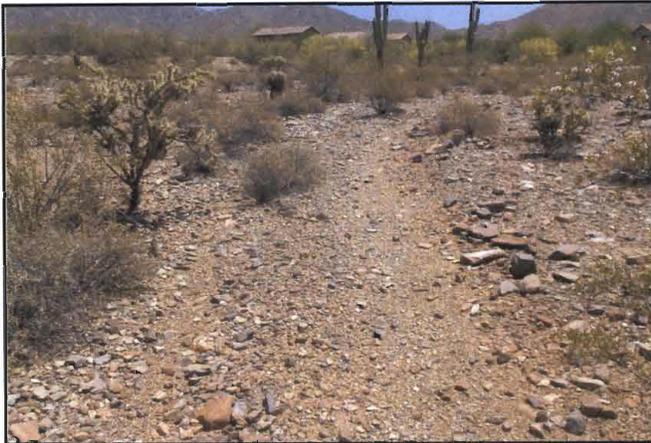
Picture 7 – A remnant dirt road that crosses the southern portion of the Property.

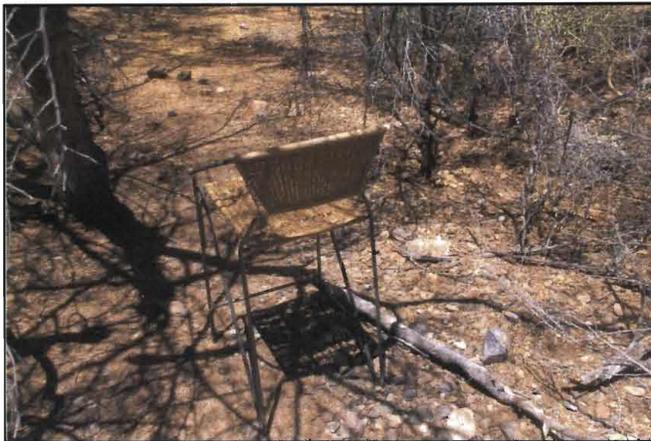
Picture 9 – A chair in the Old Verde Canal.

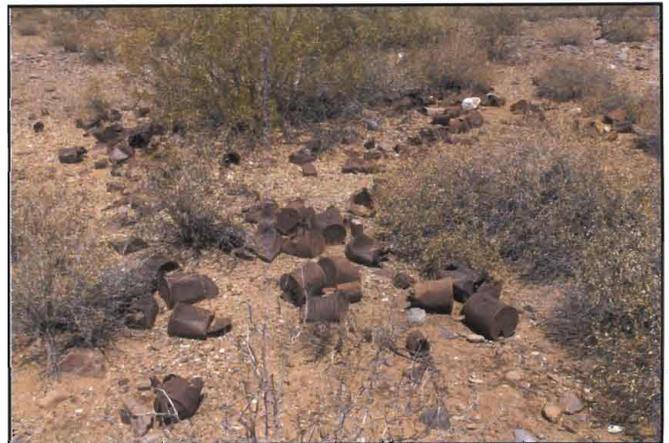
Incidental litter consisting of bottles, paper, cans, and other loose materials were scattered on the Property. Several dozen one-gallon or less cans were observed near the east central portion of the Property as shown on Figure 2. The cans appeared to very old and were

extremely weathered. Labels identifying the contents have long since deteriorated. We did not observe stained soil or other indications of spillage or leakage of the cans.

Picture 10 – Rusted cans observed near the east central portion of the Property.

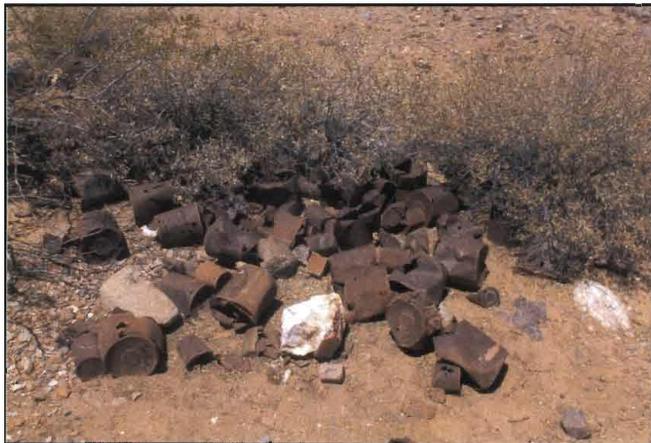
Picture 11 – An alternate view of the rusted cans in Picture 10.

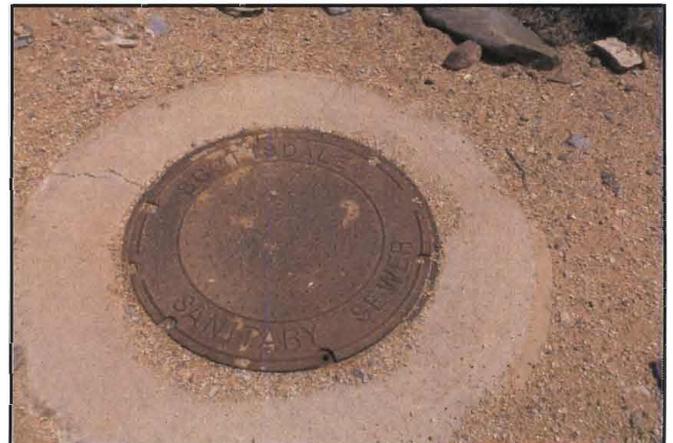
Utilities were not provided to the Property. A City of Scottsdale sanitary sewer manhole was observed several feet north of the Property.

Picture 18 – The sanitary sewer manhole near the northern boundary of the Property.
