**Earth Fissure Evaluation
Vineyard Road Flood Retarding Structure
Contract FCD 2016C010, Work Assignment No. 34
Pinal County, Arizona**

**Flood Control District of Maricopa County
Phoenix, Arizona**

**Wood
Environment & Infrastructure Solutions, Inc.
Phoenix, Arizona**

April 1, 2020

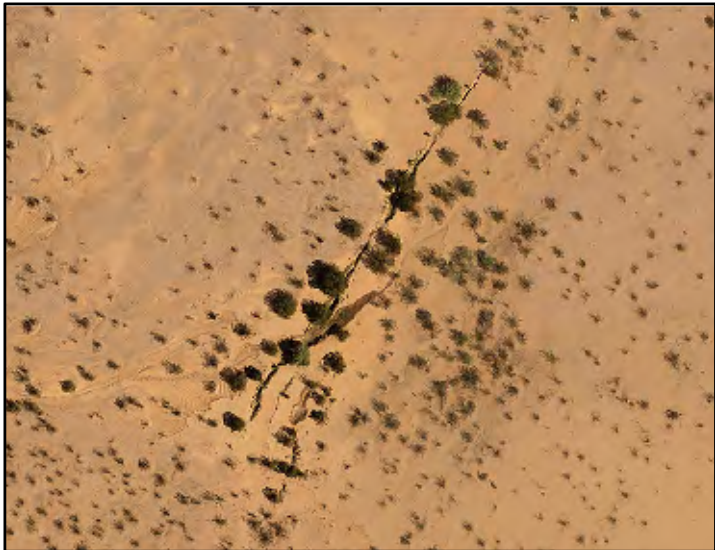
2019

Figure 2 shows annual high-resolution aerial images at the site of the newly identified earth fissure from 2010 to 2019. In the image from 2014, the newly identified earth fissure is present nearly to the full extent as it is in 2019. Detailed, step-by-step, annual observations are listed below.

10. 2019: The earth fissure is clearly visible as a set of three en échelon fissure gullies. The gullies show small to moderate amounts of additional erosion/widening occurring since 2018 and a shorter, third fissure gully has become observable between the original two. The development of the third fissure gully is likely due to local collapse and settlement of the fissure gullies, as has been observed with other earth fissure gullies in the Hawk Rock area. There is no apparent extension of the fissure to the north or south.
