## REPORT ON PHASE I ENVIRONMENTAL SITE ASSESSMENT

**DESIGNATION:** Arizona State Land Parcel - 83rd & Happy Valley

**LOCATION:** Northeast of 83rd Avenue and Happy Valley Road  
Peoria, Arizona

**PROJECT NO:** 210195EA

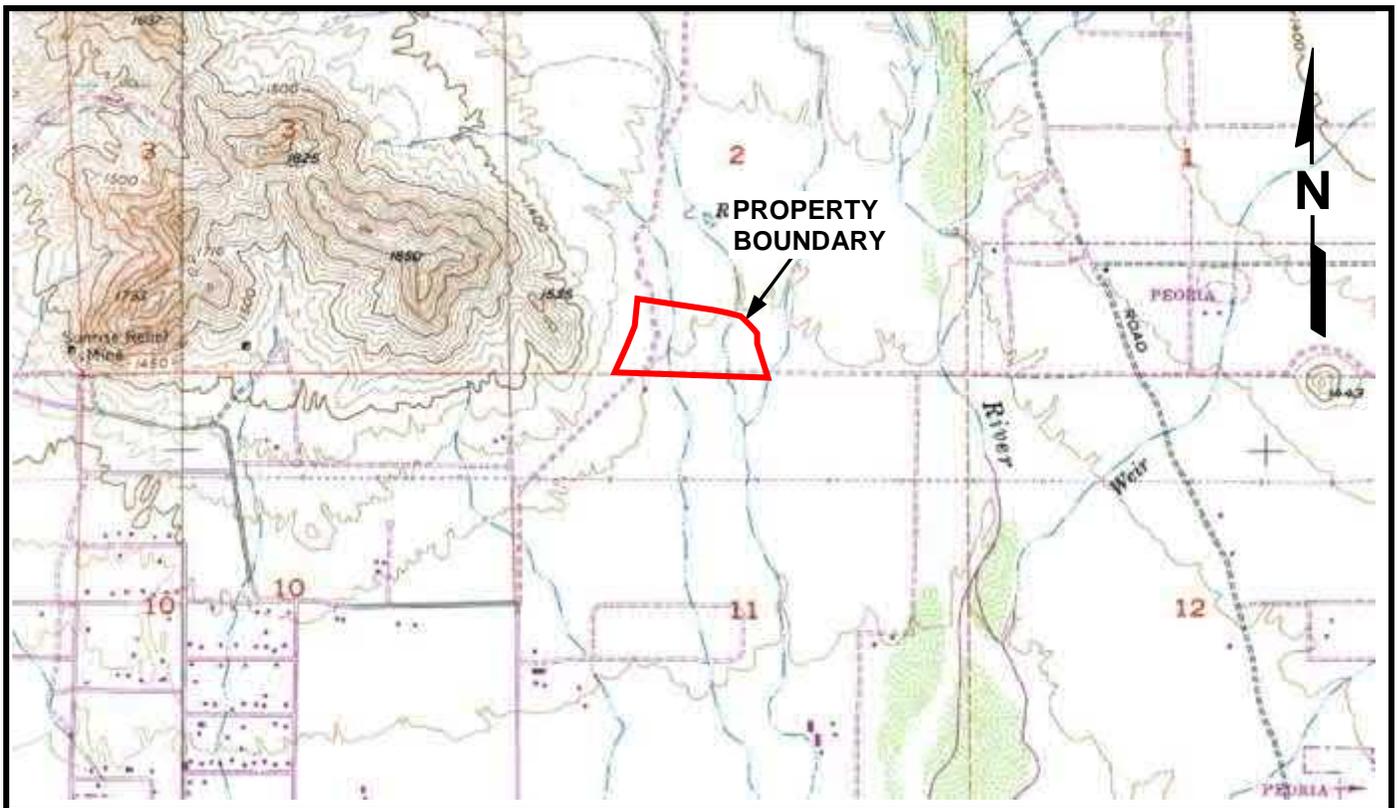
Figure 2.1.1 – Property Topography

Flooding zone: The eastern portion of the Property appeared to be located within Zone AE. Zone AE areas are defined as the 1% annual chance flood (100-year flood), also known as the base flood, is the flood that has a 1% chance of being equaled or exceeded in any given year. The Special Flood Hazard Area is the area subject to flooding by the 1% annual chance flood. Areas of Special Flood Hazard include Zones A, AE, AH, AO, AR, A99, V and VE. The Base

Flood Elevation is the water-surface elevation of the 1% annual chance flood. Base Flood Elevation is determined for Zone AE. The western portion of the Property appeared to be located within Zone X. Zone X is defined as areas of 0.2% annual chance flood (500-year flood); areas of 1% annual chance flood (100-year flood) with average depths of less than one (1) foot or with drainage areas less than one (1) square mile; and areas protected by levees from 1% annual chance flood (FEMA).

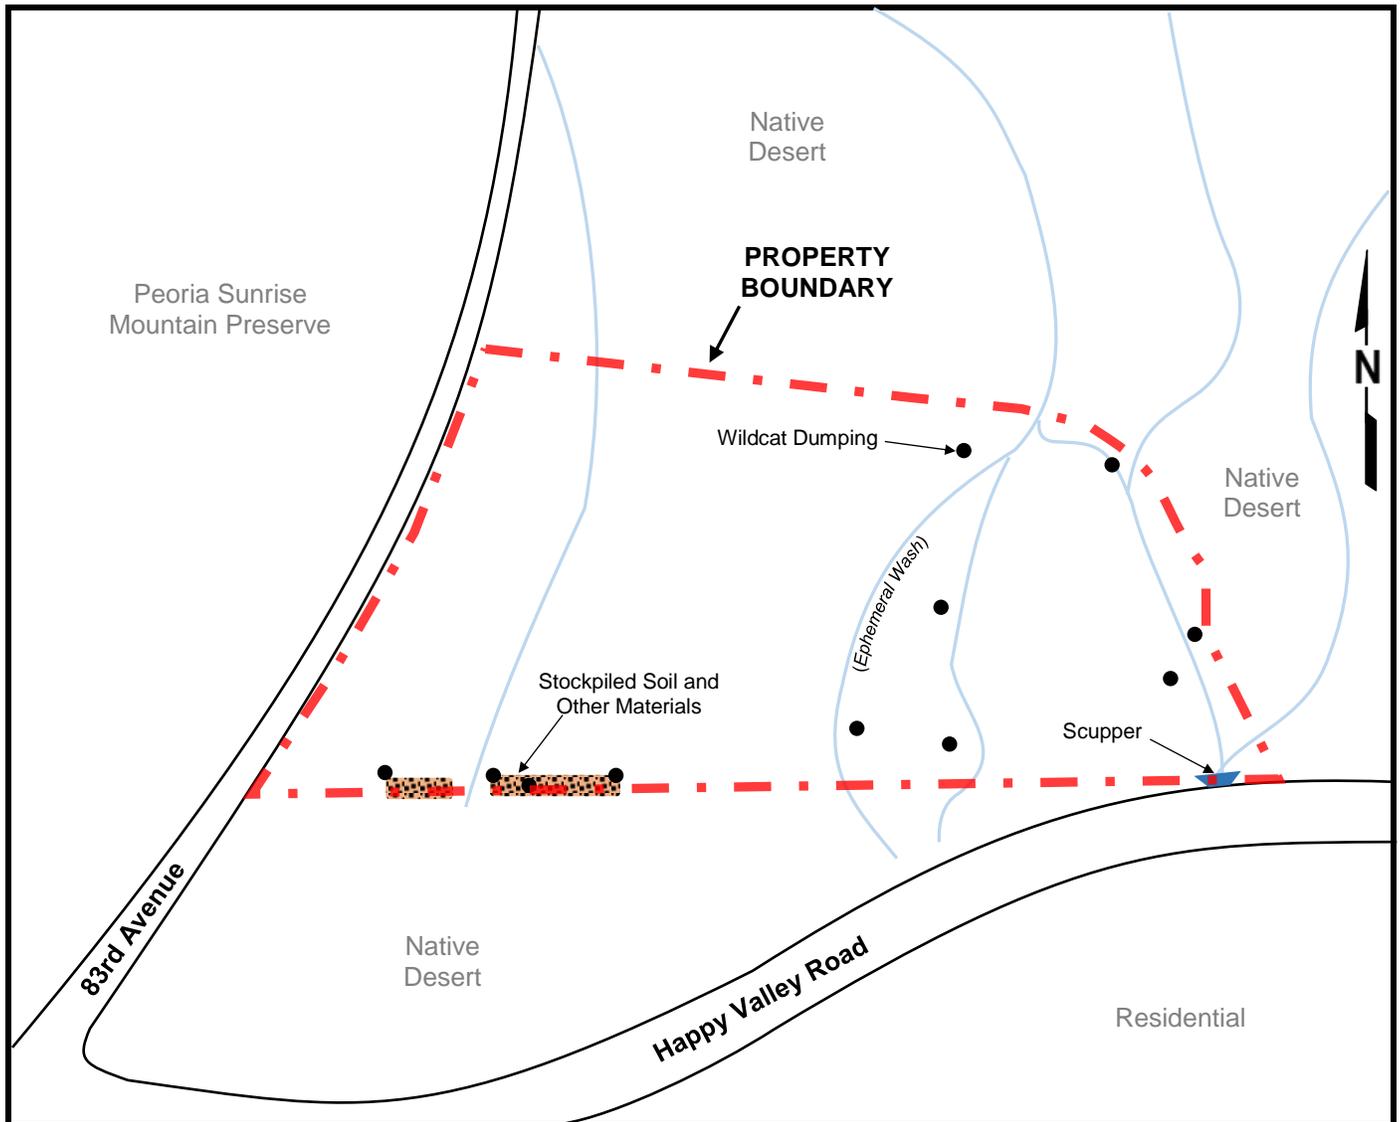
Figure 5.1.1 - Property Plan

A site reconnaissance was conducted to observe and record information concerning present site development, use, and conditions. A visual and physical survey of the existing Property was conducted on February 11, 2021 by Mr. Benjamin Larson of Speedie and Associates. Complete visual assessment of the Property was hindered by vegetation and terrain. However, these limiting conditions do not impact our ability to identify RECs on the Property. The site visit was conducted by walking and driving about the Property. Selected photographs, taken on the site visit, are included in Appendix A (Surface Photographs). Figure 5.1.1 identifies Property boundaries.

At the time of the site reconnaissance, the subject Property consisted of approximately 26.11 acres of native desert land. Ground cover consisted of bare soil with indigenous desert vegetation consisting of brush, shrubs, trees and cacti. Numerous stockpiles were located on the southern Property boundary. The stockpiles largely consisted of soil, but landscaping rock, gravel and asphalt materials stockpiles were also observed in the area. Ephemeral washes extended north to south across the Property. Worn gravel roadways also extended across the Property. A scupper appeared to direct water from the easternmost wash beneath Happy Valley Road to the adjoining properties to the south. Areas of wildcat dumping were observed along the southern boundary and along the ephemeral washes on the east central portions of the Property. Materials observed in these dumped areas included household trash, concrete, rock, soil, tires, landscaping debris, building materials, and furniture. No signs of previous development were observed and no unusual stains or

odors were detected during the site reconnaissance. No other significant features were observed on the Property at the time of the site visit.

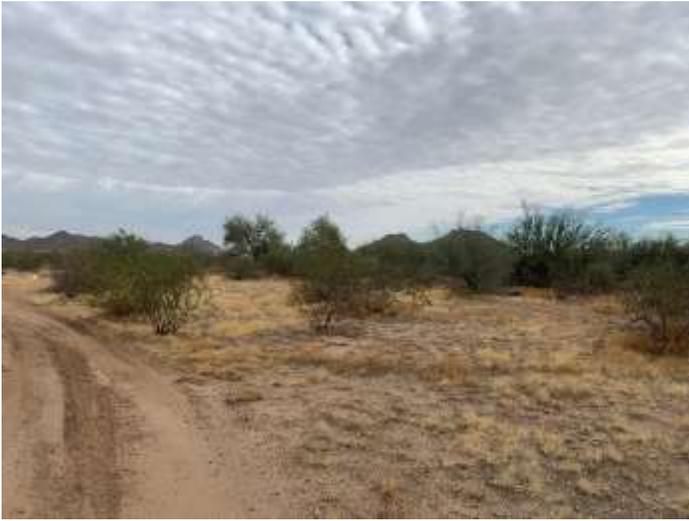
**Photo No. 13: View of typical native desert land with gravel pathways centrally located on the Property.**

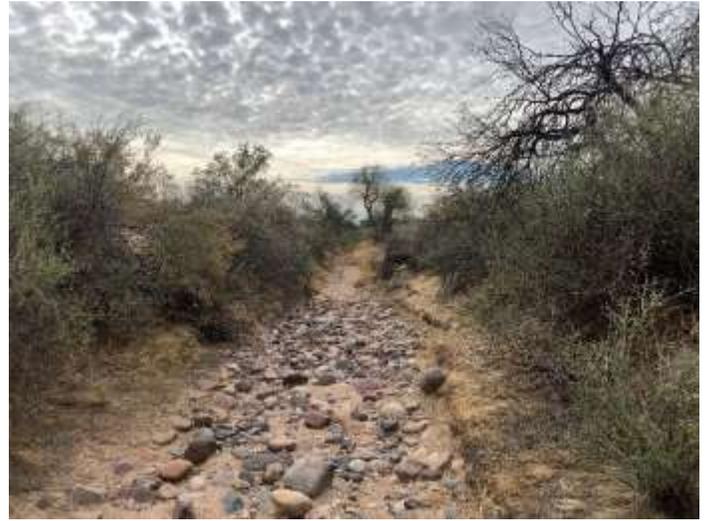
**Photo No. 14: View of ephemeral wash located on the eastern Property boundary.**

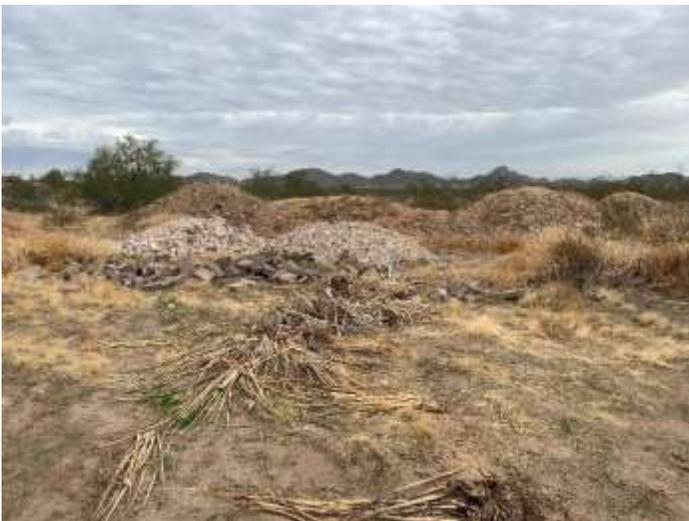
**Photo No. 15: View of stockpiled material consisting of rock, landscape clippings and soil located on southern Property boundary.**

- ◆ Based on the observation of stockpiled soils, the stockpiles of soil, landscaping rock, gravel, and asphalt should be removed from the subject Property. Should the soil stockpiles materials remain on-site and be used as part of future site development, we recommend further research into the soils origin, spreading of the piles for further visual observation soils contents, and/or random soil sampling and chemical analysis to confirm or deny the presence of contaminants within these soils.
- ◆ The household trash, concrete, rock, soil tires, landscape building materials, and furniture should be removed and properly disposed.

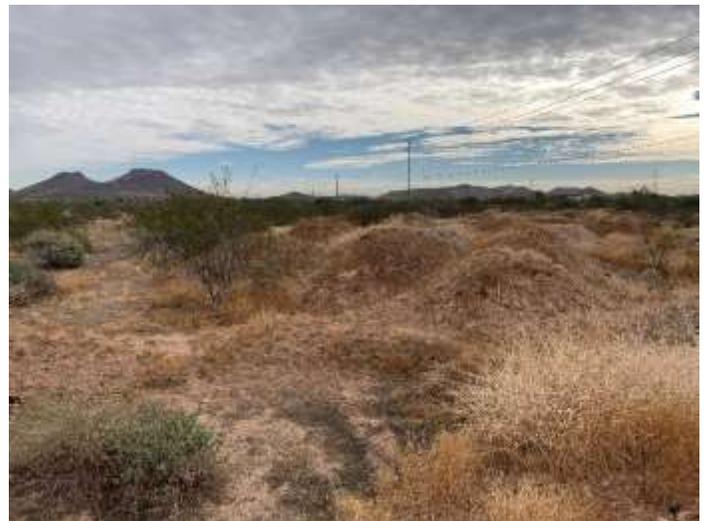
**Photo No. 16: View of numerous soil stockpiles located on the southern Property boundary.**
