PHASE I ENVIRONMENTAL SITE ASSESSMENT (ESA) FOR THE 267± ACRES AT

# ALORAVITA SOUTH

## PARCELS 3 - 8

GTI PROJECT NO. 195738E

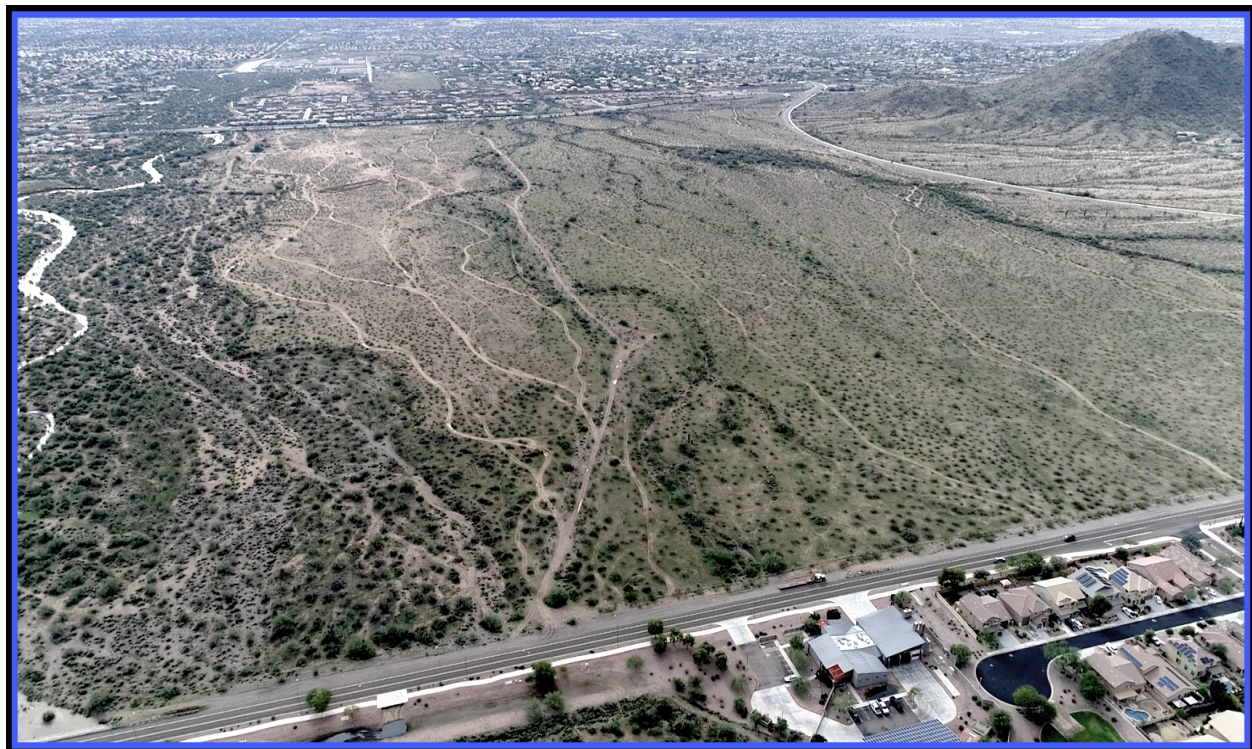
*Figure 3 - Aerial Photograph of the Property*

East of the Gila and Salt River Base and Meridian, Peoria, Maricopa County, Arizona 85383. A general site vicinity map is shown on Figure 2. An aerial photograph of the Property and surrounding area is shown on Figure 3.

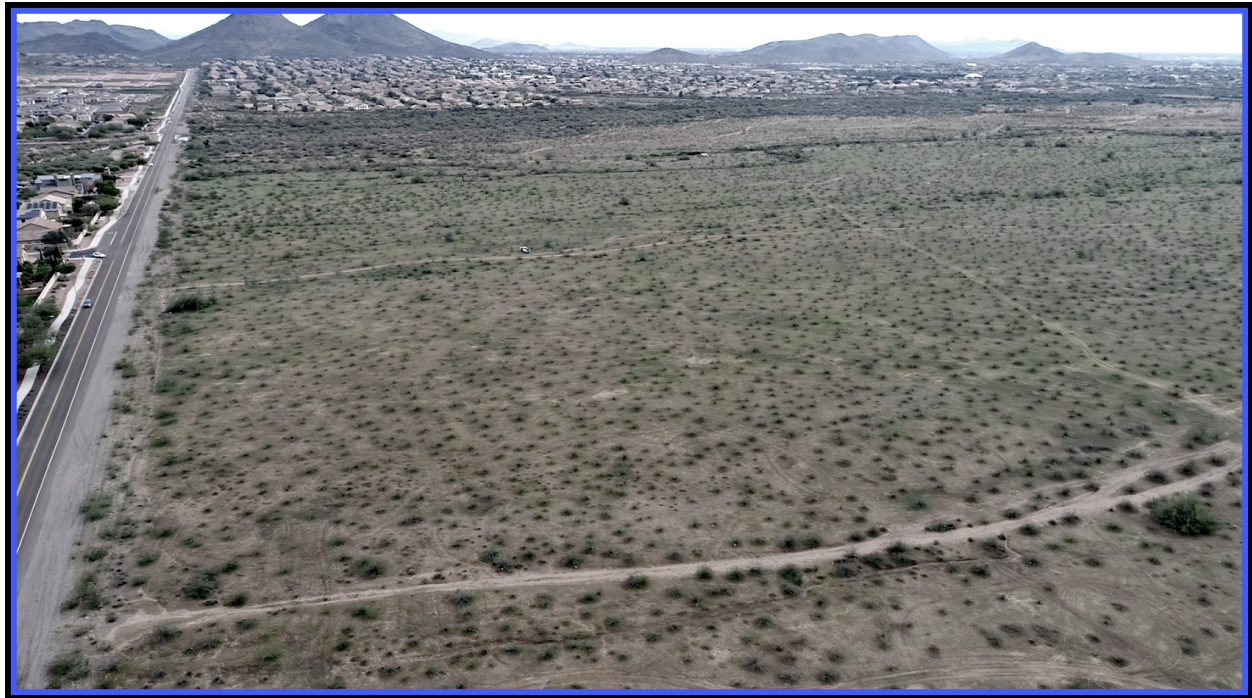
*Figure 4 - Aerial Photograph Looking South Across the Property*

The site reconnaissance was conducted on foot, while the area reconnaissance was conducted by use of a vehicle and a drone. Details of GTI's site and border zone area reconnaissance are provided in the following sections. An aerial photograph of the Property looking south is shown on Figure 4.

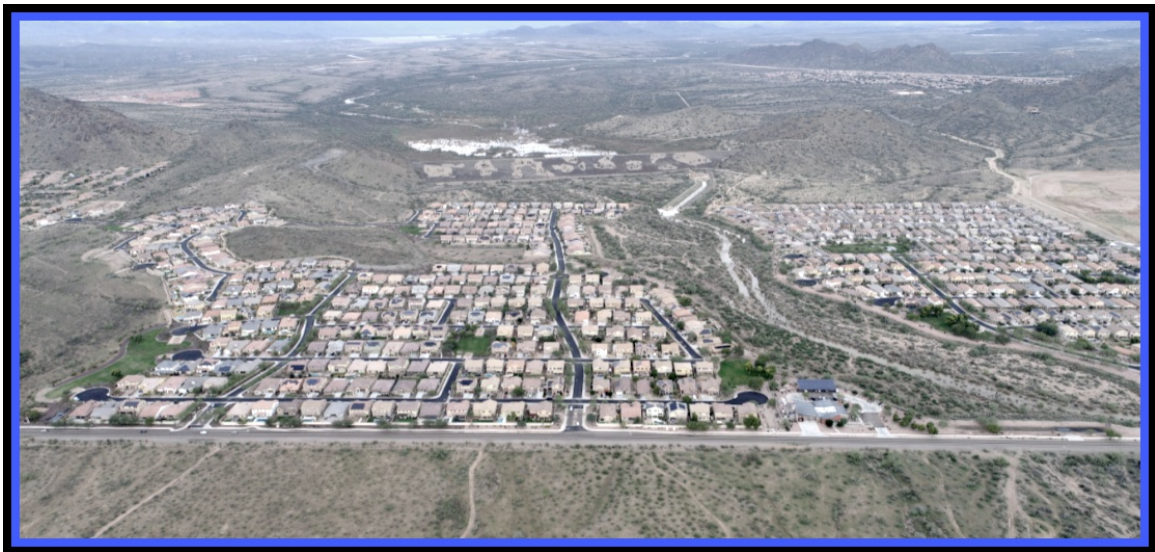
*Figure 7 - Aerial Photograph Looking North of the Property*

North of the area of the Property is an arterial road (West Jomax Road) followed by native desert land with the New River wash to the east and West Jomax Road to the North, followed by Peoria Fire Department Station 197 and the Rock Springs residential subdivisions. GTI does not believe activities at these locations result in a REC to the Property. An aerial photograph looking north of the Property is shown on Figure 7.

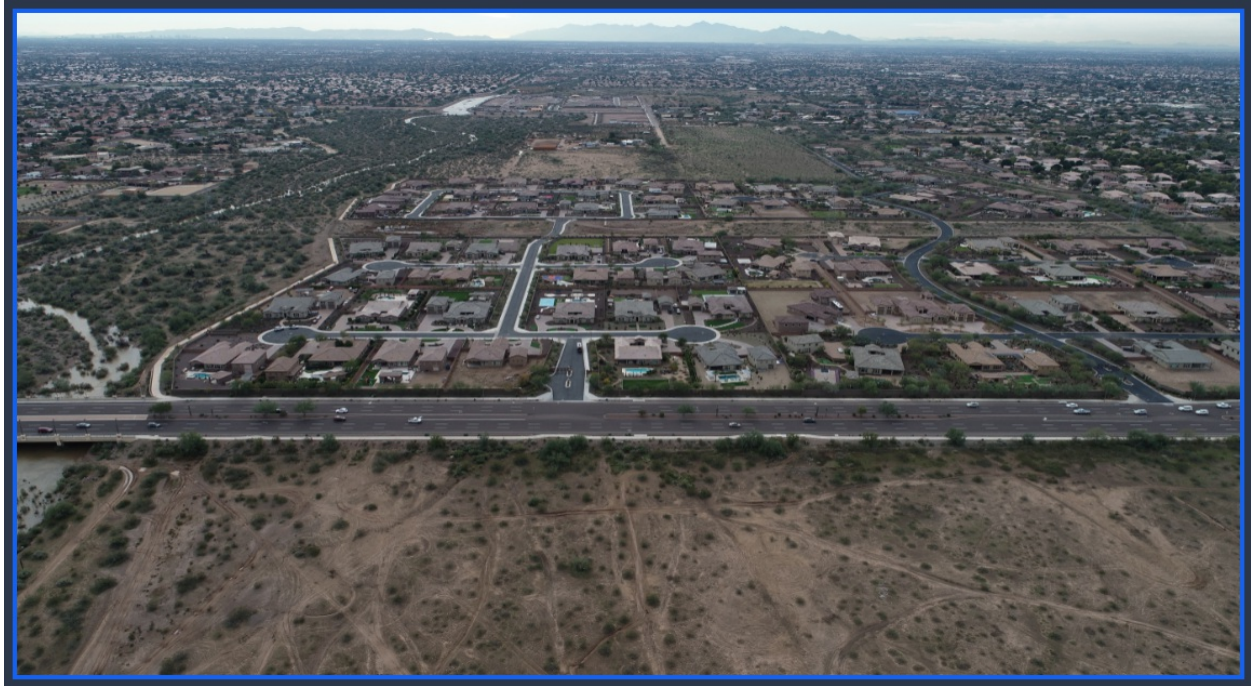
*Figure 8 - Aerial Photograph Looking South of the Property*

South of the area of the Property is an arterial road (West Happy Valley Road) followed by the Vista Montana and Caballos Del Rio residential subdivisions with the New River wash to the east. GTI does not believe activities at these locations result in a REC to the Property. An aerial photograph looking south of the Property is shown on Figure 8.

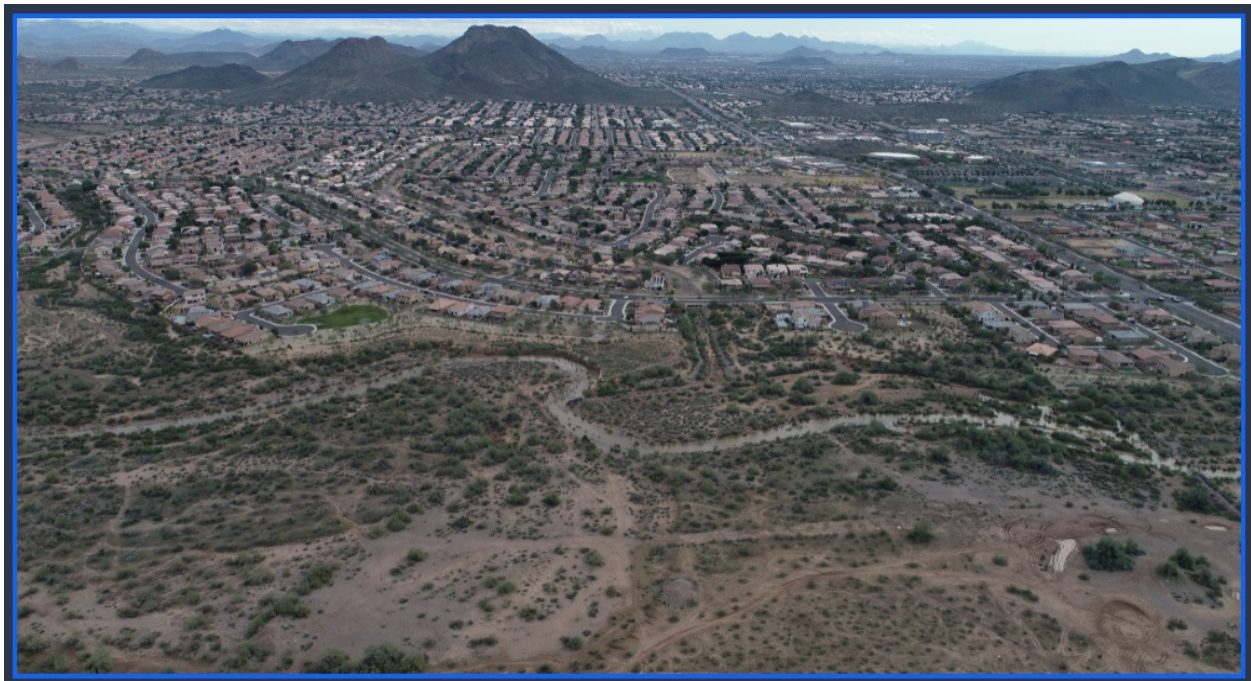
*Figure 9 - Aerial Photograph Looking East of the Property*

East of the area of the Property is the New River wash with residential subdivisions east of the watercourse. GTI does not believe activities at these locations result in a REC to the Property. An aerial photograph looking east of the Property is shown on Figure 9.

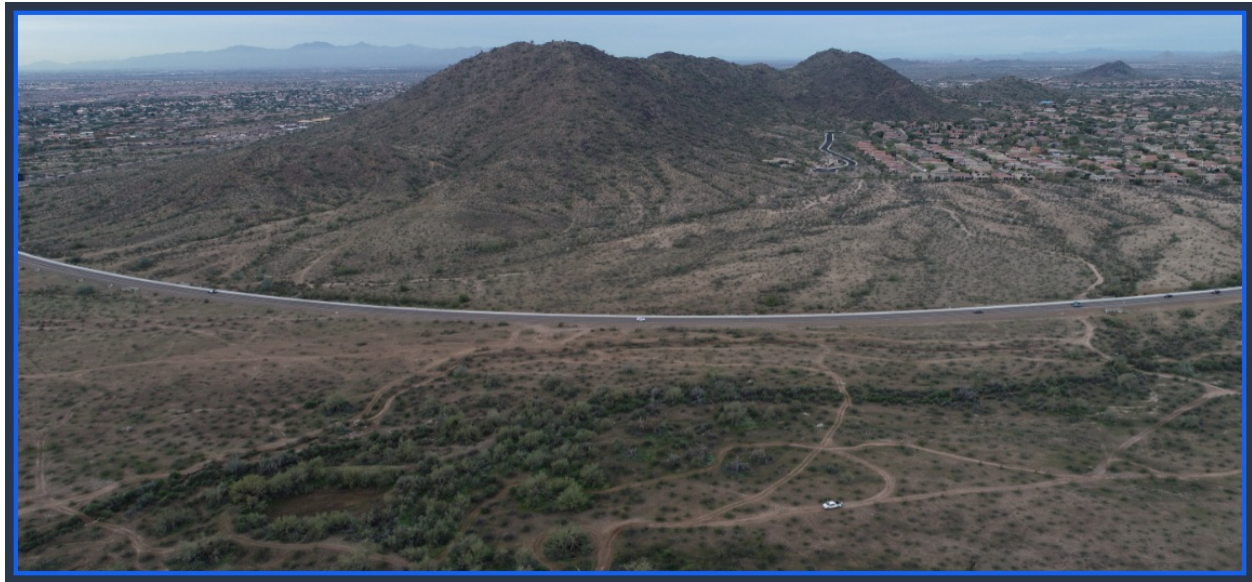
*Figure 10 - Aerial Photograph Looking West of the Property*

West of the Property is undeveloped desert land followed by North 83<sup>rd</sup> Avenue. GTI does not believe activities at these locations result in a REC to the Property. An aerial photograph looking west of the Property is shown on Figure 10.

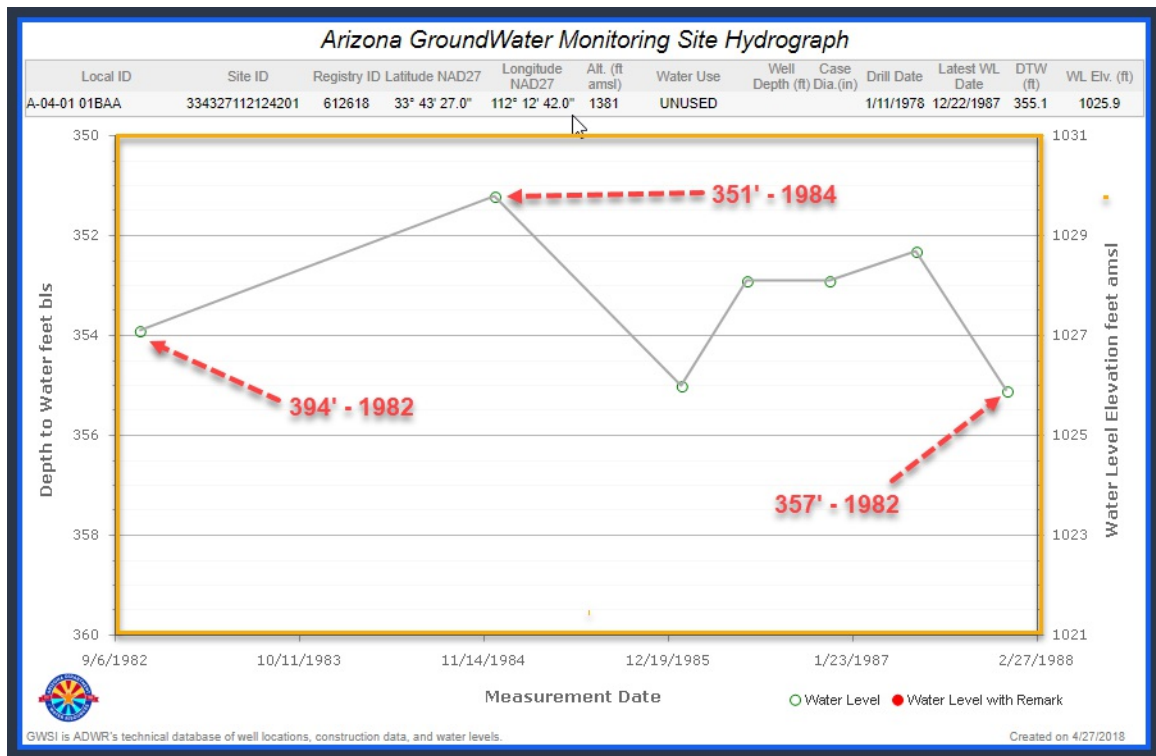
Figure 12 - Nearby Water Well Hydrograph

In addition, GTI reviewed the Arizona Groundwater Well Data for a well located approximately ¼± mile northeast of to the Property. A groundwater hydrograph for that well indicated that groundwater in 1982 was at 394± feet below the ground surface, in 1984 it was at a depth of 351± feet below the ground surface. In 1982, the water level was at 357± feet below the ground surface. A copy of this groundwater hydrograph is shown on Figure 12.

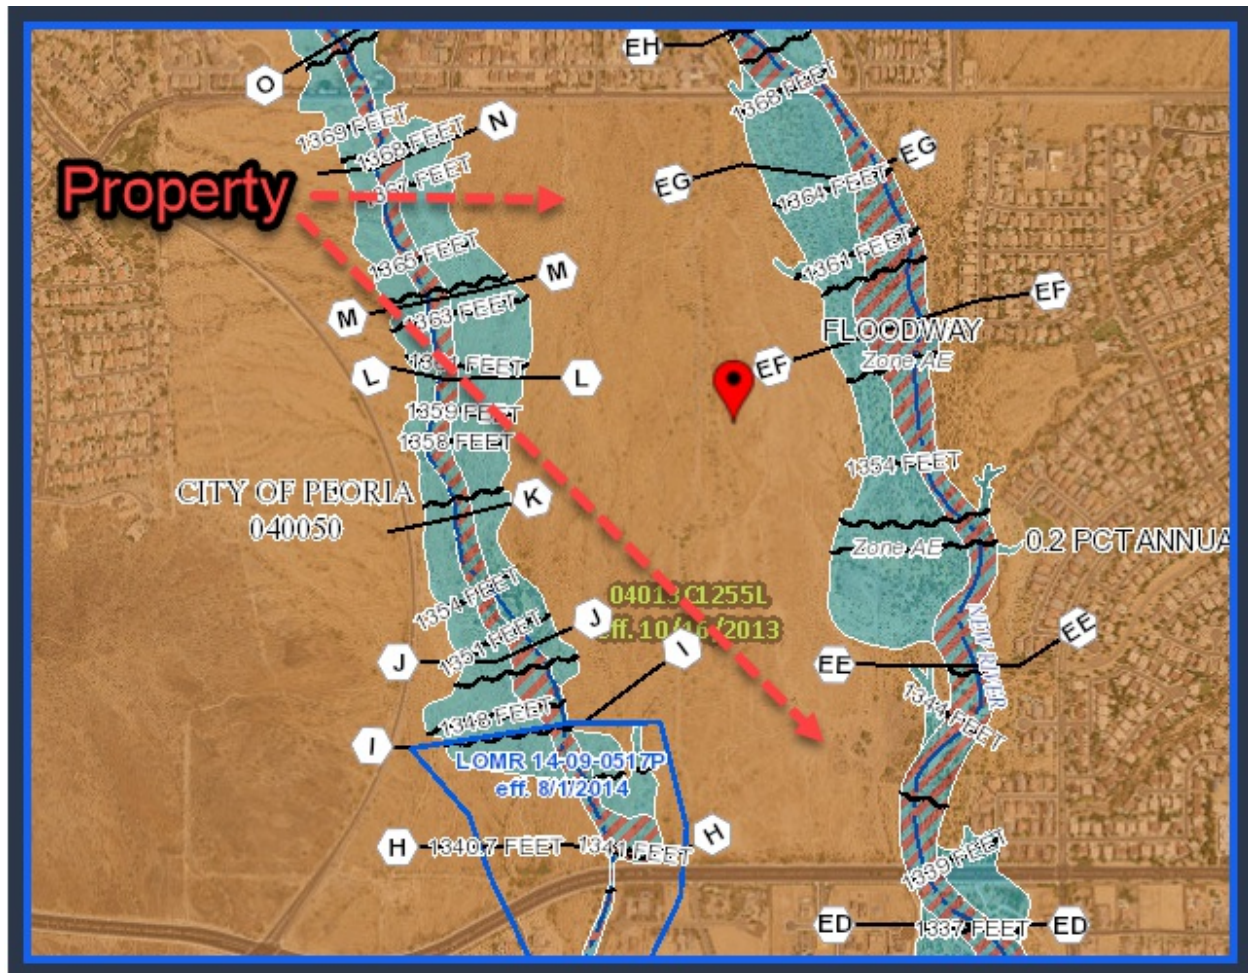
Figure 13 - FEMA Flood Insurance Rate Map

Flood Zone “X” are moderate risk areas within the 0.2 percent annual chance floodplain, areas of 1 percent chance flooding where average depths are less than 1 foot, areas of 1 percent annual chance flooding where the contributing drainage area is less than 1 square mile, and areas protected from the 1 percent annual chance flood by a levee. Flood insurance is **not** required within Flood Zone “X”.

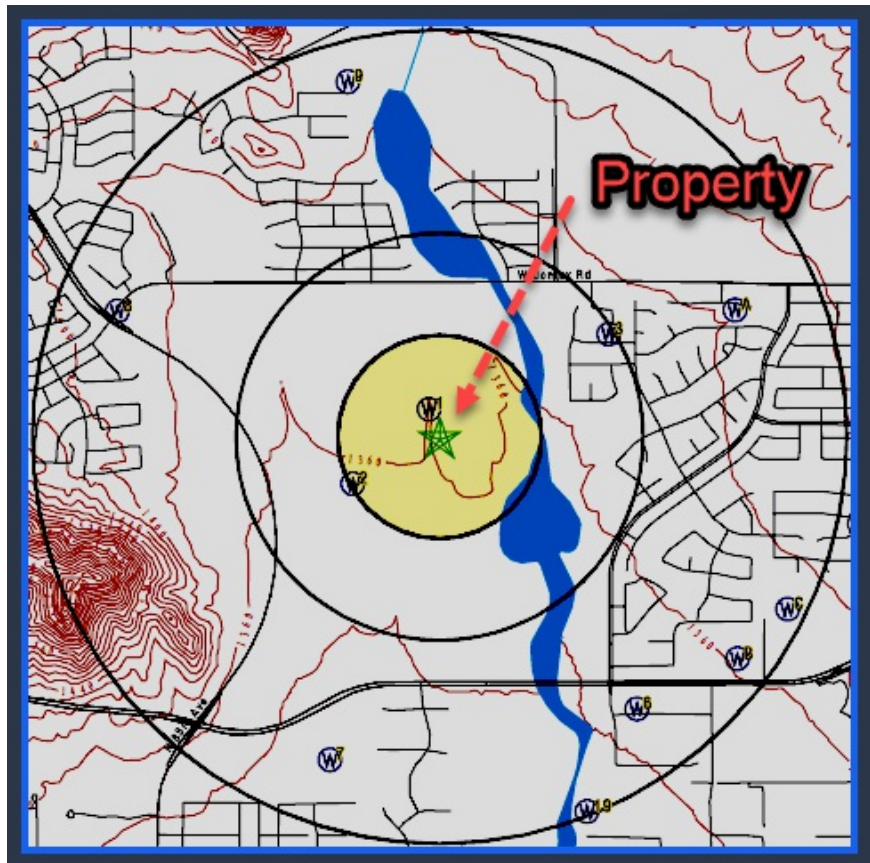
*Figure 17 - Map of FRDS Water Wells*

The Regulatory Listed Facilities search reported **nineteen (19)** water wells located within a one (1) mile radius of the Property, with one of the wells (W1) located within the 267+ Acres encompassing the Property. A map showing the Property and wells in the general vicinity is shown on Figure 17.

None of the wells identified on the Property or in the general vicinity of the Property have any citations or any other environmental issues. GTI does not believe any of these wells result in a REC to the Property.
