**PHASE I**  
**ENVIRONMENTAL SITE ASSESSMENT**

3.38 Acre Land Parcel  
14501 S. Taylor Pass Road  
Willcox, Arizona 85643

21A-0013

**May 19, 2021**

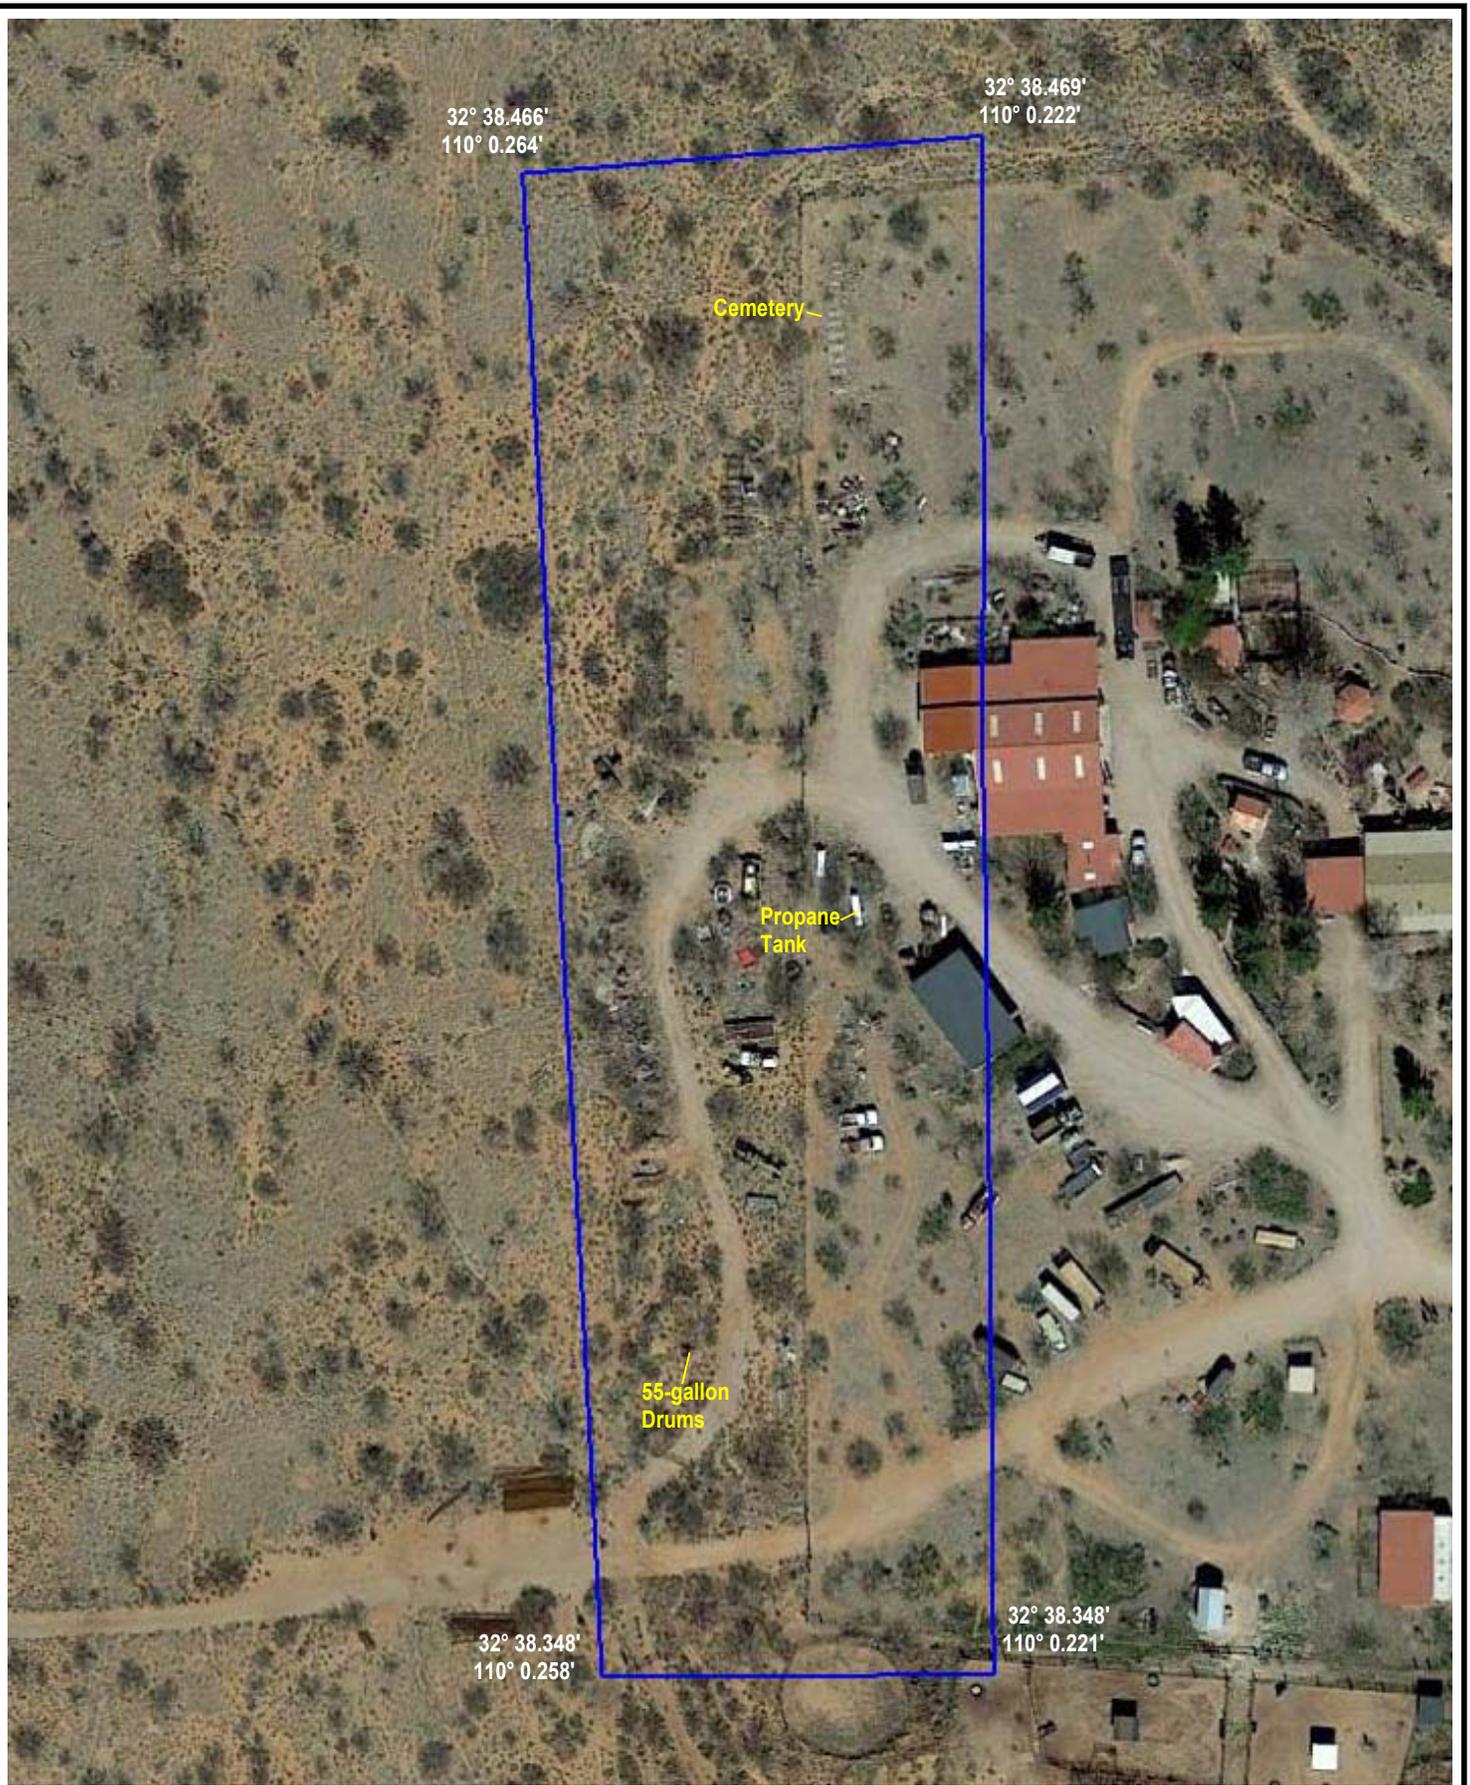
## FIGURE 2 - SITE PLAN

The Site Location Map (Figure 1) depicts the geographic location of the subject site. The Site Plan (Figure 2) depicts the general configuration of the subject site as well as pertinent site observations which are discussed further in Section 6.0 of this report.

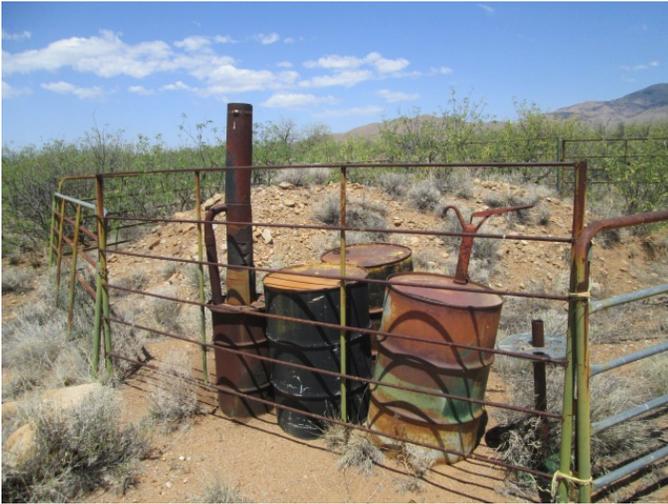
**Stored Hazardous and/or Regulated Materials/Substances:** Three (3), 55-gallon drums were observed in a fenced-in area in the southwestern portion of the subject site. All appeared to be full. While the contents of two of the drums could not be determined, one (1) appeared to contain a heavy, petroleum based grease. There was surface rust on all of the containers, but there was no evidence of physical damage, excessive corrosion or leakage. There was also a crude type of burner in this same area that was likely used to burn petroleum products and other discarded flammable liquids and materials.

**Photo 7** - View of the 3, 55-gal. drums in the southwestern portion of the subject site. One containing grease and the other two suspected to contain grease or waste oil.

Based on the current condition and remote location of the 55-gallon drums and the 5-gallon plastic bucket, and the lack of any evidence of leakage, it is our opinion that their presence does not represent a "Recognized Environmental Condition" as defined by the ASTM.

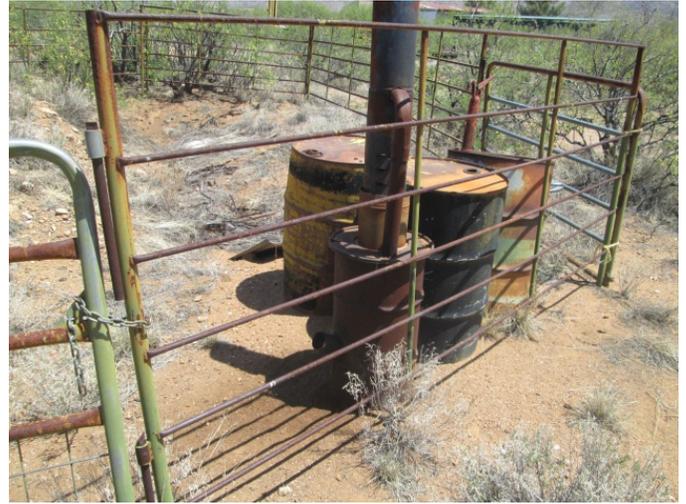
**Photo 8** - View of what appears to be some type of crude burn device indicating that this area was likely used to burn petroleum products, flammable liquids and discarded trash..

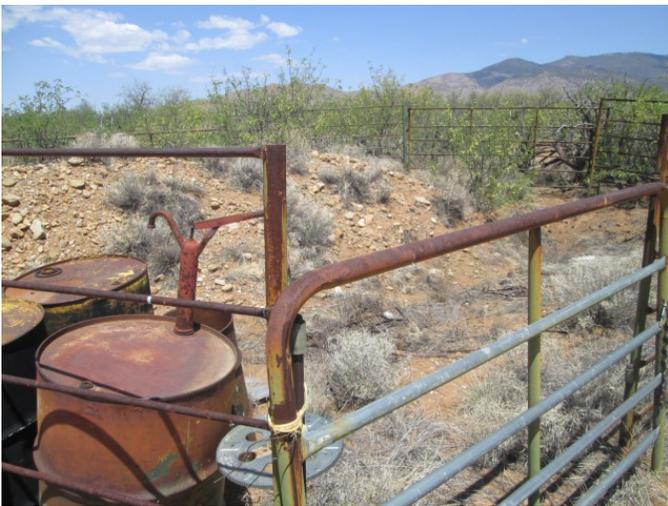
- \* Two (2) shallow excavations were observed on the subject site, one adjacent to the three (3), 55-gallon drums in the fenced-in area, and another just north of the 55-gallon drums. The one nearest the 55-gallon drums appeared to be a former "burn pit". The one to the north of the 55-gallon drums is also assumed to be a "burn pit" since it was filled with cardboard boxes that were likely to be burned, not buried. Since there was no visible soil staining or evidence to suggest anything was being buried in either area, it is our opinion that neither area represents a "Recognized Environmental Condition" as defined by the ASTM.

**Photo 9** - View of the shallow excavation adjacent to the 55-gal. drums that appeared to be a possible burn pit.

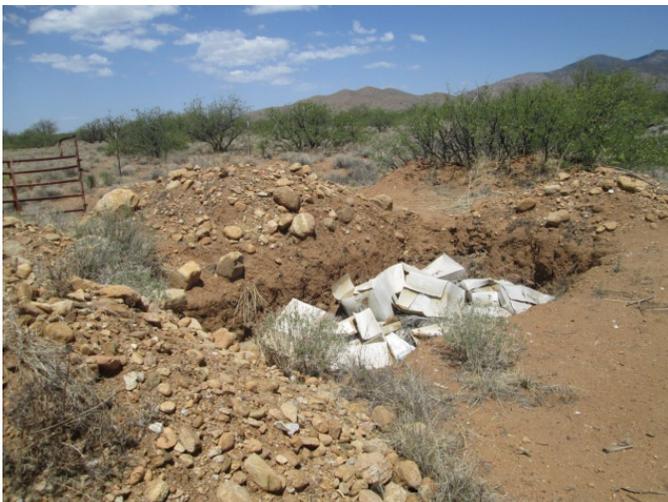
**Surface Anomalies/Depression:** Visual observations were also made to determine the presence of environmentally unusual and/or suspicious conditions such as land depressions and other surface anomalies indicative of possible wells, dump sites, leach fields or other subsurface activities. Two (2) shallow excavations were observed on the subject site, one adjacent to the three (3), 55-gallon drums in the fenced in area, and another just north of the 55-gallon drums. The one nearest the 55-gallon drums appeared to be a former “burn pit”. The one to the north of the 55-gallon drums is also assumed to be a “burn pit” since it was filled with cardboard boxes that were more likely to be burned, not buried.

**Photo 11** - View of what is suspected to be a relatively new burn pit filled with cardboard boxes ready to be burned.

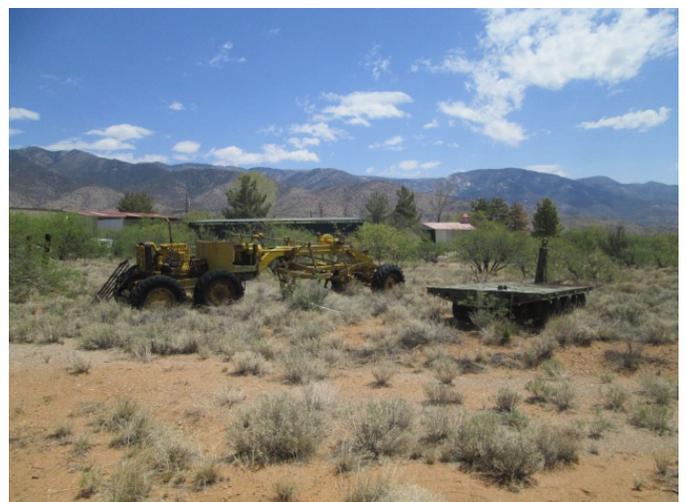
**Photo 12** - View of the old road grader and flat bed trailer in the southwestern portion of the subject site.

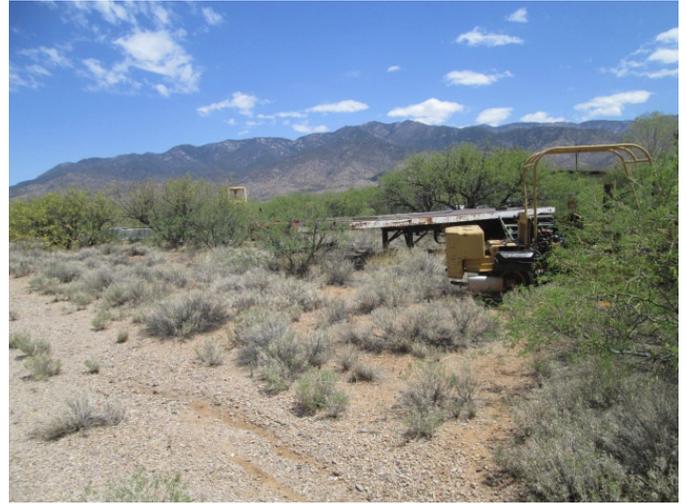
**Photo 14** - View of an old forklift and another flat bed trailer in the southwestern portion of the subject site.

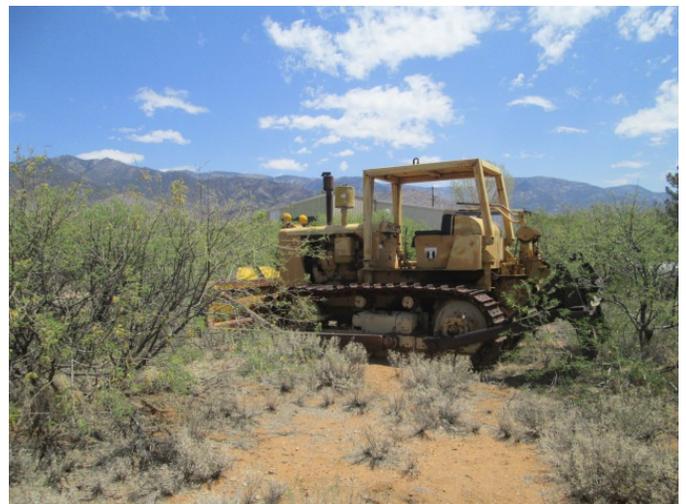
**Photo 16** - View of an old bulldozer near the center of the subject site.

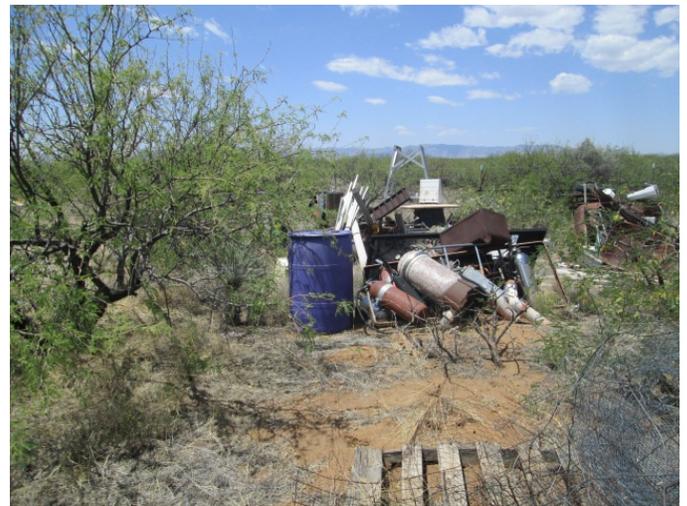
Another blue, 55-gallon drum, containing an unknown liquid, was identified in another area with other discarded materials in the northeastern portion of the subject site. This drum appeared to be in good physical condition with no evidence of physical damage, excessive corrosion or leakage.

**Photo 28** - View of another 55-gallon drum of what is assumed to be waste oil and another trash pile in the northeastern portion of the subject site.

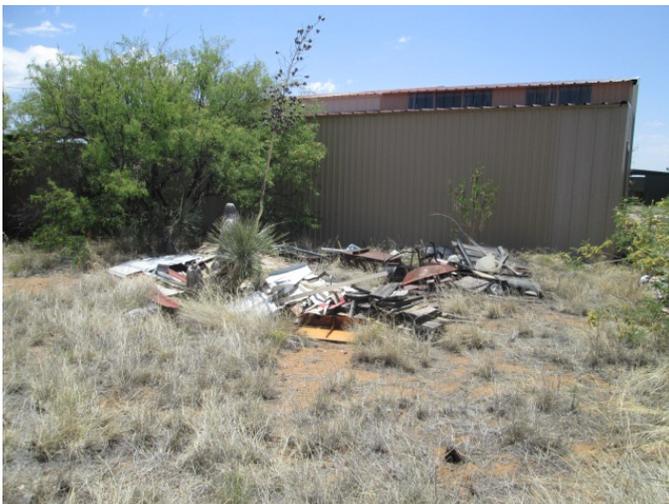
**Photo 29** - View of what appeared to be demolition debris on the north side of the garages constructed on the subject site.

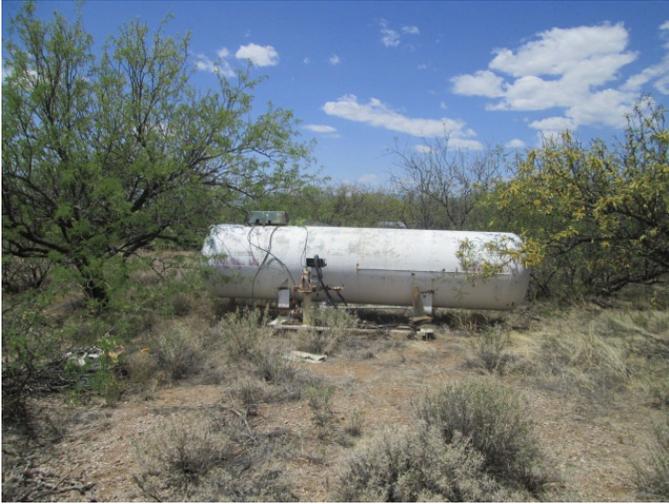
**Aboveground Storage Tanks:** One (1), roughly 750 to 1,000-gallon aboveground propane tank was observed on the north side of the building, partially constructed on the subject site. This tank appeared to be empty.

**Photo 31** - View of the propane tank near the north end of the structure that was constructed on the subject site.
